Kielty Arborist Services LLC
Certified Arborist WE#10724A TRAQ Qualified
P.O. Box 6187
San Mateo, CA 94403
650-532-4418

Site: 1385 Hillside Circle, Burlingame, CA

As requested on December 4th, 2023, Kielty Arborist Services visited the above site to provide a Tree Inventory Report/Tree Protection Plan for the proposed construction. 3 new homes are proposed for this site, and your concern as to the future health and safety of the tree has prompted this visit. Preliminary landscape plans L1 through L7 dated January 2024, lot 1 site plans A.1 through A.6 dated 10/26/22, lot 2 site plans A.1 through A.6 dated 10/26/21, and lot 3 plans A.1 through A.8 dated 10/26/21 were also reviewed for writing this report. This Tree Inventory Report is not a Tree Risk Assessment. As such, no trees were assessed for risk in accordance with industry standards, nor are there any tree risk ratings or risk mitigation recommendations provided within this preservation plan.

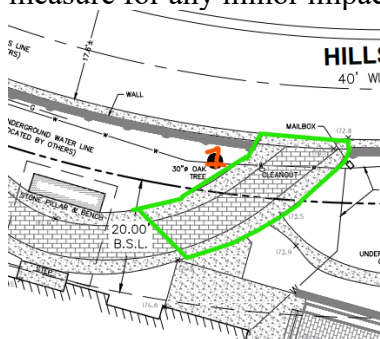
Oak tree #1 is to be retained. The tree is adjacent to an existing driveway. It is recommended to temporarily retain the existing driveway near this tree when underneath the dripline of the tree during the building phase of the project. Temporarily retaining the driveway will act as a tree protection measure and will help to increase staging and access to the site, as removing the driveway at the beginning of the project would make for a larger tree protection zone needed with the fencing being located at the tree's drip line. The existing grade within the tree's dripline is recommended to be retained as is where possible. No grading or excavation is recommended to take place within 10' from this tree (6x diameter) except for the removal of the driveway. At the end of the project, when it is time to demolish the existing driveway near this tree, the Project Arborist is

Showing portion of driveway recommended to be retained until the landscape phase of the project.

recommended to be on-site to document and witness the removal of the driveway. A jackhammer is recommended to be used when working within the tree's dripline to break the concrete material into hand manageable-sized pieces. Once broken down the driveway material is recommended to be removed by hand. Exposed roots during the process are recommended to be wrapped in layers of wetted-down burlap to avoid root desiccation. The existing driveway area is recommended to be filled back in once the driveway has been removed so that no roots are exposed to the elements. When backfilling the soil in this area, the area is also to be irrigated. The proposed driveway is further from the tree than the existing driveway and outside of the 10' range and is not expected to have impacts on the tree. The tree is recommended to be deep water fertilized with Nutriroot once the work near the tree has taken place as a mitigation measure for any minor impacts that may take place.
