# Advanced Tree Care

Re: Coastal redwood at front of property

This letter provides the justification for the proposed removal of two redwood trees located at 1347 Montero Avenue, Burlingame, California. The evaluation is based on visual ground-level inspection and assessment of tree health, structural integrity, form, suitability for preservation, and site constraints. The findings are presented in alignment with the City of Burlingame ordinance criteria for public nuisance determinations and permit review factors.

TREE INVENTORY SURVEY

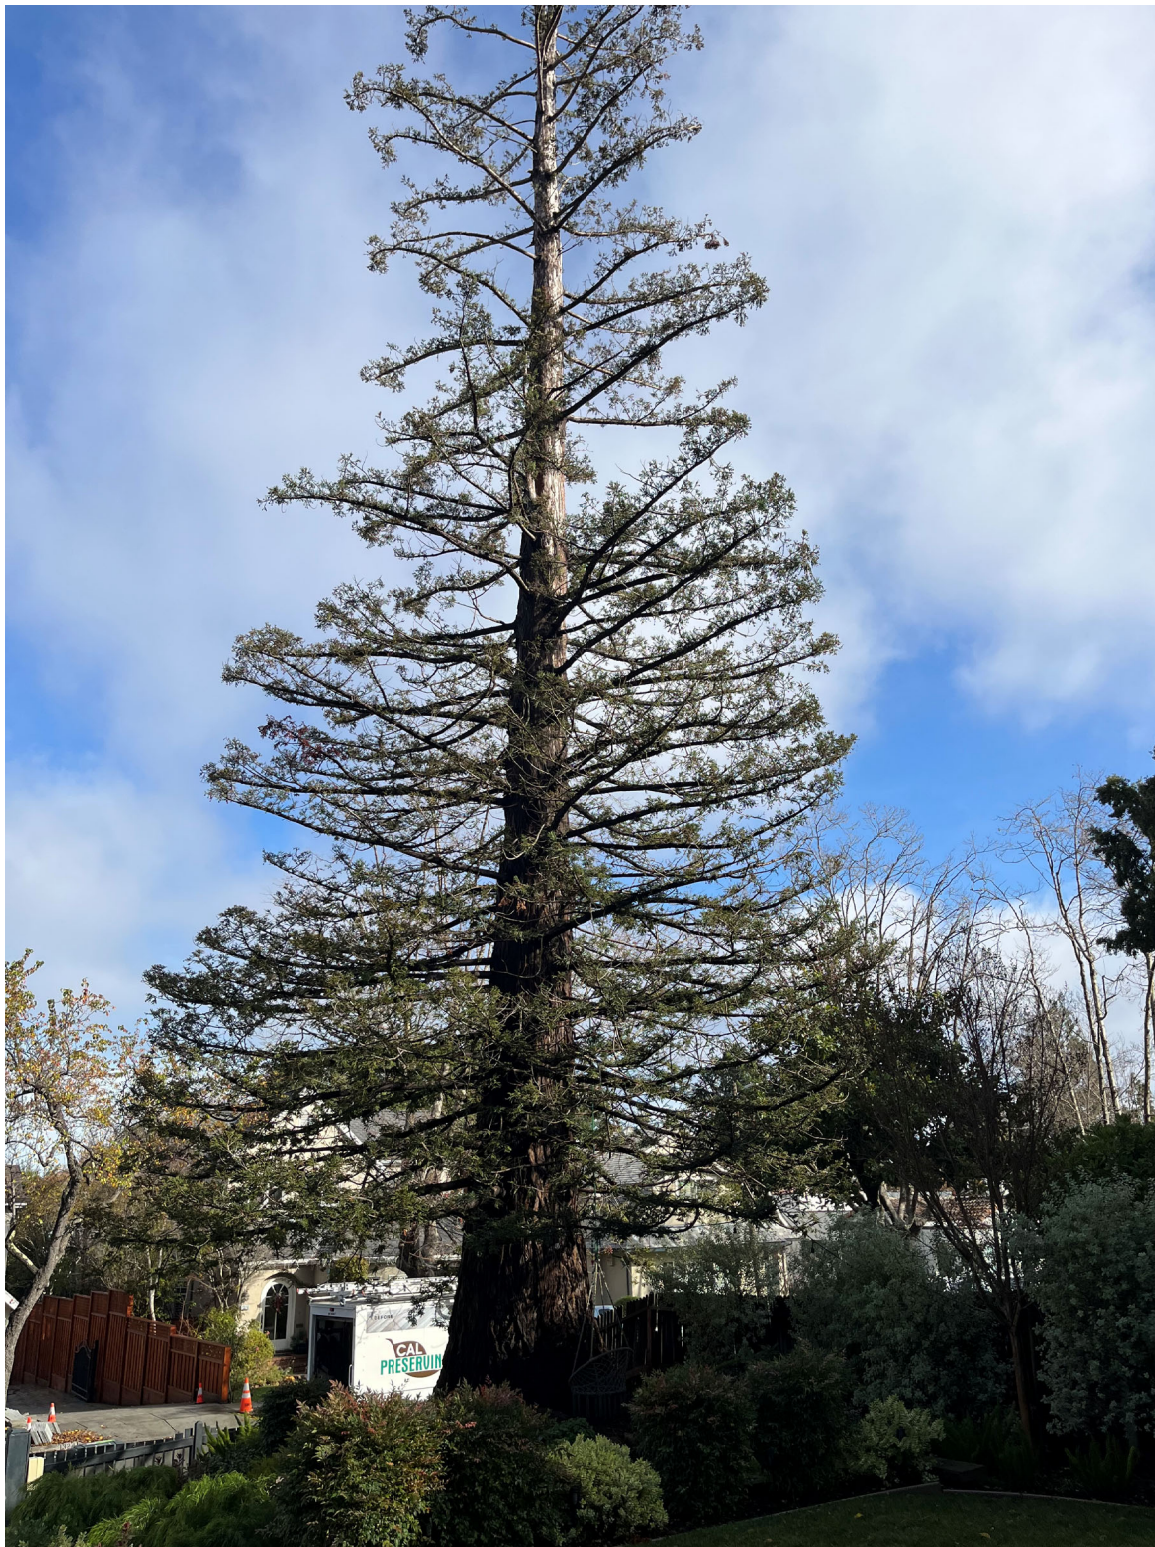
The coastal redwood is in poor health and fair condition. The diameter of the trunk of the tree is quite large for the height of the tree and the tree appears to almost be stunted in growth. The canopy is very thin. The trunk is straight with no co-dominant stems, the root crown is large with no signs of disease or insect infestation.

Looking at photos from google street view dating back to 2008; the tree was in fairly good health up until 2019 when the canopy started to thin out. The decline has been gradual but is quite noticeable. There are very few changes in the surrounding area that may account for this decline. Maybe available irrigation in the surrounding landscapes have changed. Heavier rain in more recent years do not appear to have changed the appearance of the tree. The structural stability of the tree looks good with the root system intact.

The coastal redwood relies on coastal fog for its water supply. With the current climate, this has not been available and may be a reason for the tree's decline.

The coastal redwood at the front of the house

The tree could be deep root fertilized to try to encourage a healthier canopy, however the available root zone in to which liquid fertilizer can be pumped is minimal, and this may not have any noticeable effect.

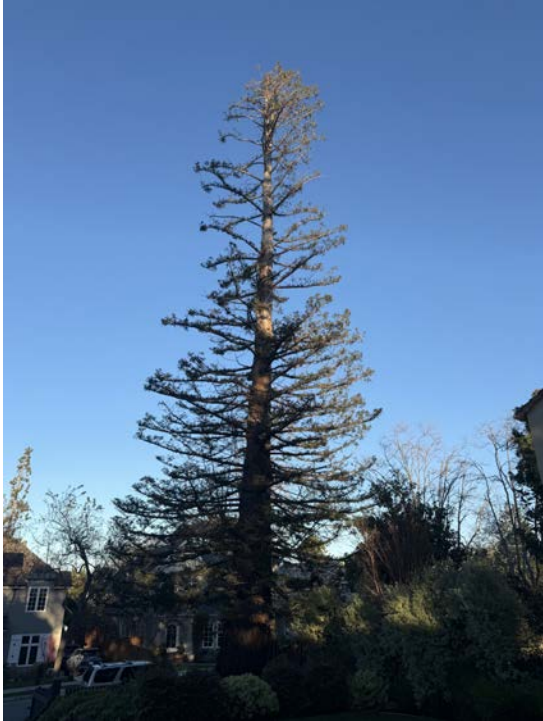
### Showing redwood tree #1 in very poor condition

#### Redwood Tree #1 (Diameter 68.5 inches, approximately 90 feet tall, 30-foot canopy spread)

Redwood Tree #1 is in severe decline and exhibits poor overall health, poor structural integrity, fair form, poor suitability for preservation, and an overall poor condition rating of 20 percent. Observed defects include a previously failed top, codominant stem structure at the top of the canopy, and extremely sparse foliage, indicating significant loss of vigor and a trajectory of continued decline. The tree is not expected to improve with mitigation measures, given the extent of its structural and physiological degradation.

Pursuant to the ordinance, this tree meets the definition of a public nuisance as follows: "Any of the following are determined to be public nuisances, subject to the provisions of Chapter 1.12 and Chapter 1.16: (1) A dead, diseased, infested or dying tree or vegetation on private property or property not owned by the city." Redwood Tree #1 is classified as a dying tree based on its advanced decline and poor vigor.

Based on the above findings, Redwood Tree #1 and Redwood Tree #3 meet multiple ordinance criteria for removal due to advanced decline, poor structural integrity, elevated risk of failure, proximity to high-value targets, and ongoing damage to existing structures. Removal of both trees is recommended to mitigate safety hazards, prevent further structural damage, and comply with City ordinance standards.

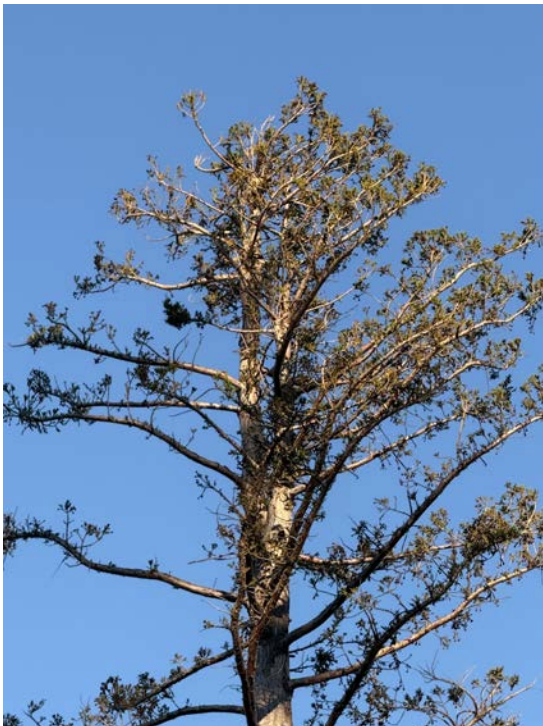
### Showing the top of redwood tree #1, notice the dead wood and codominance

In reviewing the application, the ordinance requires the director to weigh “The condition of the tree(s) with respect to: Disease, decay, structure, form and vigor, likelihood and consequences of failure and impact proximity to existing or proposed structures, yards, driveways and other trees, infrastructure and growing space constraints, utilities and improvement conflict, species desirability and age of the tree relative to average urban life span typical of the species.” Redwood Tree #1 exhibits poor structure and vigor, with a high likelihood of failure due to its codominant structure at the top of the canopy. The consequences of failure are significant, as potential targets include vehicles on the street and driveway, pedestrians on the sidewalk, and occupants within vehicles. Given the advanced decline and lack of feasible mitigation measures that would restore structural stability or vigor, removal is recommended.

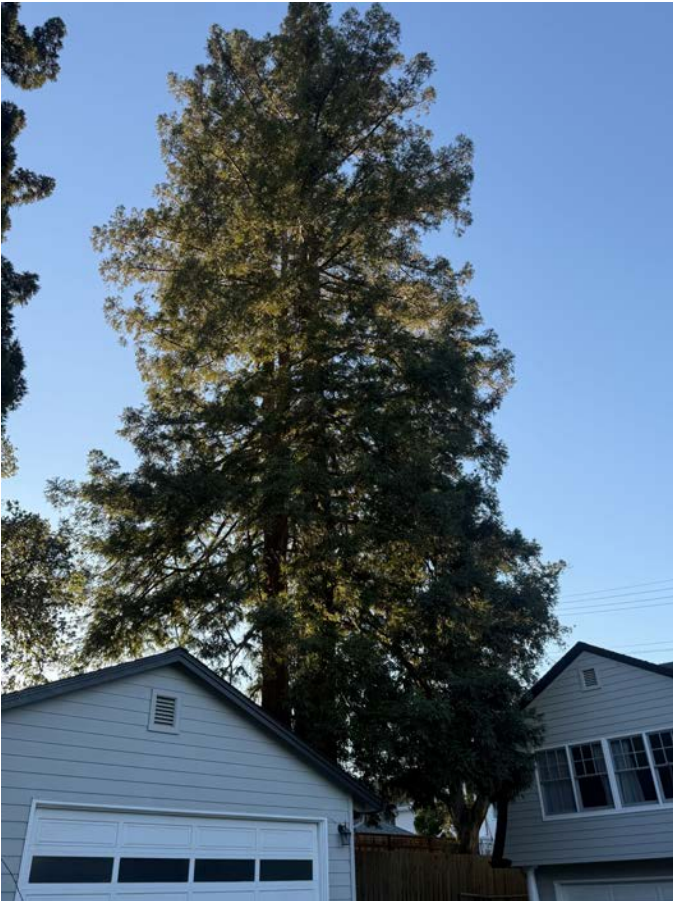
**Showing redwood tree #3 in question**

**Redwood Tree #3 (Diameter 66.7 inches, approximately 90 feet tall, 45-foot canopy spread)**

Redwood Tree #3 exhibits fair health but poor structural integrity, fair form, poor suitability for preservation, and an overall poor condition rating of 45 percent. The tree is codominant at approximately five feet above grade with a seam extending to the root crown, indicating weak attachment and elevated failure potential. A secondary codominant leader is present at approximately forty feet, with weak unions that further increase the likelihood of structural failure. The tree is located approximately four feet from the existing detached garage, and the root flare is directly abutting the garage foundation, where swelling roots are causing damage to the garage slab. The tree is also located approximately five and one-half feet from the brick retaining wall at the driveway and poses a risk of large leader failure or limb failure impacting the garage and adjacent overhead utility lines.

The ordinance requires consideration of “The condition of the tree(s) with respect to: Disease, decay, structure, form and vigor, likelihood and consequences of failure and impact proximity to existing or proposed structures, yards, driveways and other trees, infrastructure and growing space constraints, utilities and improvement conflict, species desirability and age of the tree relative to average urban life span typical of the species.” Redwood Tree #3 has poor structure, weak codominant unions, and constrained growing space adjacent to permanent structures. The likelihood of limb or leader failure is elevated, and the consequences of failure are significant to severe due to the proximity of the garage, driveway, and overhead utilities.

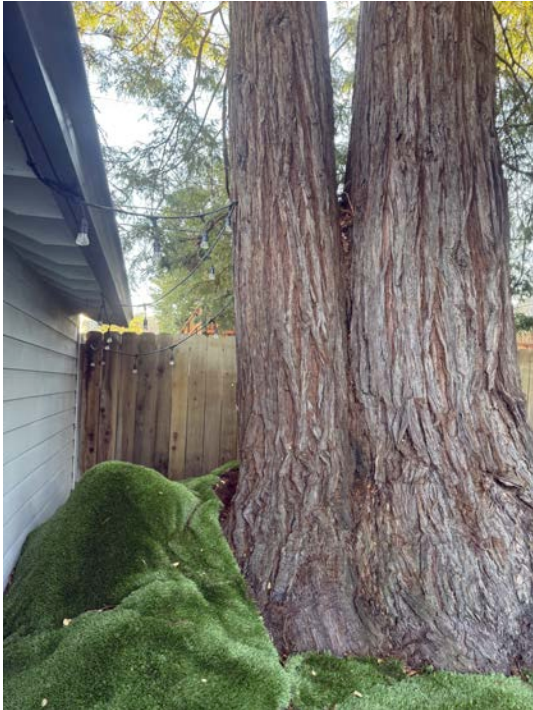
Additionally, Redwood Tree #3 meets the ordinance criterion that “That the tree or its roots are causing, or threatening to cause, damage to any main structure on the property or on any adjacent property and there are no reasonable alternative means to mitigate the damage or threatened damage. Reasonable alternative means of mitigation include, but are not limited to, cutting tree roots, trimming the tree canopy, or installing a root barrier. Removing, relocating, or in any way altering any main structure on the property shall not be considered a reasonable alternative means of mitigation for the purposes of this section.” The tree’s roots are actively damaging the existing garage slab. Installation of a root barrier is not a reasonable mitigation measure, as root cutting within the critical root zone would require removal of portions of the root crown, thereby destabilizing the tree and increasing the risk of a failure at the root crown. Canopy pruning would not address the underlying structural root conflict or weak codominant attachments. Therefore, no reasonable alternative mitigation measures are available that would prevent ongoing structural damage while maintaining tree stability.

**Showing the tree in relation to the garage**

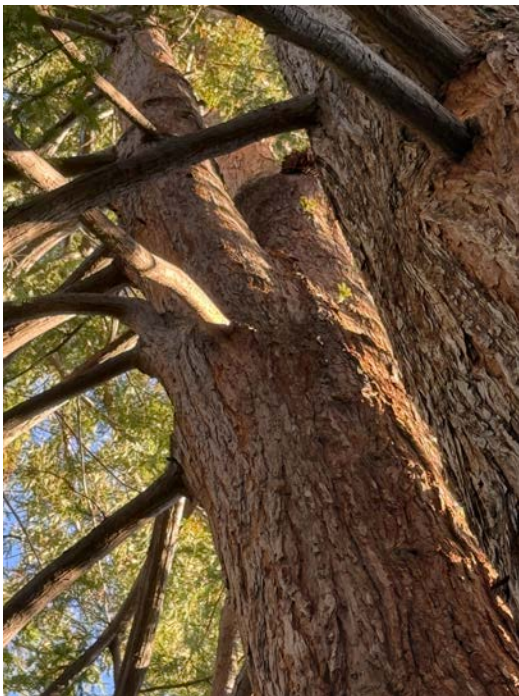
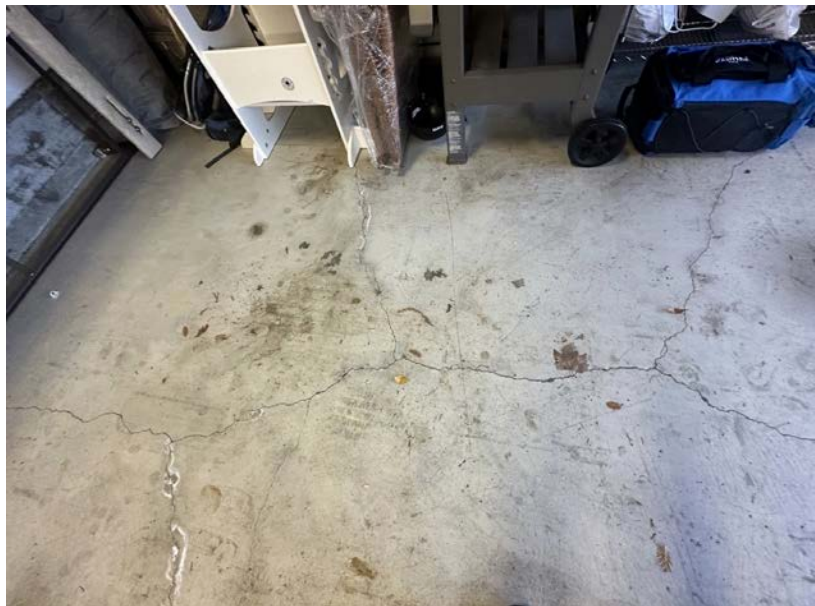
**Showing the leader closest to the garage becoming codominant again at 40’ (left), showing the interior of the garage and cracking along the garage floor (right)**

| Tree Tag Number | Protected Tree Status | Preservation or Removal Recommendation | Common Name / Botanical Name | Trunk Diameter at Breast Height (DBH, inches) | Tree Height (ft.) / Canopy Spread (ft.) | Overall Health Assessment | Structural Integrity Assessment | Form and Aesthetic Quality Assessment | Preservation Suitability Rating | Overall Condition Score (0-100%) | Arborist Observations and Tree Notes |
|---|---|---|---|---|---|---|---|---|---|---|---|
| 3 | Yes | (R) | Redwood<br><i>Sequoia sempervirens</i> | 66.7 | 90/45 | Fair | Poor | Fair | Poor | 45 | Codominant at 5' with seam running down to grade. Smaller leader closest to garage becomes codominant again at 40 feet. Weak attachments at codominant unions, 4 feet from existing garage. Swelling root flare up against garage foundation, causing damage to garage slab, covered in artificial turf. 5.5 feet from the brick retaining wall at the driveway, at risk of large leader failure damaging the garage and adjacent overhead utility lines. |
