# 1437 Cabrillo Avenue Burlingame, CA Arborist Report 2026

Attn: Kieran Woods  
 Subject: Tree protection plan for 1437 Cabrillo Ave, Burlingame, CA 94010

Kielty Arborists Services LLC visited the property at 1437 Cabrillo Ave, Burlingame, on December 31, 2025, to evaluate the trees present with respect to the proposed construction project. The report below contains an analysis of the site visit. Kieran Woods is planning a remodel to the existing home and the addition of a second story. The site consists of a residential home, driveway, landscaping, and mixed tree species. The findings and recommendations presented in this report are based on the construction plans titled *1437 Cabrillo Ave* by Mark Brand Architecture. These plans were electronically provided to us via email and are dated September 29, 2025. By thoroughly analyzing these plans in conjunction with our field observations, we have developed an accurate and reliable assessment of the tree conditions and how best to mitigate potential impacts.

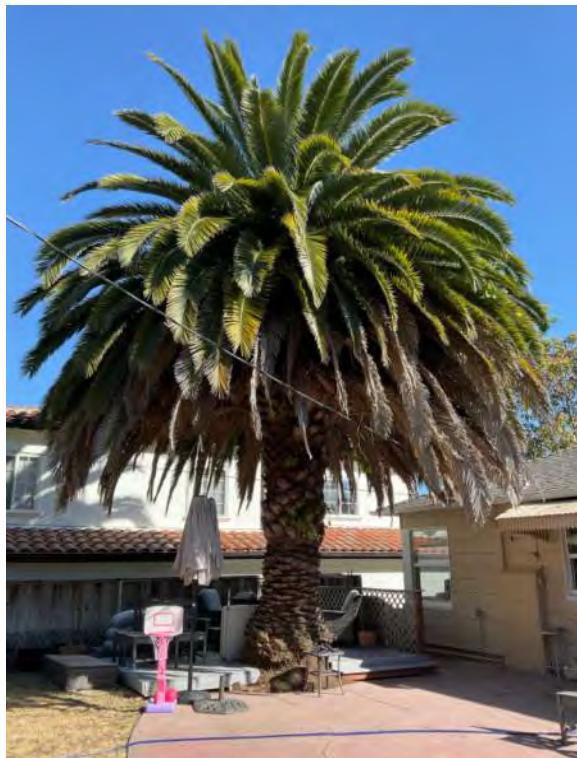
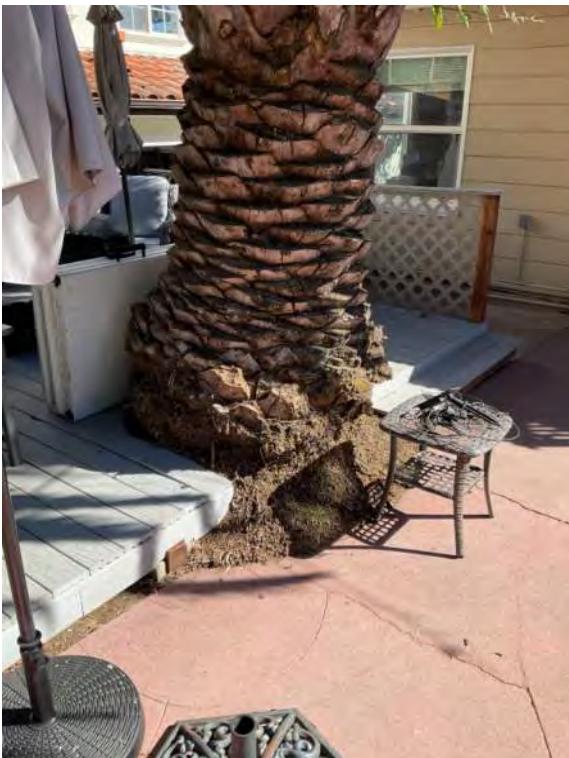
**Protected trees to be removed:****Tree Assessment and Removal Justifications:**Tree tag #1 - Canary island date palm (*Phoenix canariensis*)

Canary Island date palm #1 was assigned a fair condition rating. Tree Health, Structure, and Form were rated good overall, while Suitability for Preservation was rated fair. The tree is located in the backyard, approximately 10 feet from the existing home. Maintenance has occurred in the past throughout its lifespan, but an abundance of lower dead fronds is present. The tree is surrounded by patio hardscape and a wooden deck. Cracking is noted on the adjacent hardscape where the root fiber mass is growing on top of the concrete. The tree is also proposed for removal as a part of the development plan, as an outdoor kitchen/BBQ area is proposed within its footprint.

The tree's position on the landscape and condition issues jeopardize its health, stability and structural integrity, making it a high-risk tree for the property owner. Failure of the tree fronds could result in injury to residents and damage to the home. Removal of the palm is recommended and aligns with the following tree removal criteria set forth by the City of Burlingame:

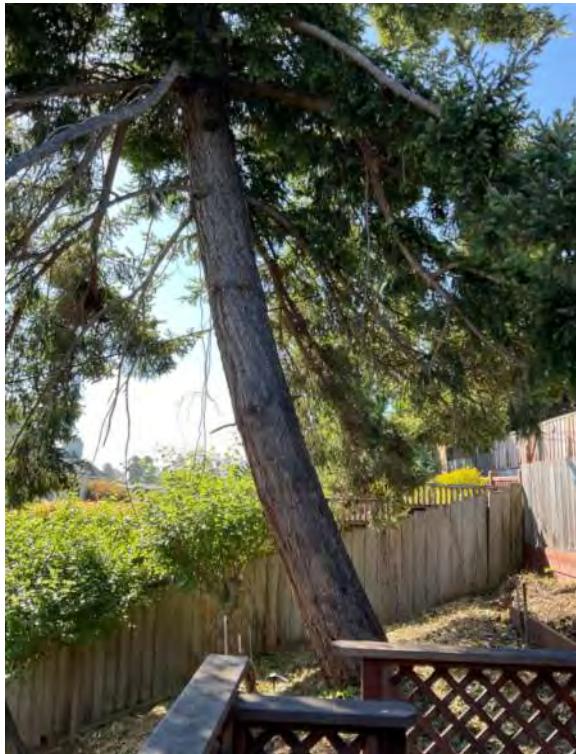
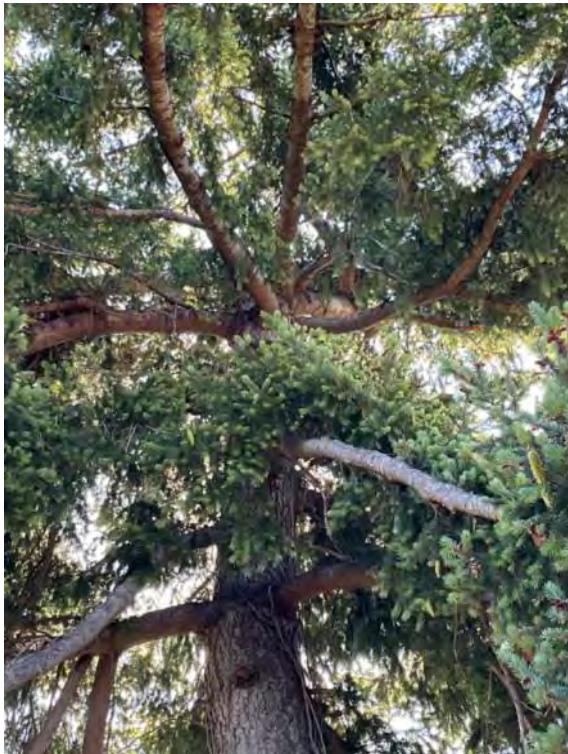
Douglas-fir #2 was assigned a fair condition rating. Tree Health was rated good, with Structure rated poor, and Form rated fair. Suitability for Preservation was rated poor. The tree is located on a slope above the backyard. Multiple codominant leaders originate from the main stem about 45 feet above grade. A flat top is visible due to main stem failure in the past. Curvature of the main stem extends towards the existing home on site, and towards the neighboring home. Lean has been corrected. The irregularly shaped crown has been pruned away from the neighbor's property boundary.

A coniferous tree exhibiting a codominant top, particularly one that has developed as a consequence of a prior structural failure, presents challenges regarding its long-term structural integrity and overall health. Codominant stems are problematic due to the weak points created at their junctions. Codominant stems share a common attachment point, which leads to structural instability. This weakness makes the tree highly susceptible to failure, especially when subjected to environmental stressors such as storms and high winds. The presence of included bark further exacerbates this structural vulnerability.

The tree's position on the landscape and condition issues jeopardize its health, stability and structural integrity, making it a high-risk tree for the property owner. Failure of the tree or branches could result in severe injury to residents and damage to adjacent homes. Tree removal is also proposed to allow a new retaining wall to be built as the property is sloped. This will make the backyard of the home more functional for use. Removal of the tree is recommended and aligns with the following tree removal criteria set forth by the City of Burlingame:
