**Kielty Arborist Services LLC**  
Certified Arborist WE#10724A TRAQ Qualified  
P.O. Box 6187  
San Mateo, CA 94403  
650-532-4418

February 16<sup>th</sup>, 2024

Site: 1385 Hillside Circle, Burlingame, CA

As requested on December 4<sup>th</sup>, 2023, Kielty Arborist Services visited the above site to provide a Tree Inventory Report/Tree Protection Plan for the proposed construction. 3 new homes are proposed for this site, and your concern as to the future health and safety of the tree has prompted this visit. Preliminary landscape plans L1 through L7 dated January 2024, lot 1 site plans A.1 through A.6 dated 10/26/22, lot 2 site plans A.1 through A.6 dated 10/26/21, and lot 3 plans A.1 through A.8 dated 10/26/21 were also reviewed for writing this report. This Tree Inventory Report is not a Tree Risk Assessment. As such, no trees were assessed for risk in accordance with industry standards, nor are there any tree risk ratings or risk mitigation recommendations provided within this preservation plan.

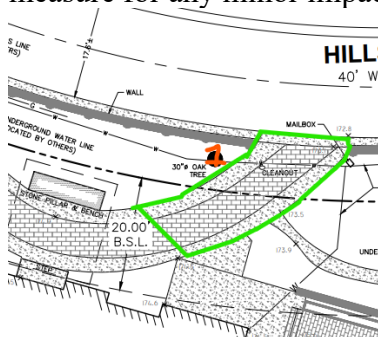
**Showing portion of driveway recommended to be retained until the landscape phase of the project.**

Oak tree #1 is to be retained. The tree is adjacent to an existing driveway. It is recommended to temporarily retain the existing driveway near this tree when underneath the dripline of the tree during the building phase of the project. Temporarily retaining the driveway will act as a tree protection measure and will help to increase staging and access to the site, as removing the driveway at the beginning of the project would make for a larger tree protection zone needed with the fencing being located at the tree's drip line. The existing grade within the tree's dripline is recommended to be retained as is where possible. No grading or excavation is recommended to take place within 10' from this tree (6x diameter) except for the removal of the driveway. At the end of the project, when it is time to demolish the existing driveway near this tree, the Project Arborist is

recommended to be on-site to document and witness the removal of the driveway. A jackhammer is recommended to be used when working within the tree's dripline to break the concrete material into hand manageable-sized pieces. Once broken down the driveway material is recommended to be removed by hand. Exposed roots during the process are recommended to be wrapped in layers of wetted-down burlap to avoid root desiccation. The existing driveway area is recommended to be filled back in once the driveway has been removed so that no roots are exposed to the elements. When backfilling the soil in this area, the area is also to be irrigated. The proposed driveway is further from the tree than the existing driveway and outside of the 10' range and is not expected to have impacts on the tree. The tree is recommended to be deep water fertilized with Nutriroot once the work near the tree has taken place as a mitigation measure for any minor impacts that may take place.
