# 121 Pepper Avenue Burlingame, CA Arborist Report 2024

January 9th, 2025. **Revised April 7, 2025**

Subject: Tree protection plan for 121 Pepper Ave, Burlingame, CA 94010

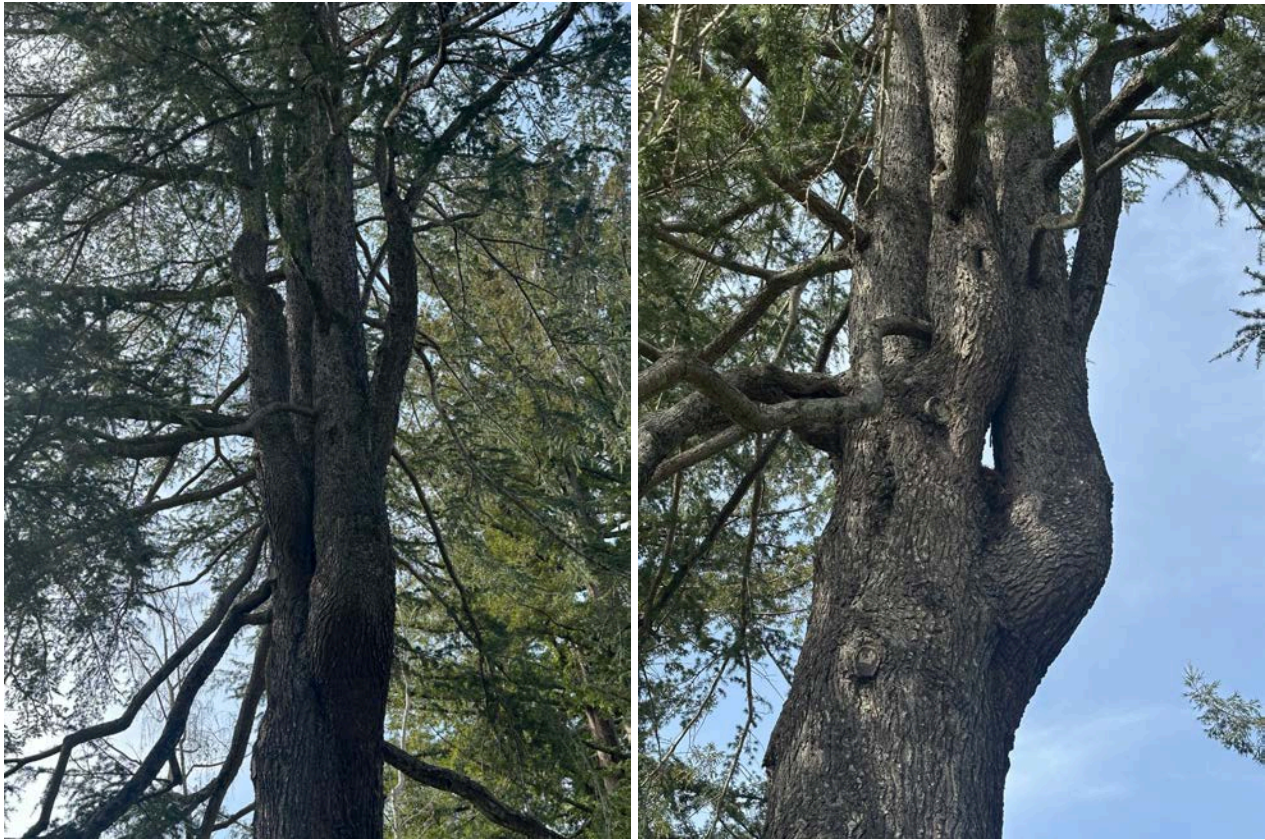
**PHOTOS OF TREE #3**

Tree tag #3 - deodar cedar was assigned a poor condition rating. The tree exhibits codominance of the main stem 30 feet above grade and previous limb loss. A cavity, debris, and included bark are visible at the codominant union. The cavity at the codominant union with included bark makes the tree a hazard to property residents, pedestrians, and construction personnel, as the tree is at risk of a significant leader failure. A Level II Tree Risk Assessment was performed on the tree and documentation will be included in this report outlining the findings.

A Level II Tree Risk Assessment was conducted on deodar cedar #3. The tree parts of most concern are the large codominant leaders attached to the main stem approximately 30' above grade. The tree has multiple leaders with included bark observed in the union and a cavity. Swelling at the union was observed, indicating the presence of included bark. Load factors include strong winds and heavy rains, which are normal for the area. Prevailing winds in the area blow from the northwest. The load on the tree defect is moderate, with the likelihood of failure being probable due to the poorly formed codominant union with included bark and a cavity present. The targets observed on site are the future home, pedestrians, and vehicles parked on the driveway/street. The targets are within 1x the tree's drip line and have an occupancy rate ranging between constant and occasional. It is not practical to move the targets or to restrict access to areas surrounding the tree's target zone. The likelihood of impacting the three targets is high as the targets are positioned within the fall distance of the failing parts. Using the failure and impacts matrix as seen on the risk assessment form, it is likely that failure onto the targets #1 and #3 would happen at the point of failure with significant consequences for the home and vehicles. Failure onto target #2 (pedestrians) would happen at the point of failure with severe consequences for people walking within the fall distance of the crown/branches. Using the risk rating matrix as seen on the risk assessment form, the tree is at a high risk of a codominant leader failure impacting the three targets. Mitigation measures such as crown reduction pruning (within ANSI Standards) would reduce the risk to moderate.

**Showing poor structure with multiple codominant leaders with included bark**

Removal of deodar cedar #3 is recommended, and aligns with the following criteria set forth by the City of Burlingame: (1) ***The condition of the tree(s) with respect to disease; danger of falling; proximity to existing or proposed structures, yards, driveways and other trees; and interference with public utility services;*** (2) ***The necessity to remove the tree(s) in order to construct any proposed improvements to allow economic enjoyment of the property.***

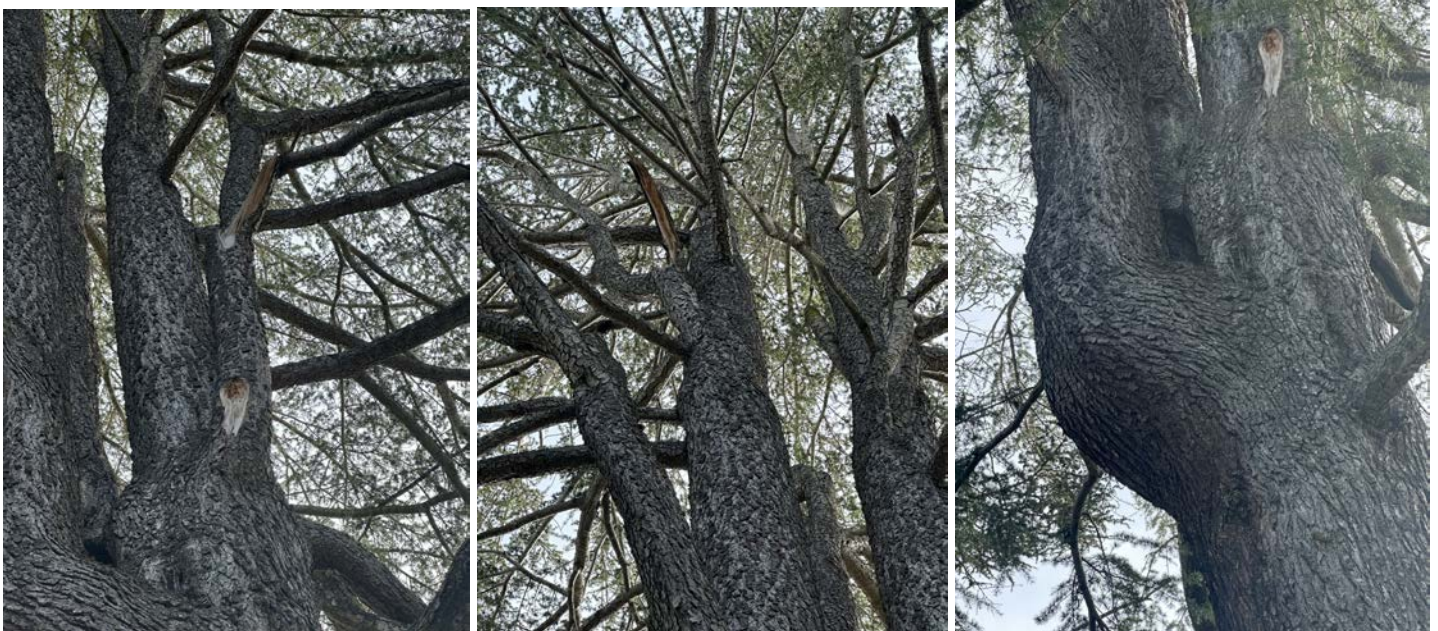
**Showing previous limb loss (left and middle), showing cavity at union (right)**

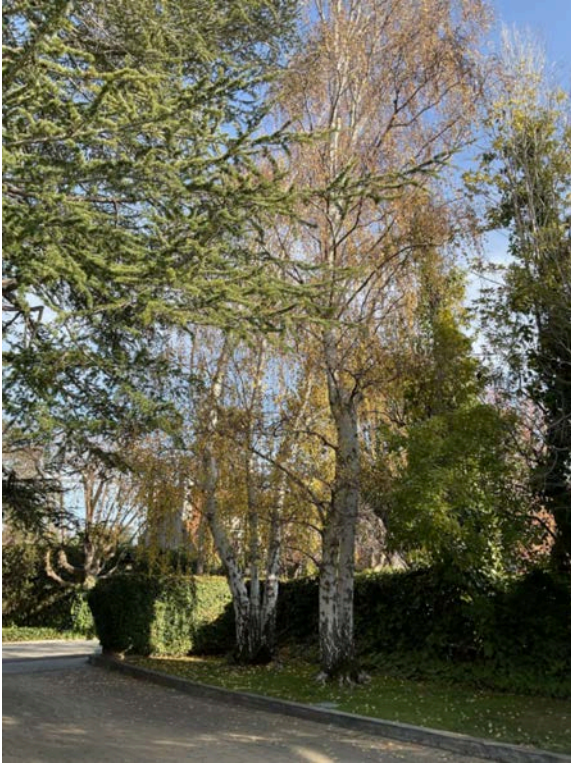
Tree tag #5 - European white birch was assigned a fair condition rating. The tree is located 20 feet from the property boundary, and 4 feet from the existing driveway hardscape. Codominance of the main stem occurs 18 inches above grade, and surface roots are visible under the tree's dripline.

A new, concrete driveway bordered by permeable pavers is proposed for construction where the birch tree is located on the landscape. Birch species generally have shallow root systems that are easily damaged by soil compaction, and are highly sensitive to heat, drought, and soil disturbance.

Removal tree #5 is requested to allow for site improvements. The proposed tree removals align with the following criteria set forth by the City of Burlingame:

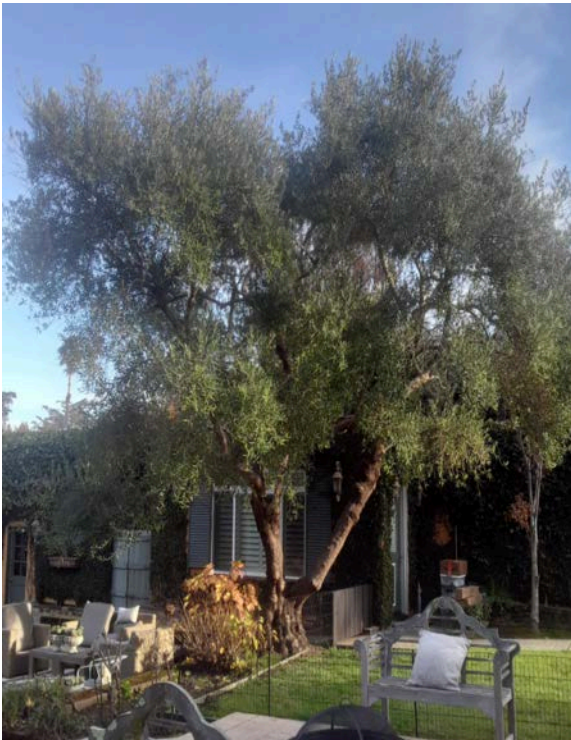
Tree tag #52 - olive was assigned a fair condition rating. This aesthetically pleasing tree is located next to the existing pathway and pool house. Codominance of the main stem occurs 2 feet above grade.

A new swimming pool is proposed for construction where the tree is located on the landscape. Extensive digging, soil disturbance, and cutting of roots, from demolition of existing features and new construction, will lead to a reduction in tree health and stability, and potentially tree mortality.

Removal tree #52 is requested to allow for site improvements. The proposed tree removals align with the following criteria set forth by the City of Burlingame: *(1) The condition of the tree(s) with respect to disease; danger of falling; proximity to existing or proposed structures, yards, driveways and other trees; and interference with public utility services;*

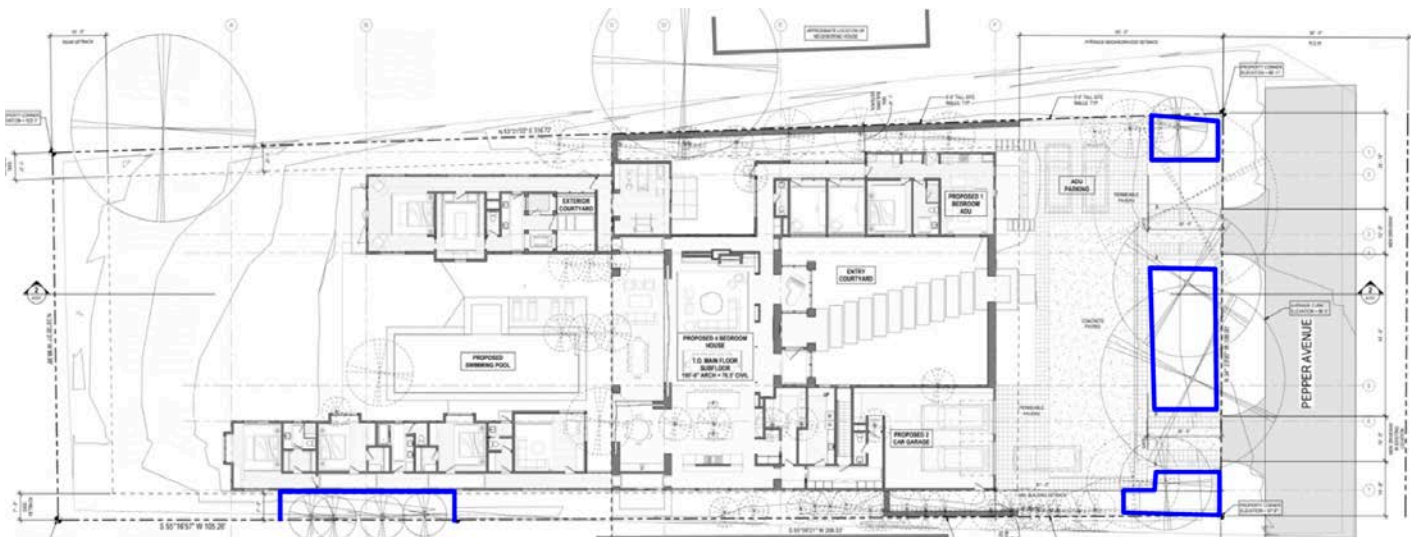
# TREE PROTECTION MAP

**Approximate placement area of Type I Tree Protection Fencing outlined in BLUE.**

and construction schedules shall be implemented in full by the owner and contractor. Trees #1, 2, 4, 6-8, and 53-56 are to be protected by Type I Tree Protection Fencing.
