**Kielty Arborist Services LLC**  
Certified Arborist WE#10724A TRAQ Qualified  
P.O. Box 6187  
San Mateo, CA 94403  
650-532-4418

February 16<sup>th</sup>, 2024

Site: 1385 Hillside Circle, Burlingame, CA

As requested on December 4<sup>th</sup>, 2023, Kielty Arborist Services visited the above site to provide a Tree Inventory Report/Tree Protection Plan for the proposed construction. 3 new homes are proposed for this site, and your concern as to the future health and safety of the tree has prompted this visit. Preliminary landscape plans L1 through L7 dated January 2024, lot 1 site plans A.1 through A.6 dated 10/26/22, lot 2 site plans A.1 through A.6 dated 10/26/21, and lot 3 plans A.1 through A.8 dated 10/26/21 were also reviewed for writing this report. This Tree Inventory Report is not a Tree Risk Assessment. As such, no trees were assessed for risk in accordance with industry standards, nor are there any tree risk ratings or risk mitigation recommendations provided within this preservation plan.

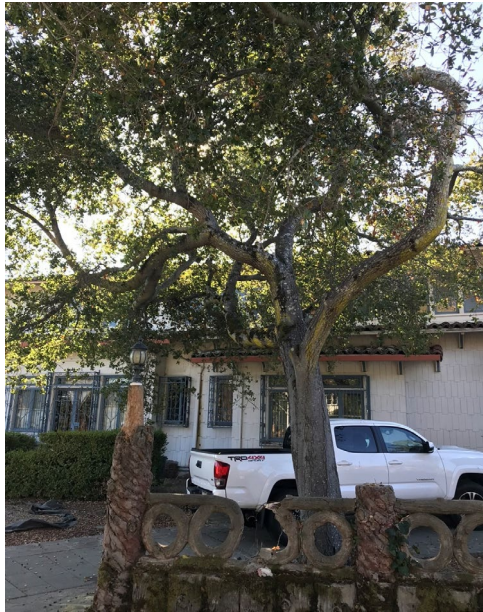
5 trees were surveyed. 3 native oak trees were observed as well as one invasive acacia tree and a neighboring African fern pine tree. All of the trees except acacia tree #4 are of a protected size in the city of Burlingame. Non-protected Black Acacia tree #4 is proposed for removal due to the tree's location near the proposed driveway/grading.

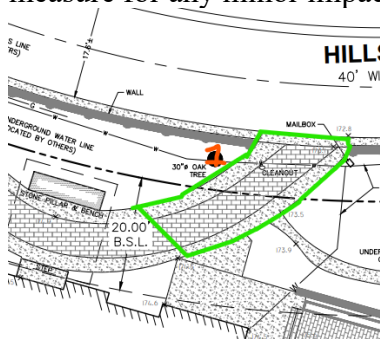
Oak tree #1 is to be retained. The tree is adjacent to an existing driveway. It is recommended to temporarily retain the existing driveway near this tree when underneath the dripline of the tree during the building phase of the project. Temporarily retaining the driveway will act as a tree protection measure and will help to increase staging and access to the site, as removing the driveway at the beginning of the project would make for a larger tree protection zone needed with the fencing being located at the tree's drip line. The existing grade within the tree's dripline is recommended to be retained as is where possible. No grading or excavation is recommended to take place within 10' from this tree (6x diameter) except for the removal of the driveway. At the end of the project, when it is time to demolish the existing driveway near this tree, the Project Arborist is

**Showing portion of driveway recommended to be retained until the landscape phase of the project.**

recommended to be on-site to document and witness the removal of the driveway. A jackhammer is recommended to be used when working within the tree's dripline to break the concrete material into hand manageable-sized pieces. Once broken down the driveway material is recommended to be removed by hand. Exposed roots during the process are recommended to be wrapped in layers of wetted-down burlap to avoid root desiccation. The existing driveway area is recommended to be filled back in once the driveway has been removed so that no roots are exposed to the elements. When backfilling the soil in this area, the area is also to be irrigated. The proposed driveway is further from the tree than the existing driveway and outside of the 10' range and is not expected to have impacts on the tree. The tree is recommended to be deep water fertilized with Nutriroot once the work near the tree has taken place as a mitigation measure for any minor impacts that may take place.

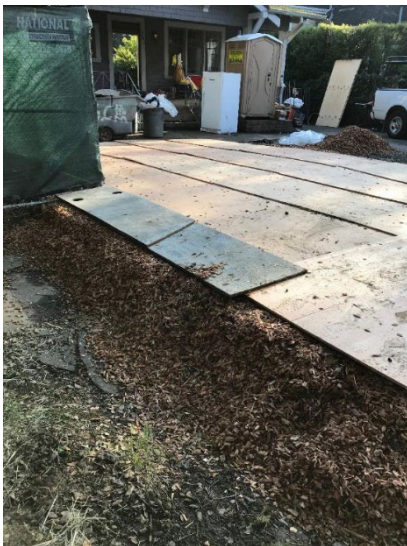
**Landscape barrier example**

Where tree protection does not cover the entire root zone of the trees, or when a smaller tree protection zone is needed for access, a landscape barrier consisting of wood chips spread to a depth of four to six inches with plywood or steel plates placed on top will be placed where foot traffic is expected to be heavy. The landscape buffer will help to reduce compaction to the unprotected root zone. If plywood is to be used, the plywood pieces shall be attached together to minimize movement.
