**Bay Rise Park  
Arborist Report**

**Project #4113-02**

May 1, 2024

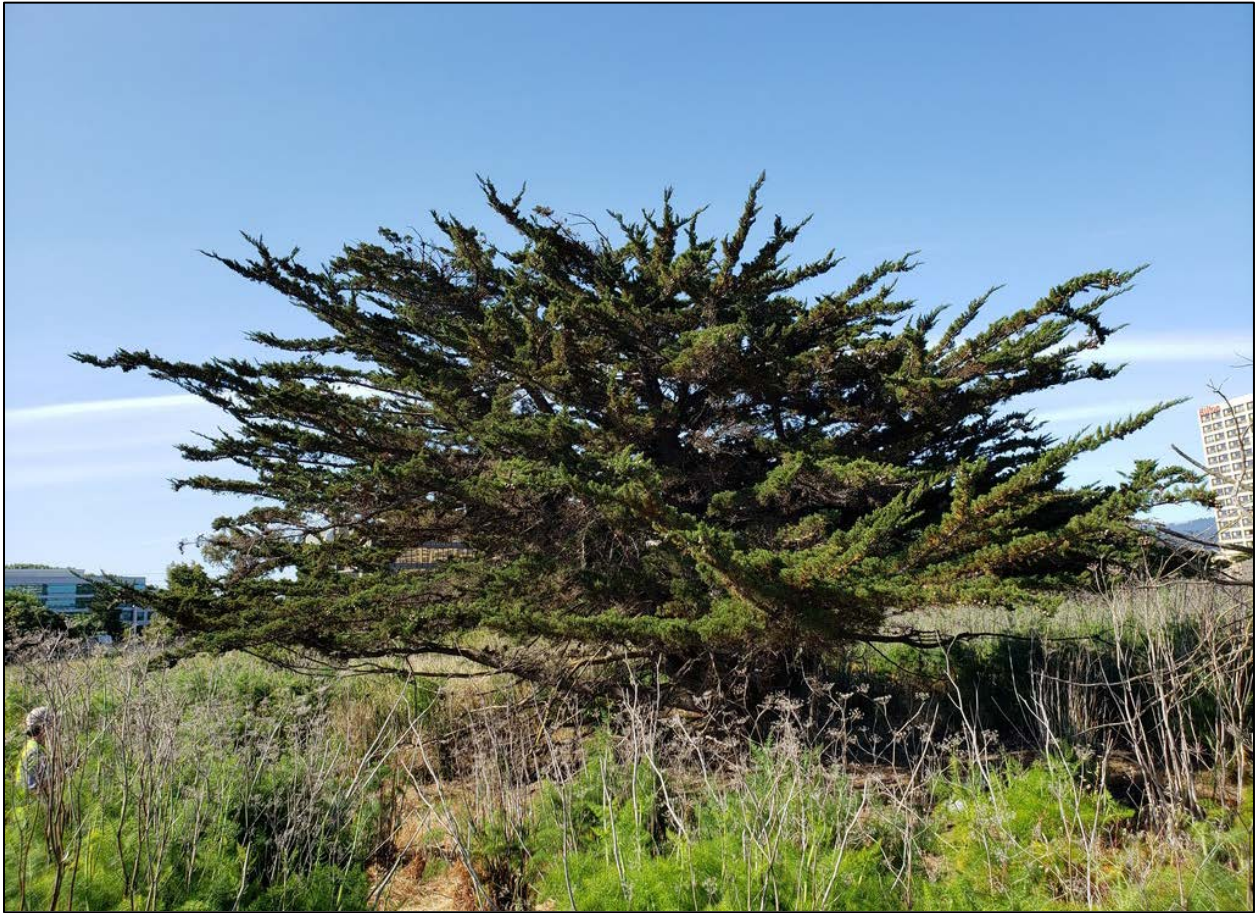
**Photo 1a. Tree #7102, Monterey Cypress (*Hesperocyparis macrocarpa*)**

This is a protected tree and was in good condition (May 21, 2020).

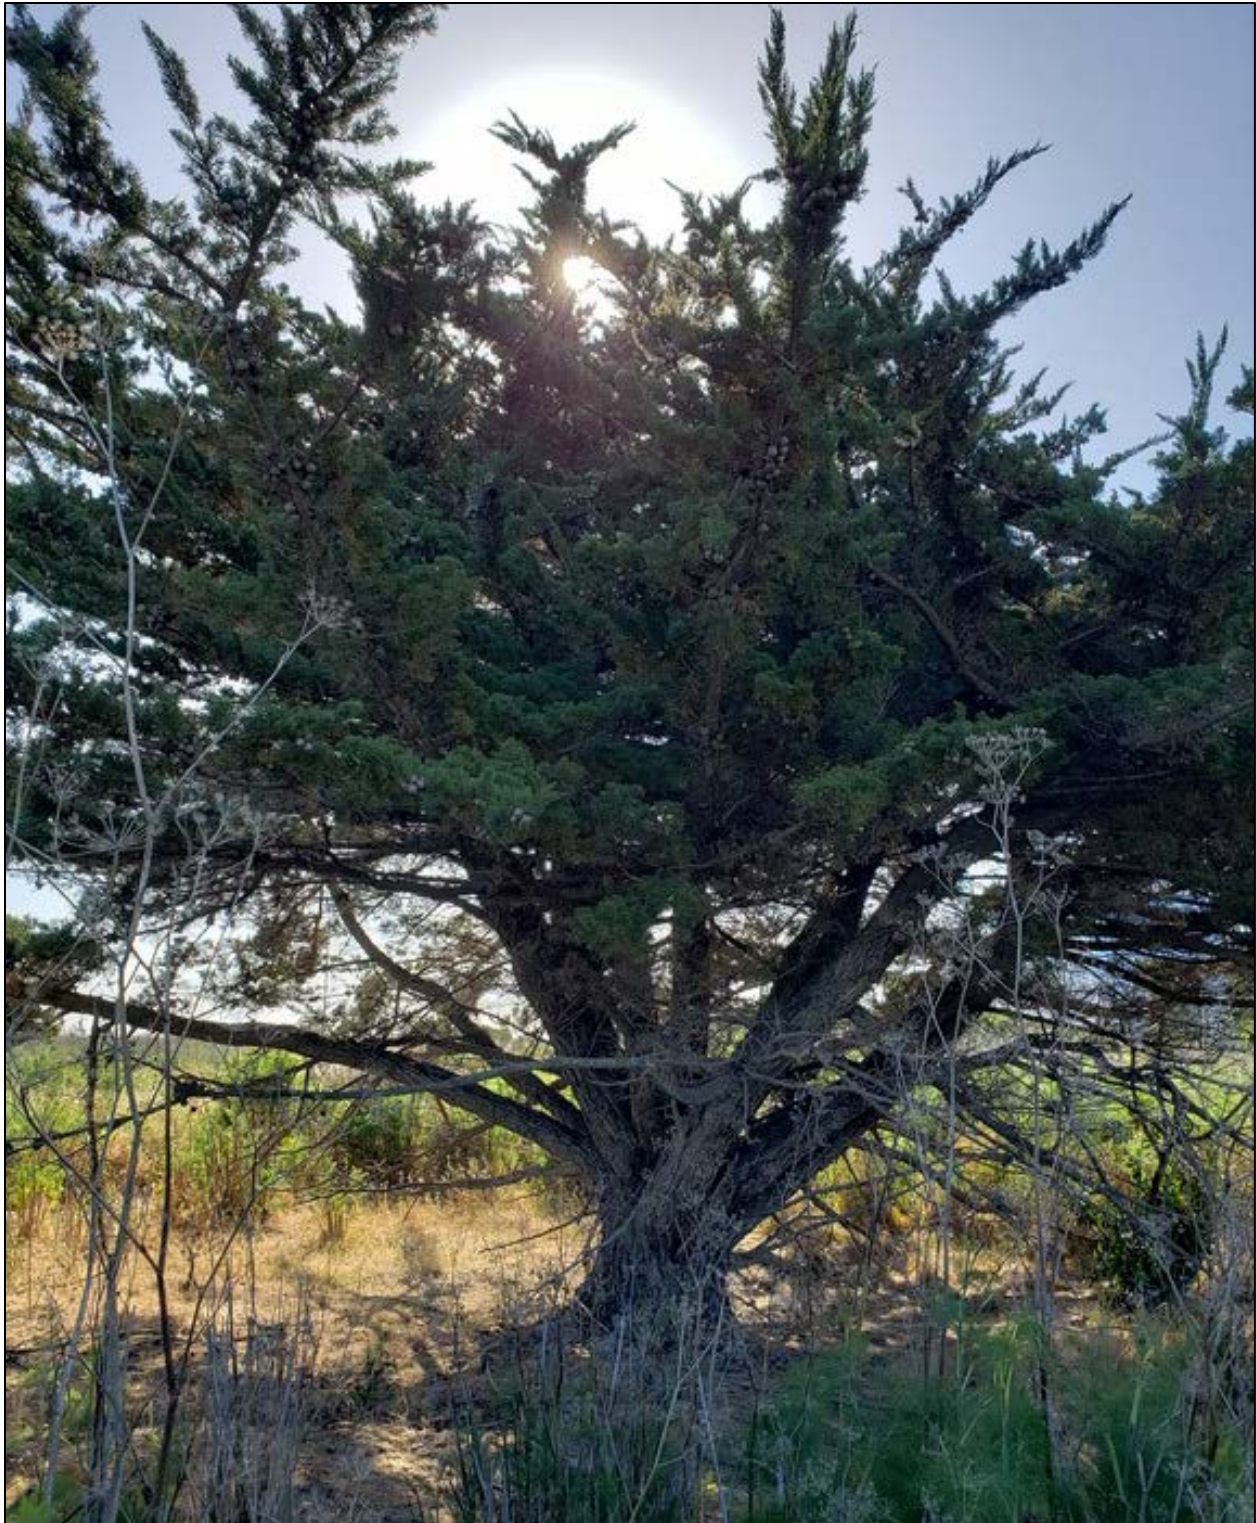
**Photo 1b. Tree #7102, Monterey Cypress (*Hesperocyparis macrocarpa*)**

This is a protected tree and was in good condition (May 21, 2020).

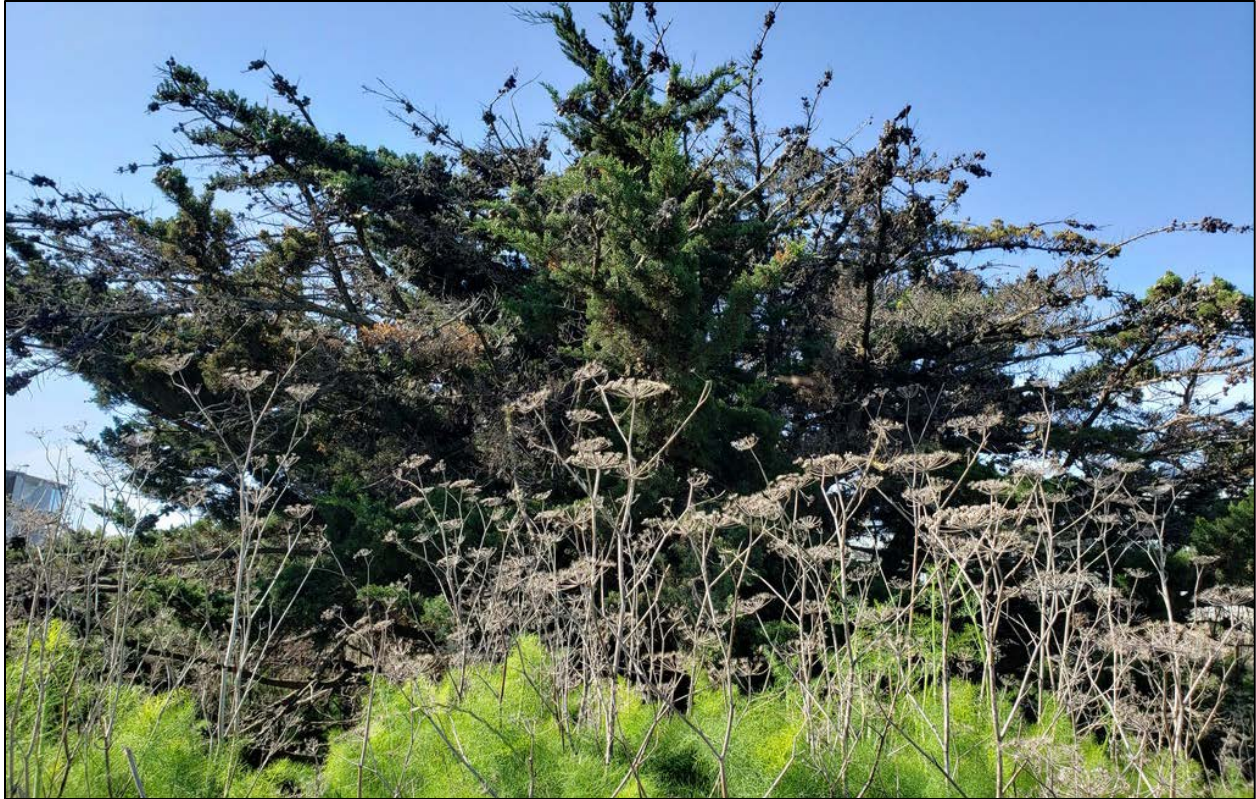
**Photo 2a. Tree #7103, Monterey Cypress (*Hesperocyparis macrocarpa*)**

This is a protected tree and was in fair condition (May 21, 2020).

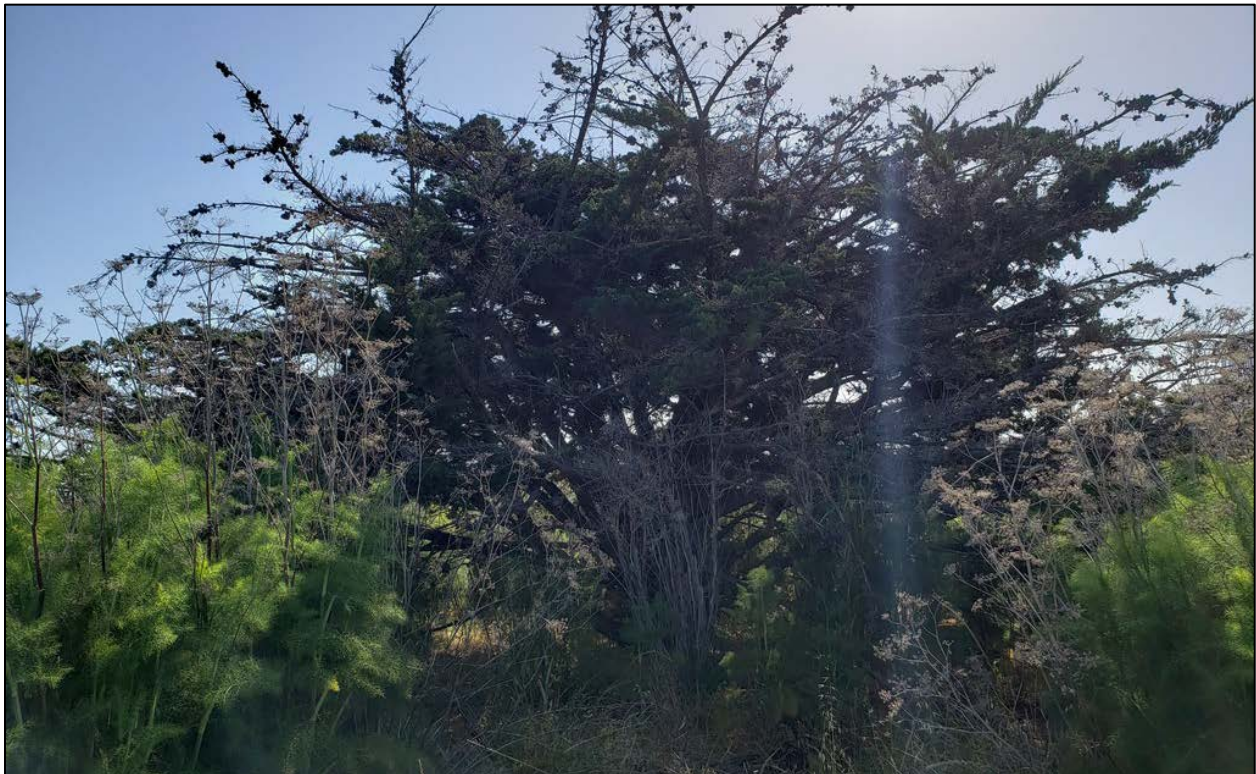
**Photo 2b. Tree #7103, Monterey Cypress (*Hesperocyparis macrocarpa*)**

This is a protected tree and was in fair condition (May 21, 2020).

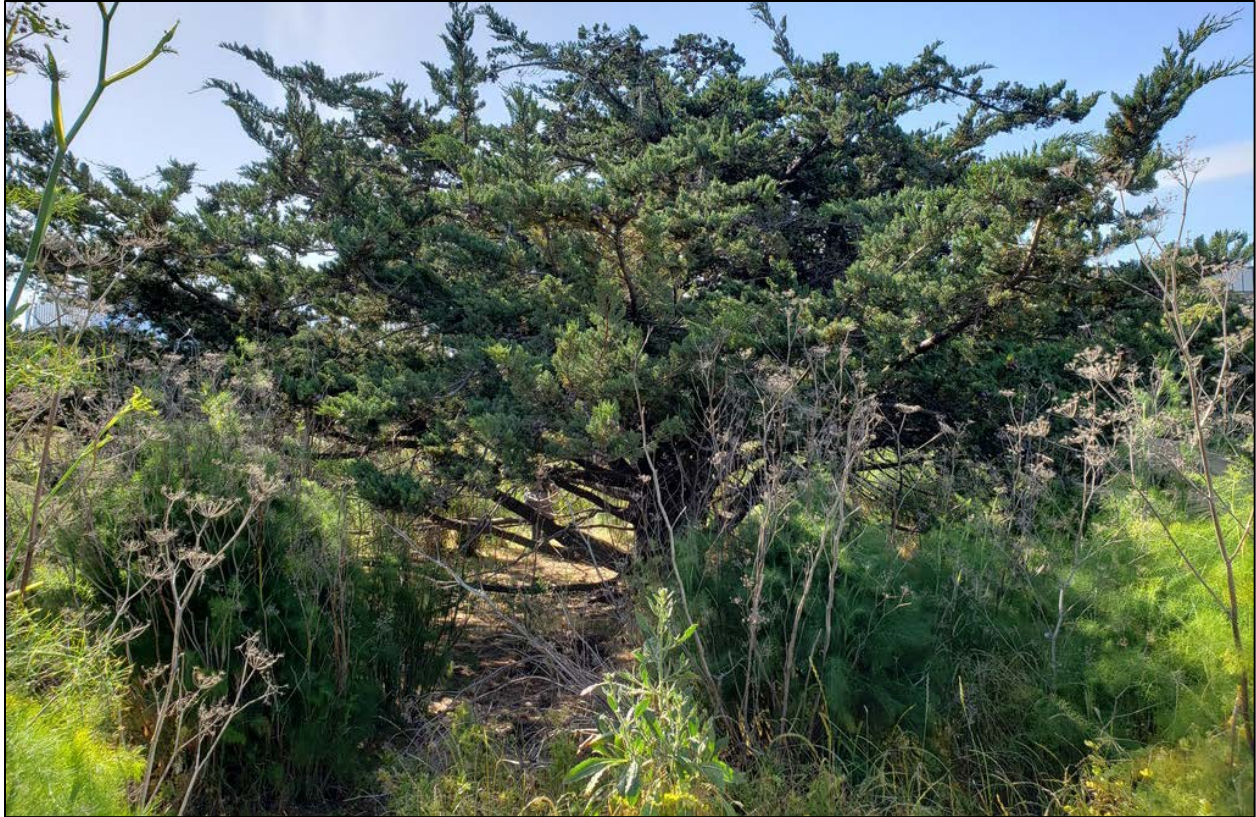
**Photo 3a. Tree #7104, Monterey Cypress (*Hesperocyparis macrocarpa*)**  
 This is a protected tree and was in good condition (May 21, 2020).

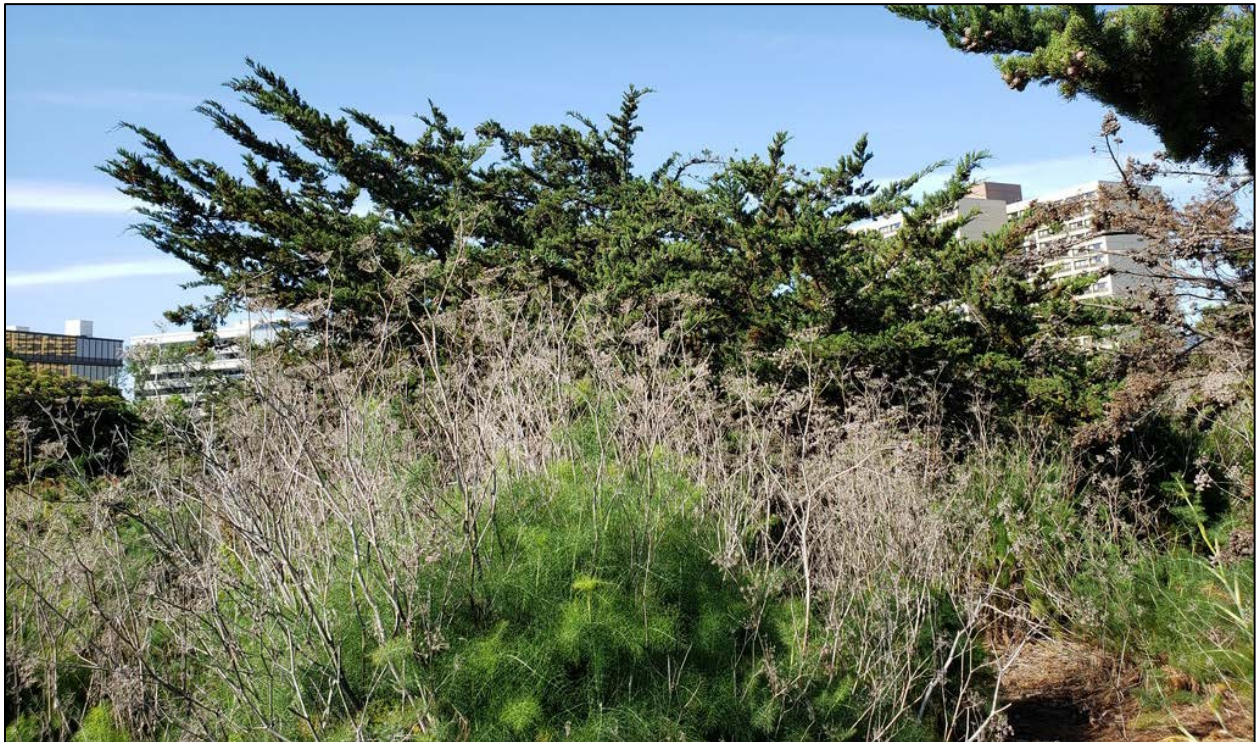
**Photo 3b. Tree #7104, Monterey Cypress (*Hesperocyparis macrocarpa*)**  
 This is a protected tree and was in good condition (May 21, 2020).

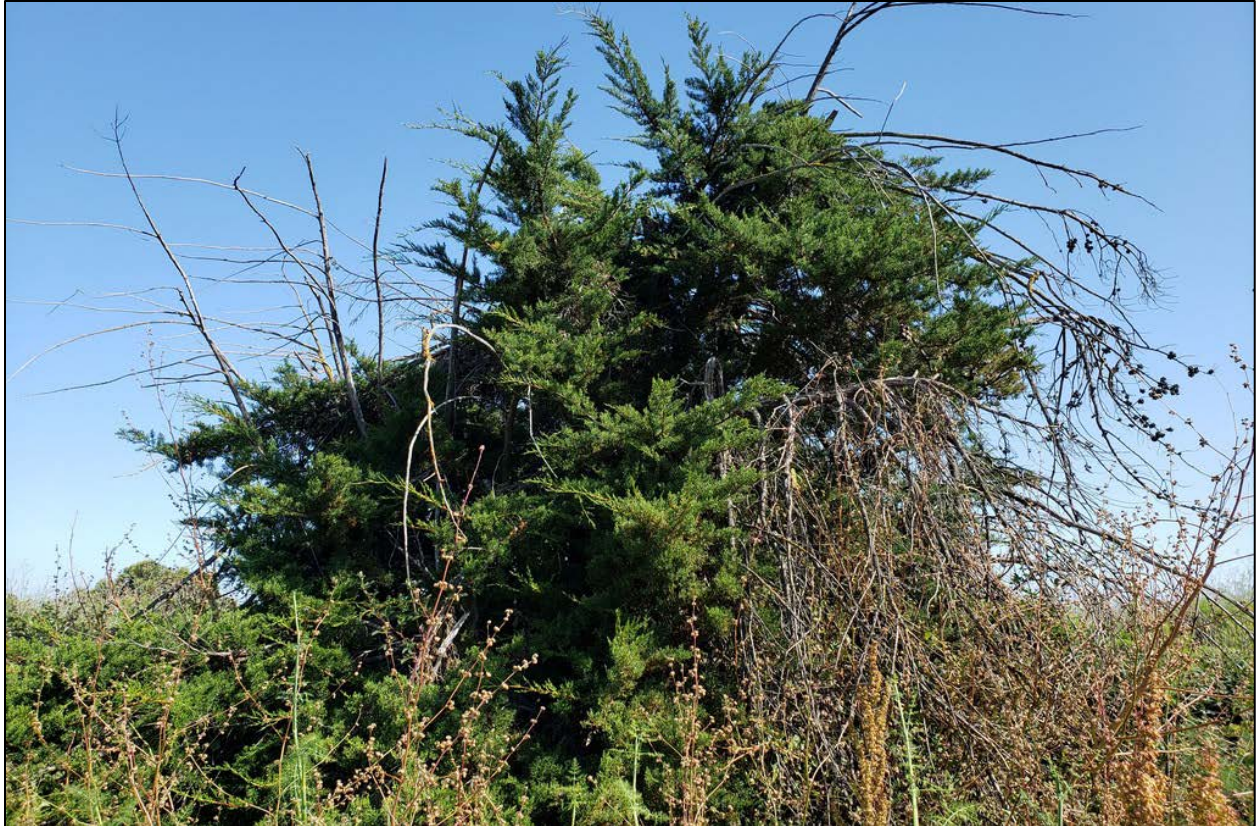
**Photo 4a. Tree #7105, Monterey Cypress (*Hesperocyparis macrocarpa*)**

| Tree Tag | Scientific Name | Common Name | Native Status | DBH | Protected Status | Health Score | Structure Score | Condition Rating | Notes |
|---|---|---|---|---|---|---|---|---|---|
| 7105 | <i>Hesperocyparis macrocarpa</i> | Monterey cypress | Native | 25 | Protected | 3 | 3 | Fair | surrounded by blackberry, damage to main leader, lot of canopy dieback |

This is a protected tree and was in fair condition (May 21, 2020).

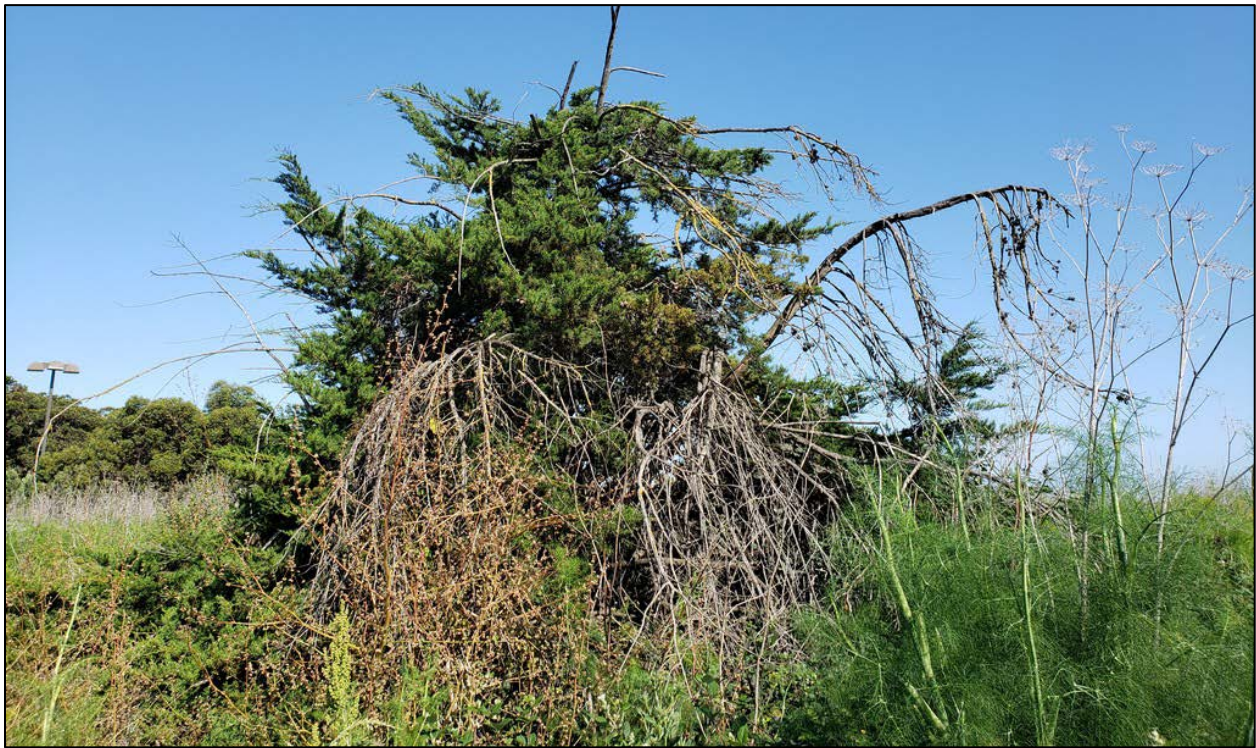
**Photo 4b. Tree #7105, Monterey Cypress (*Hesperocyparis macrocarpa*)**

This is a protected tree and was in fair condition (May 21, 2020).

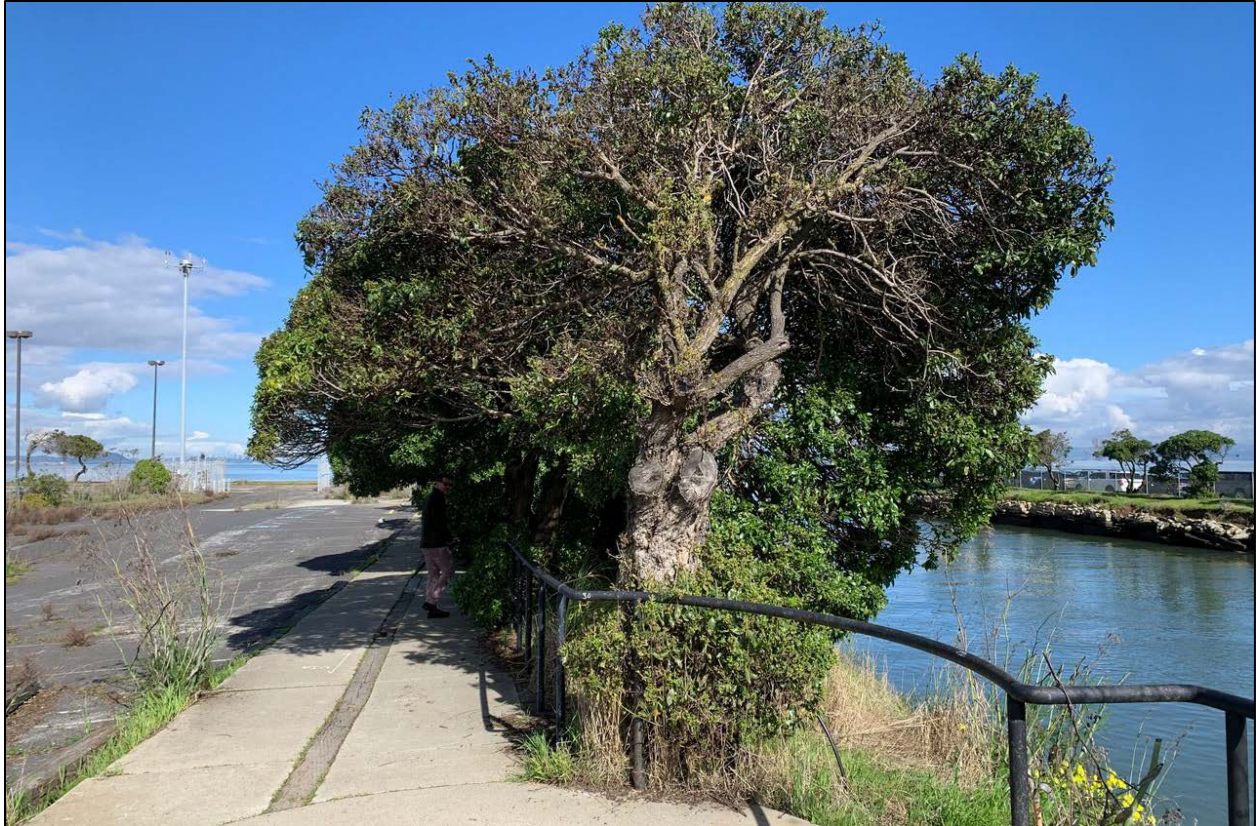
**Photo 5a. Tree #7118, Ngaio (*Myoporum luteum*)**

This is a protected tree and was in poor condition (February 6, 2024).

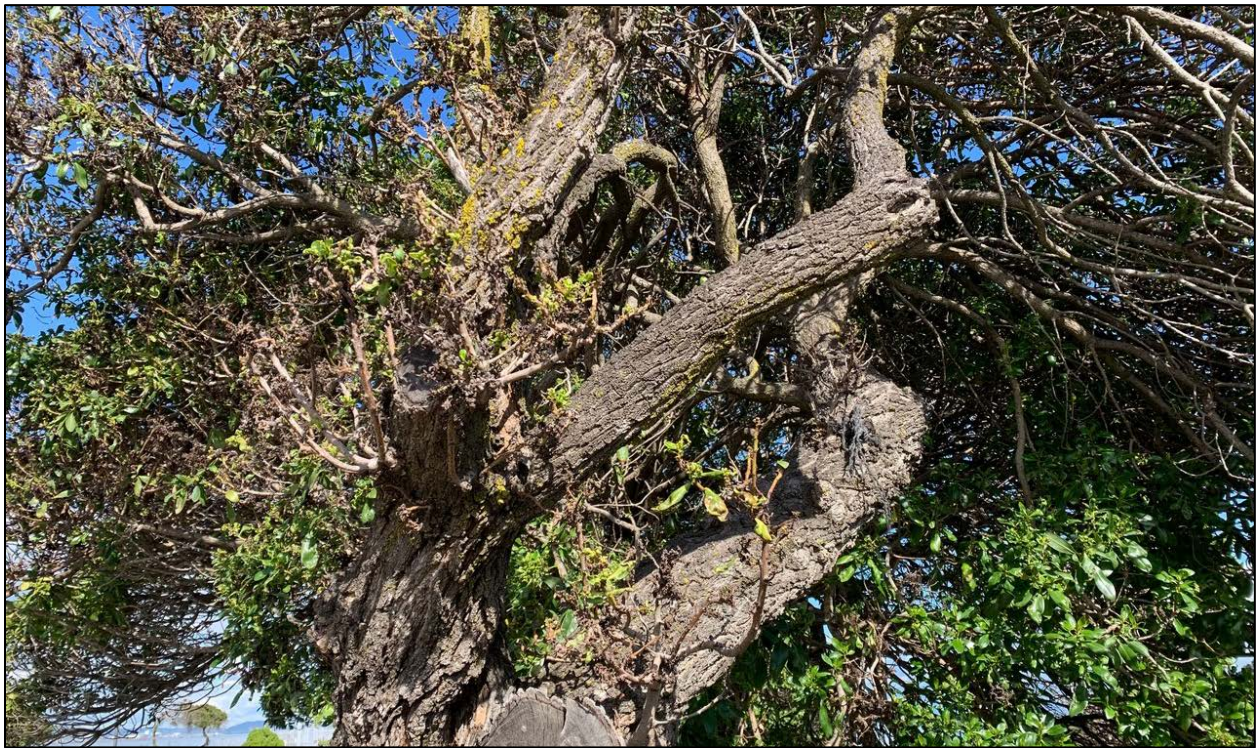
**Photo 5b. Tree #7118, Ngaio (*Myoporum luteum*)**

This is a protected tree and was in poor condition (February 6, 2024).

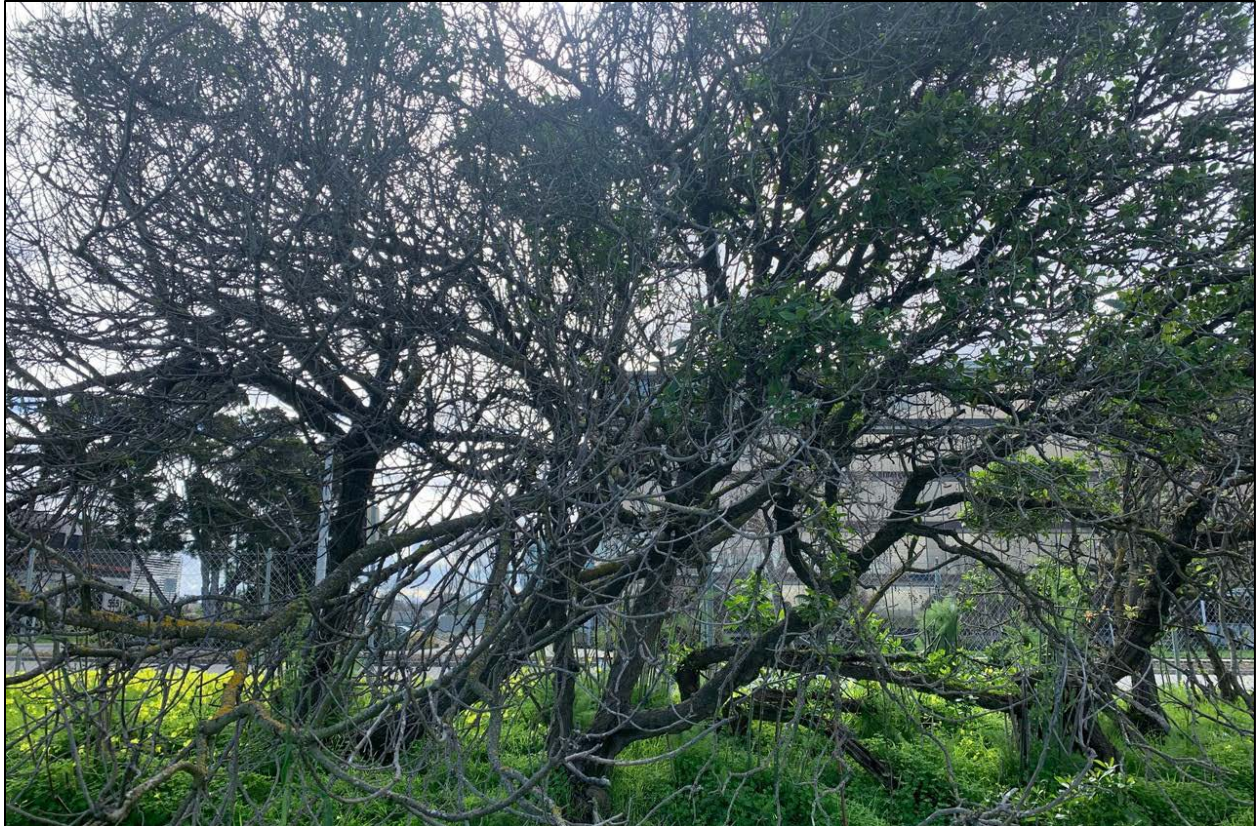
**Photo 6a. Tree #7165, Ngaio (*Myoporum luteum*)**

This is a protected tree and was in poor condition (February 6, 2024).

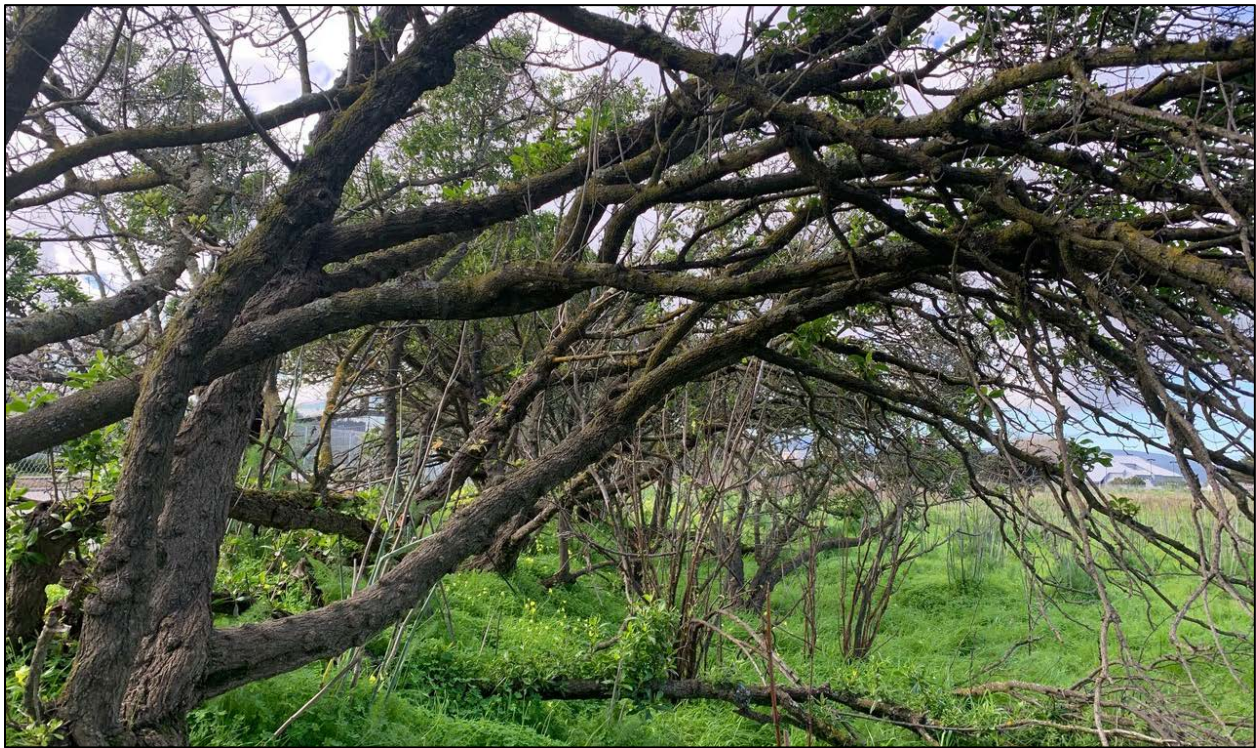
**Photo 6b. Tree #7165, Ngaio (*Myoporum luteum*)**

This is a protected tree and was in poor condition (February 6, 2024).

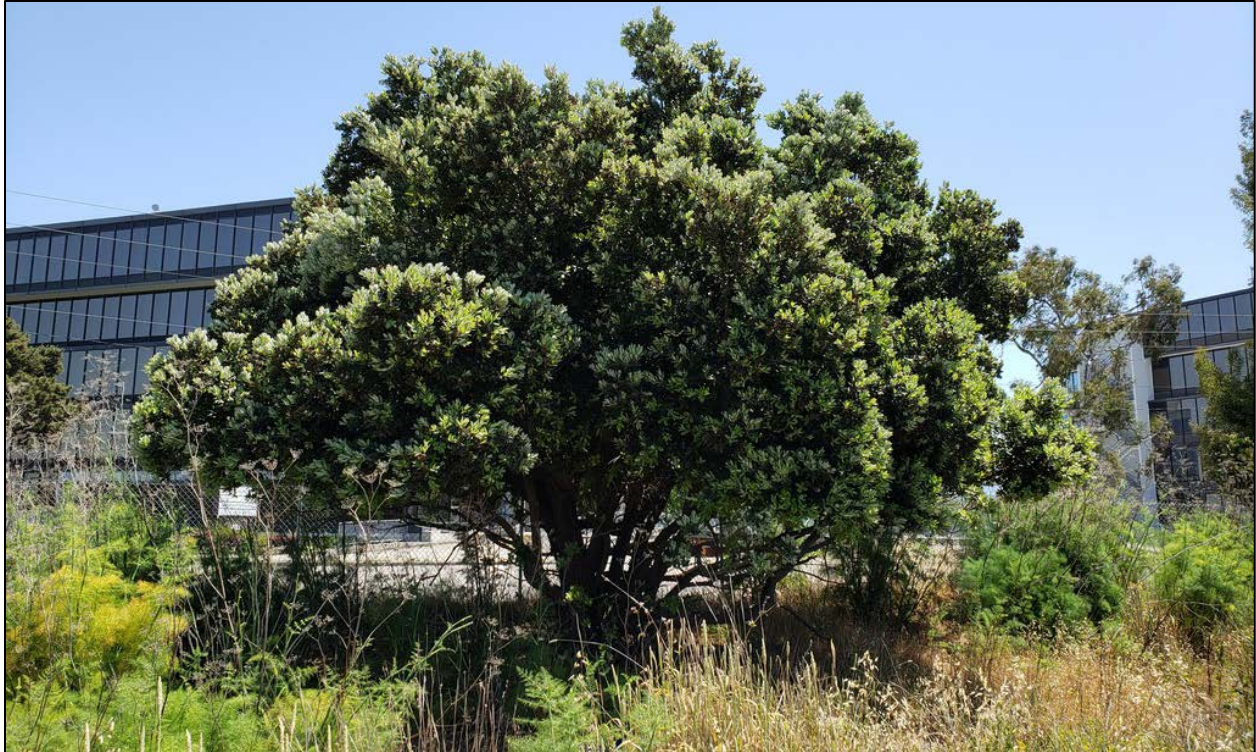
**Photo 7a. Tree #7174, New Zealand Pōhutukawa (*Metrosideros excelsa*)**

This is a protected tree and was in fair condition (May 21, 2020).

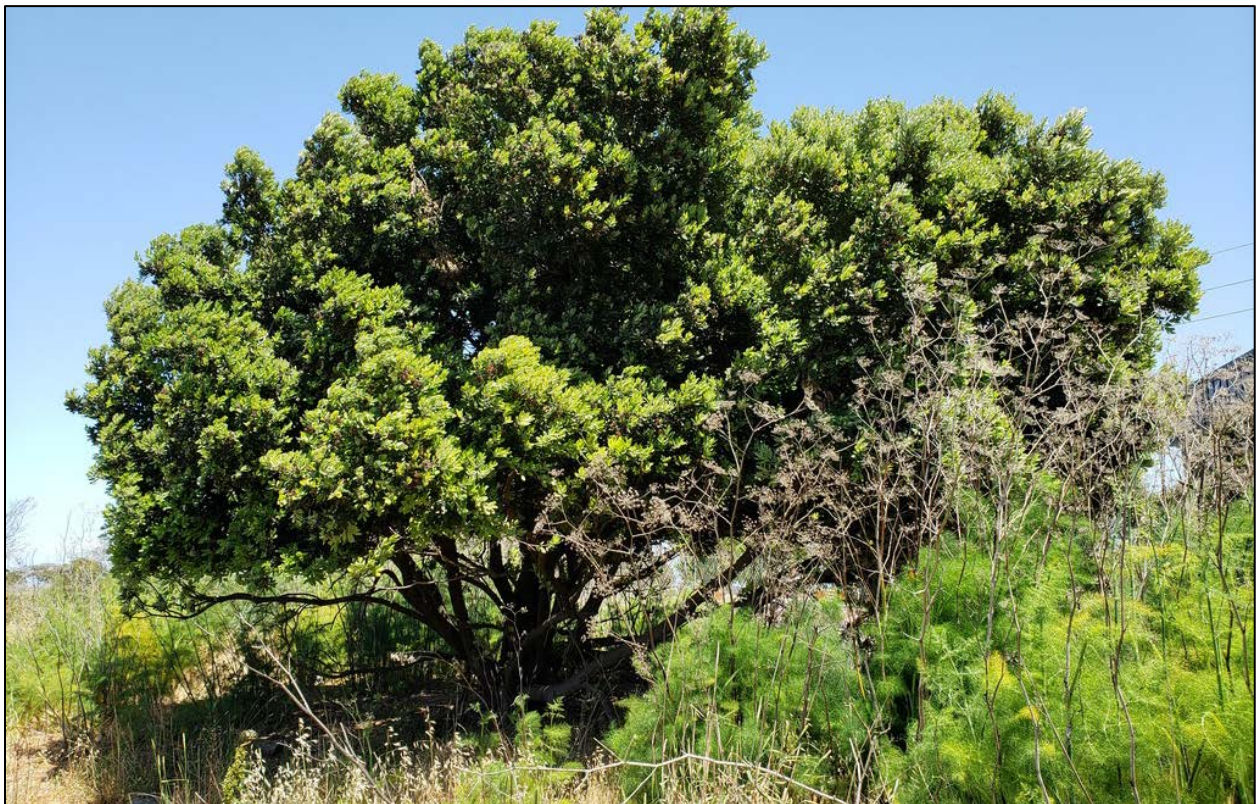
**Photo 7b. Tree #7174, New Zealand Pōhutukawa (*Metrosideros excelsa*)**

This is a protected tree and was in fair condition (May 21, 2020).

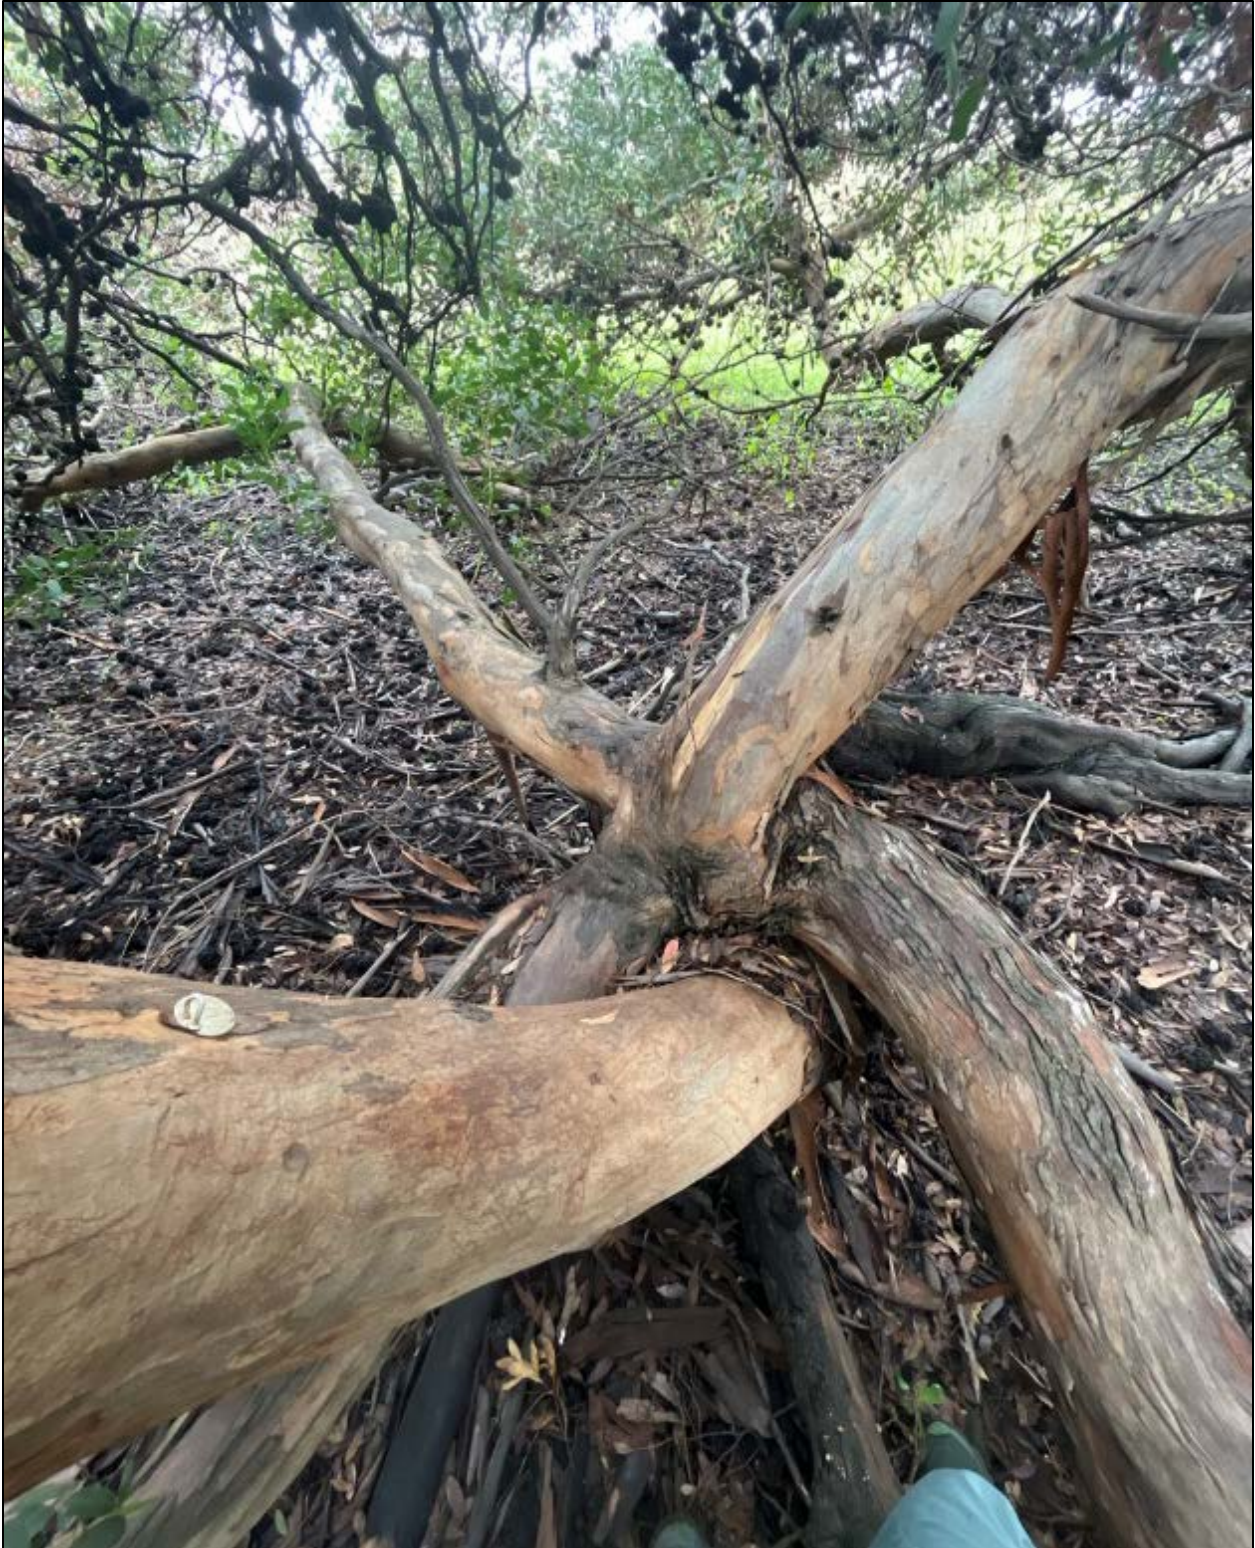
**Photo 8a. Tree #7179, Spider Gum (*Eucalyptus conferruminata*)**

This is a protected tree and was in fair condition (January 24, 2024).

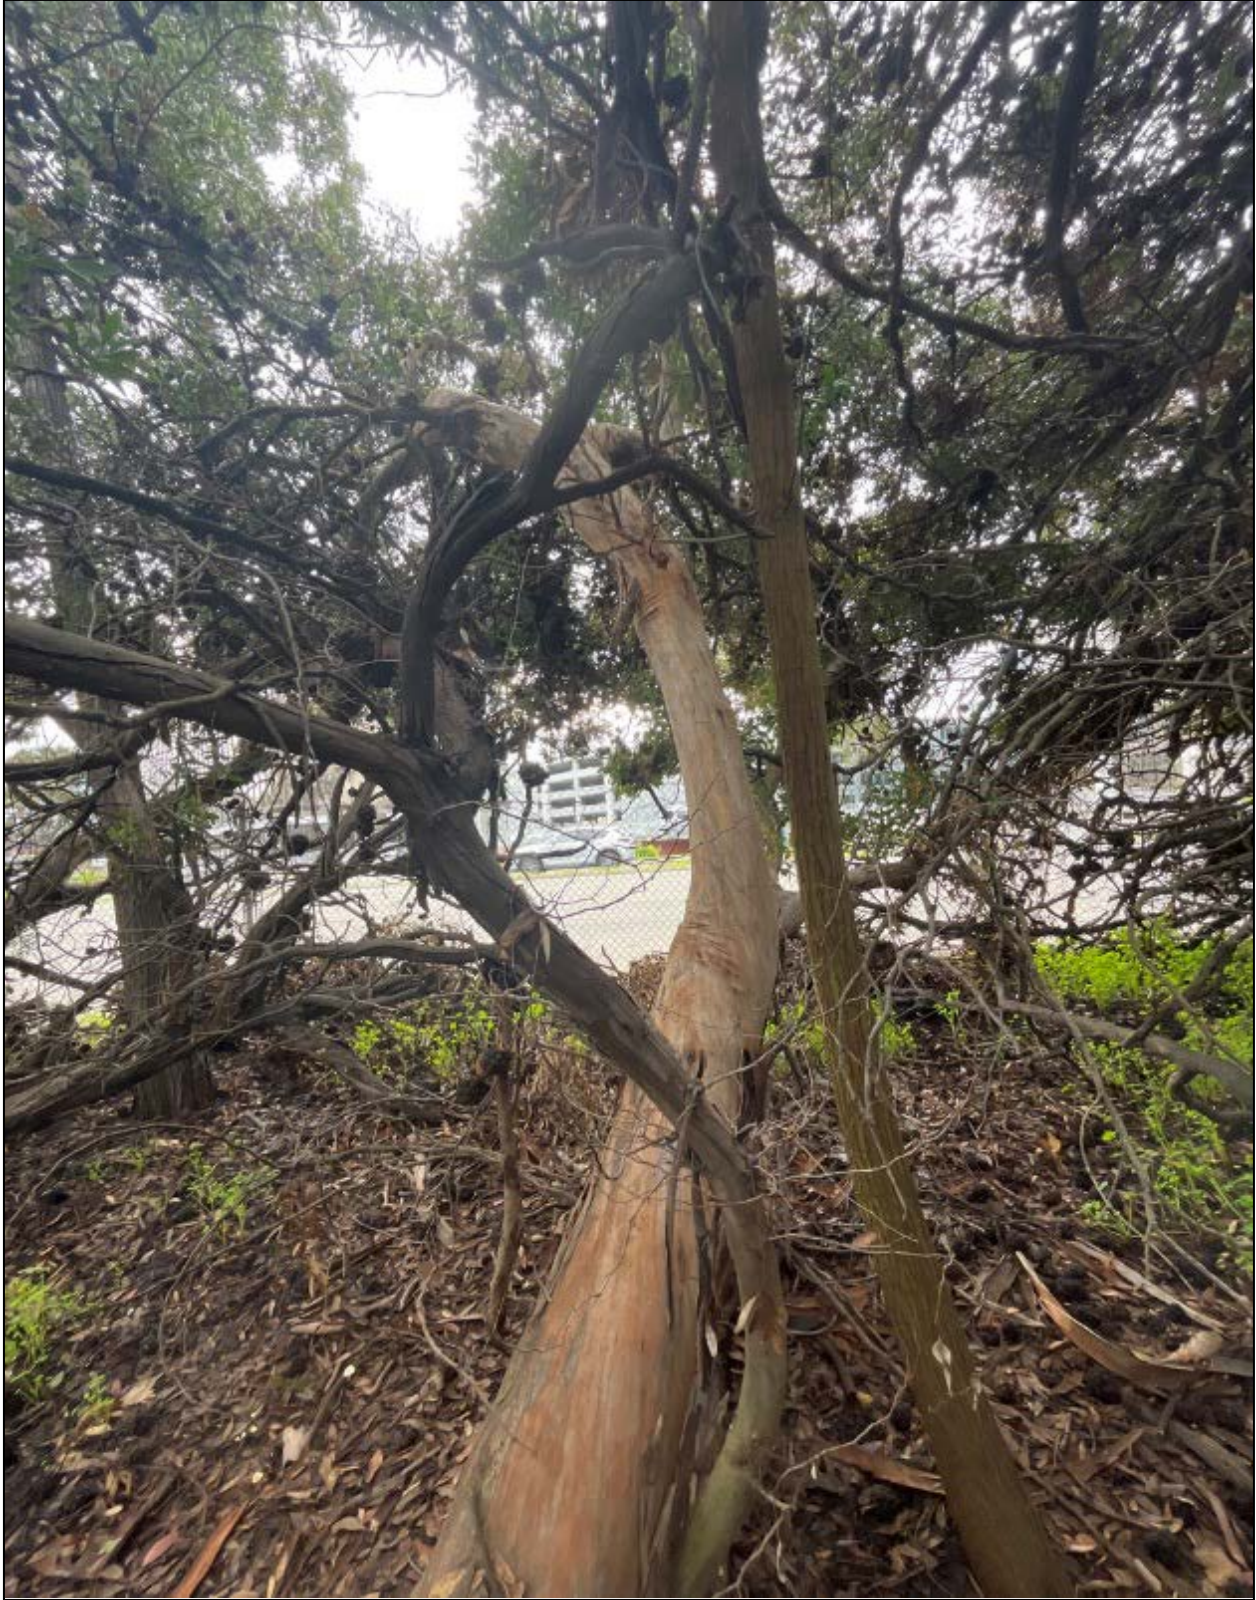
**Photo 8b. Tree #7179, Spider Gum (*Eucalyptus conferruminata*)**

This is a protected tree and was in fair condition (January 24, 2024).

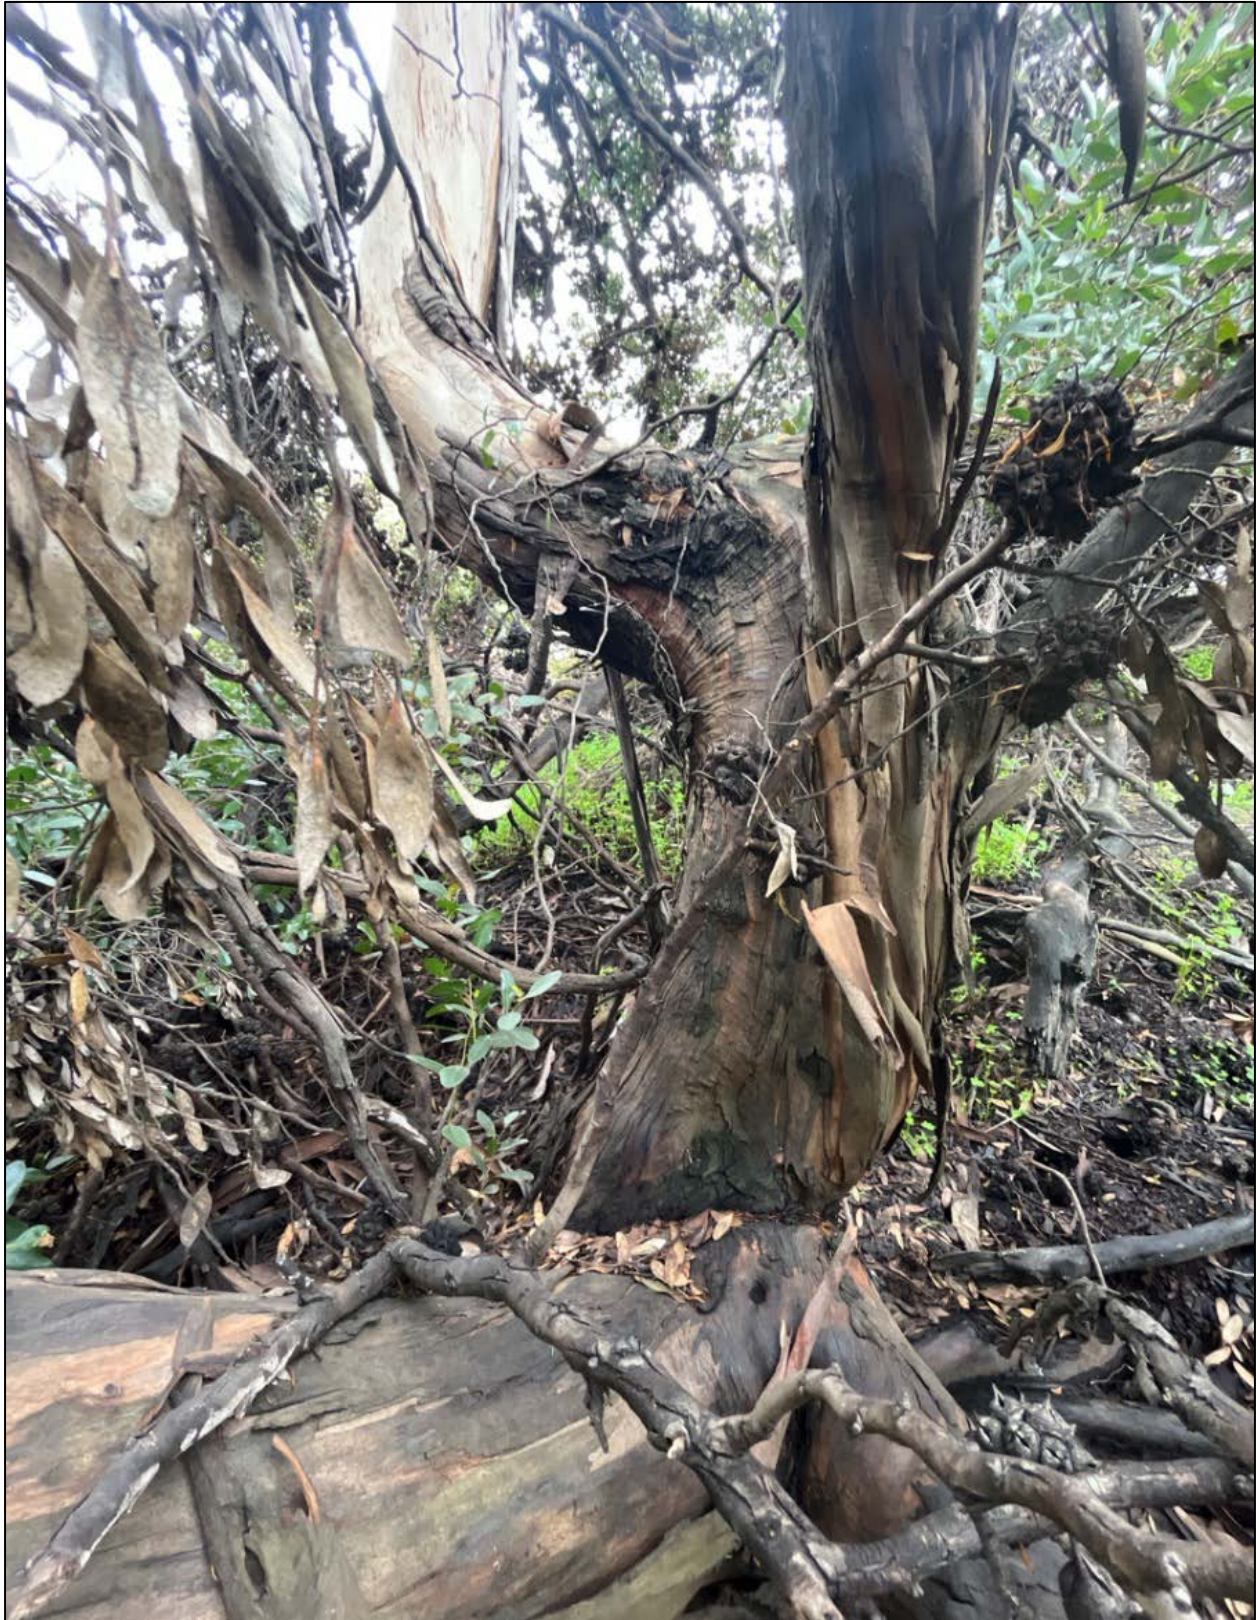
**Photo 9. Tree #7180, Spider Gum (*Eucalyptus conferruminata*)**  
This is a protected tree and was in fair condition (January 24, 2024).

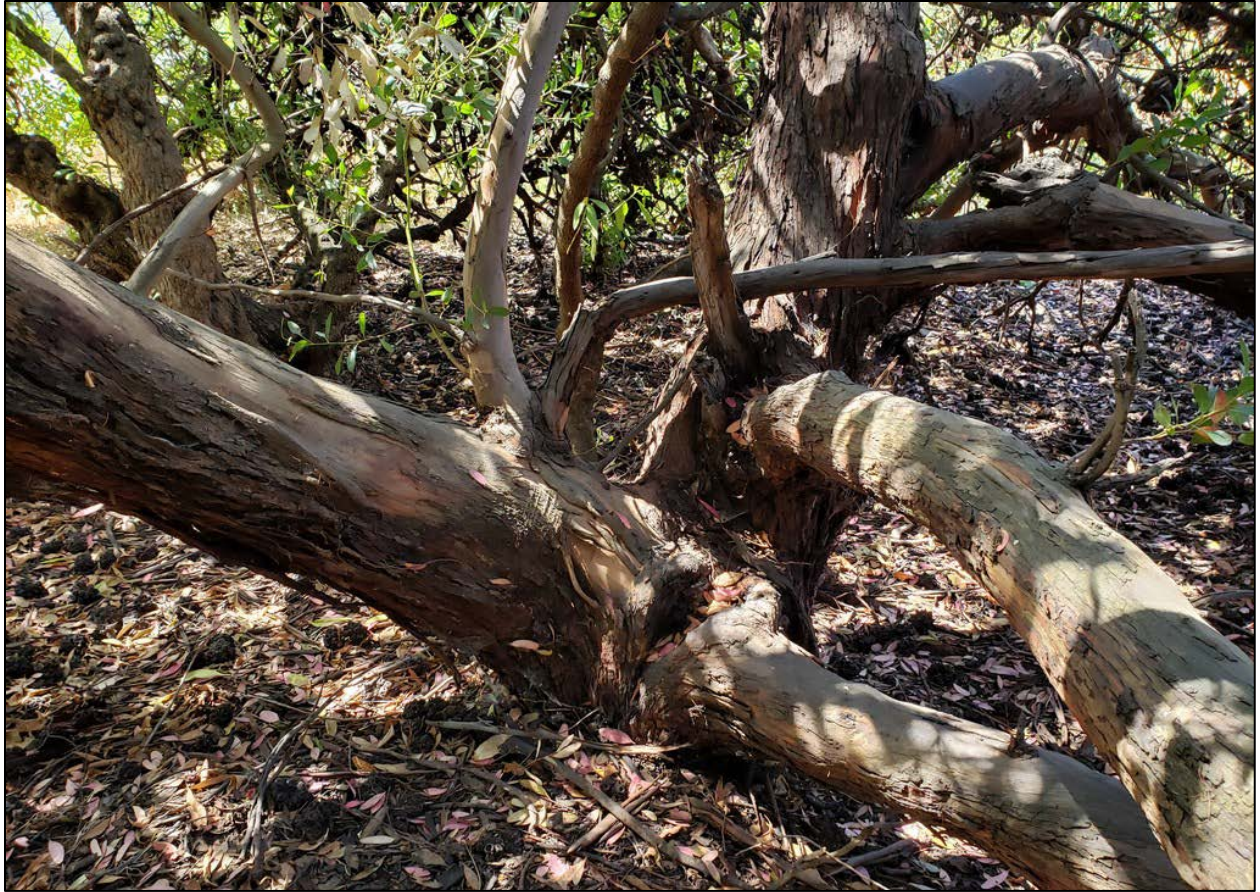
**Photo 10a. Tree # 7182, Spider Gum (*Eucalyptus conferruminata*)**

This is a protected tree and was in fair condition (May 21, 2020).
