**Bay Rise Park  
Arborist Report**

**Project #4113-02**

May 1, 2024

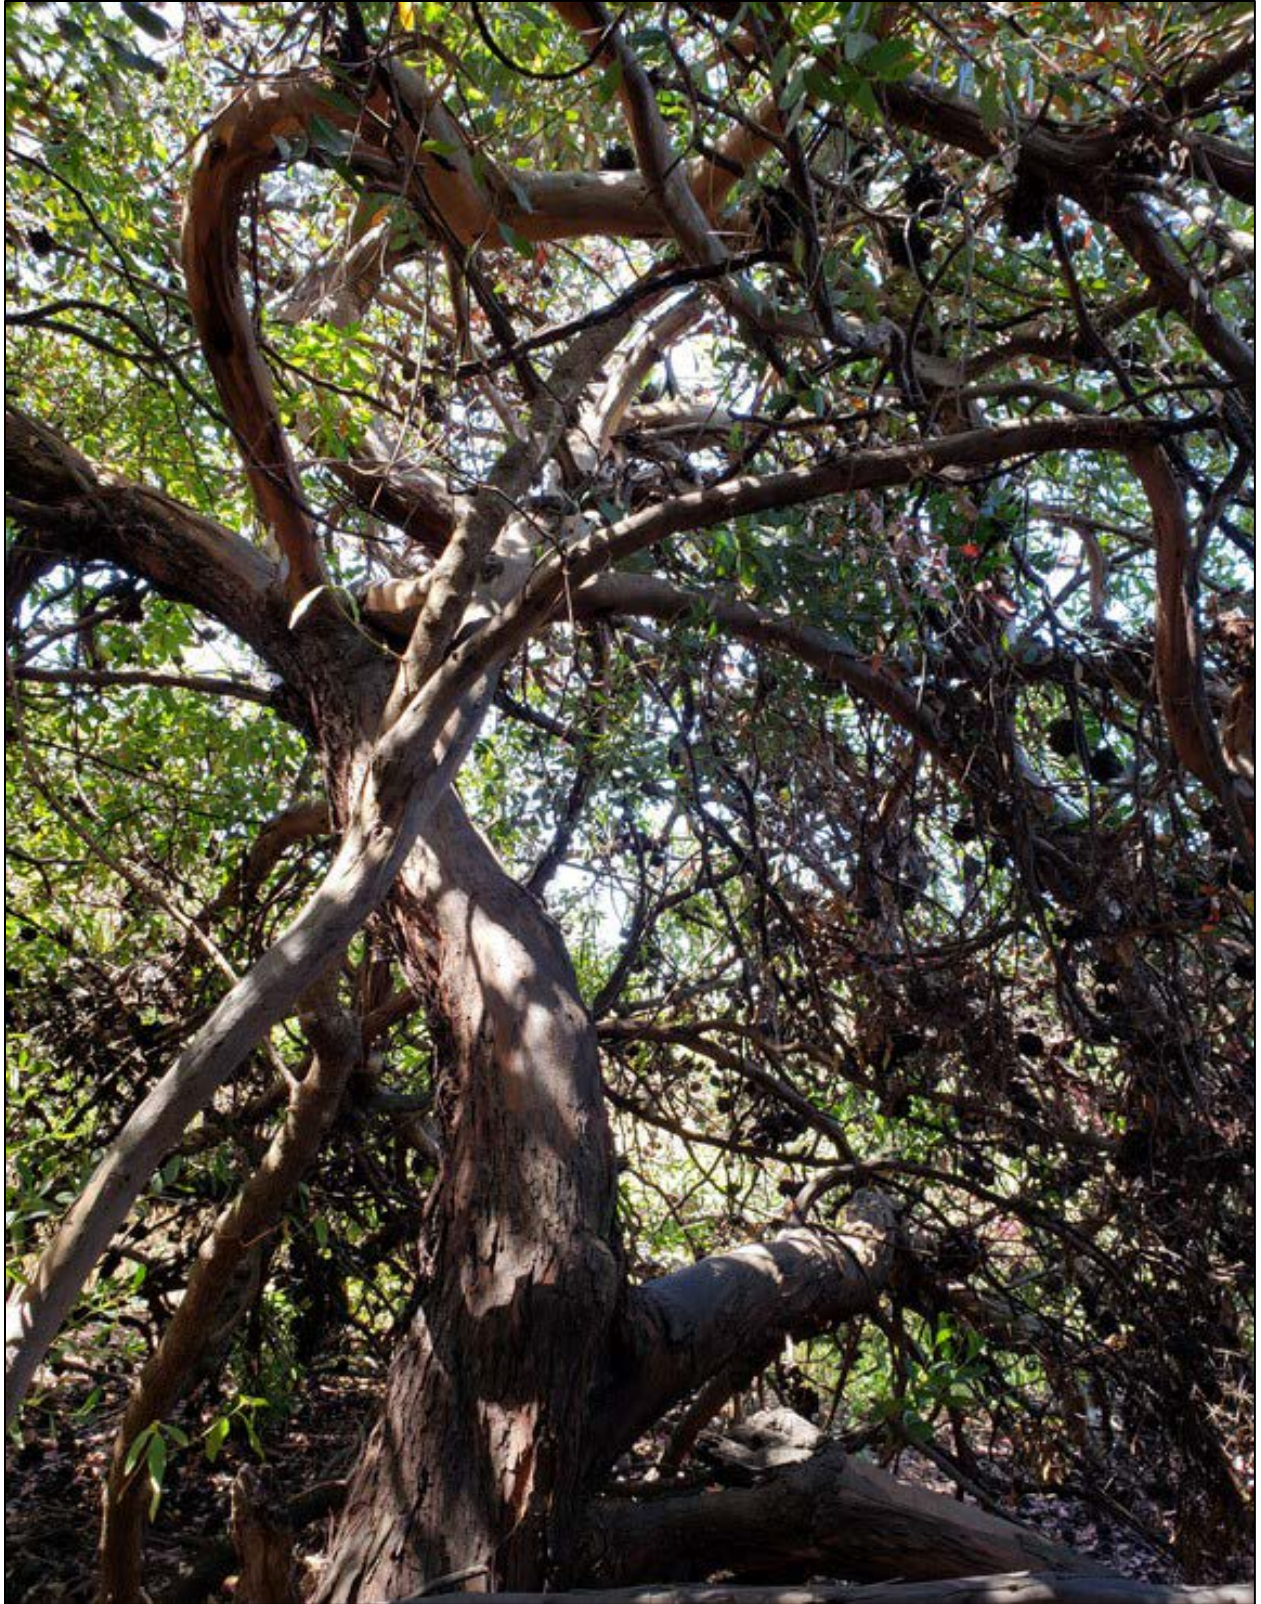
**Photo 10b. Tree #7182, Spider Gum (*Eucalyptus conferruminata*)**

This is a protected tree and was in fair condition (May 21, 2020).

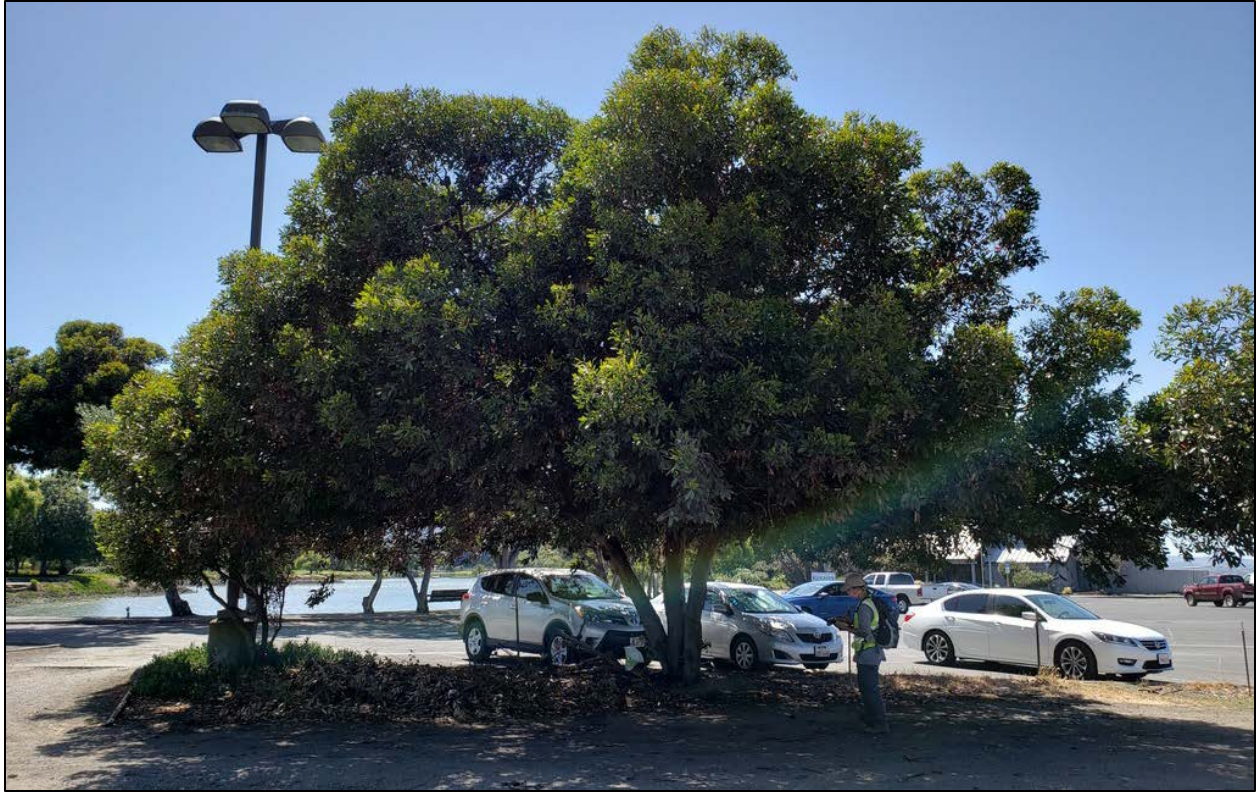
**Photo 11a. Tree #7183, Spider Gum (*Eucalyptus conferruminata*)**

This is a protected tree and was in fair condition (May 21, 2020).

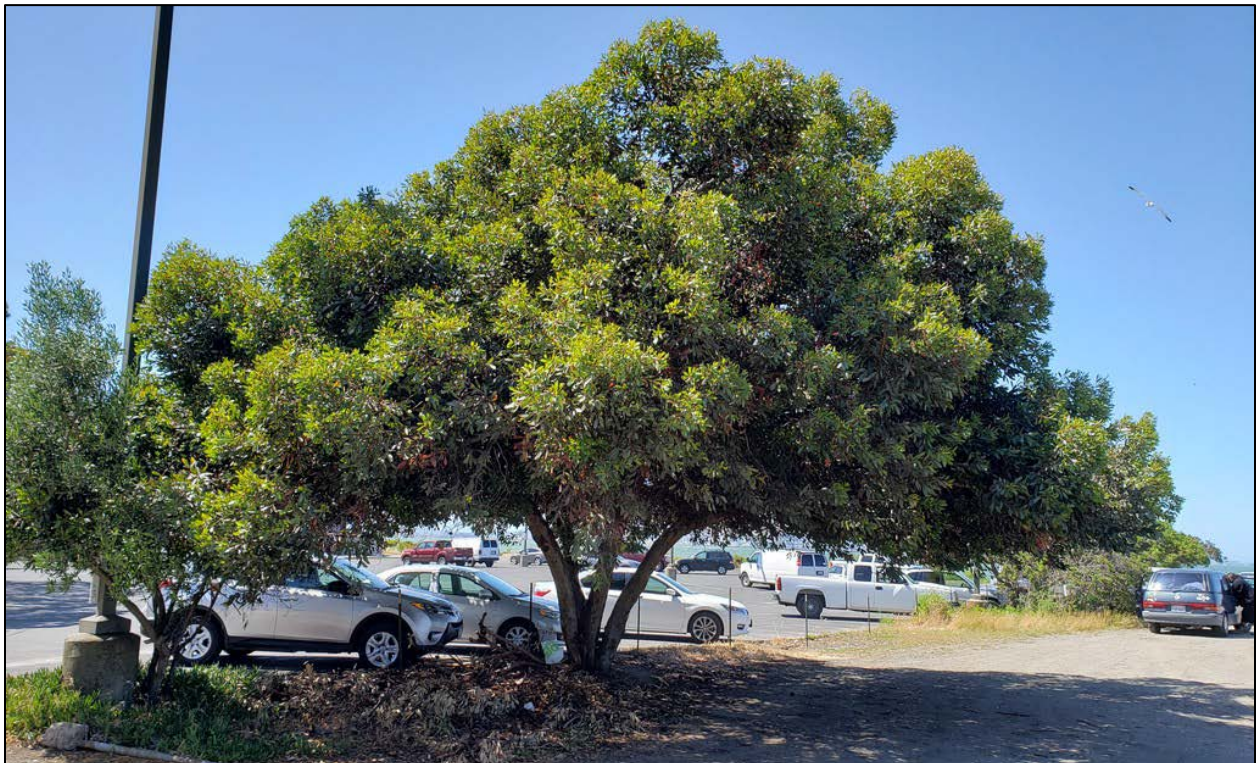
**Photo 11b. Tree #7183, Spider Gum (*Eucalyptus conferruminata*)**

This is a protected tree and was in fair condition (May 21, 2020).
