Advanced Tree Care

1341 Drake Ave, Burlingame February 20, 2025

Site: 1341 Drake Ave., Burlingame

Tree Survey

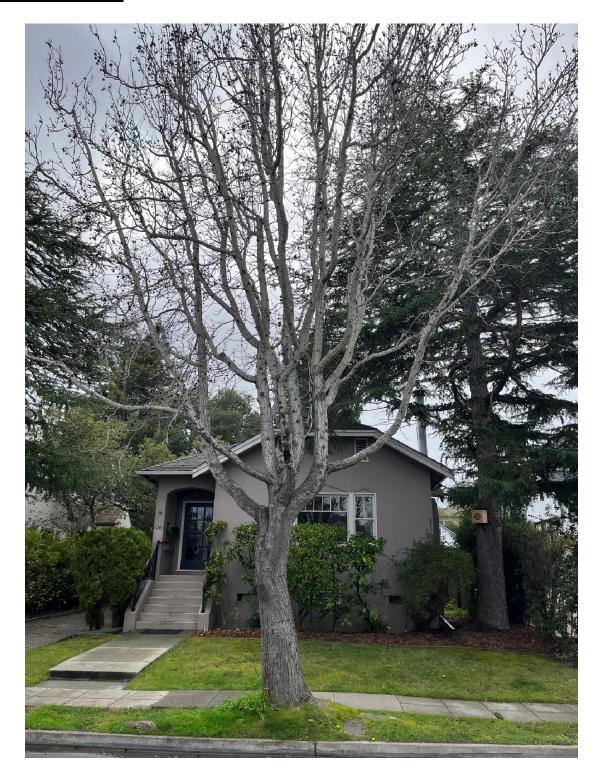
Tree # 1 is a sweet gum in good health and condition. The tree is a Street Tree that should be protected during construction.

Tree # 1: TPZ should be at 13 feet radius from the trunk, shown as a thin red line. This can be reduced to edge of sidewalk and curb in accordance with Type II Tree Protection as outlined and illustrated in image 2.15-3 ⁽⁶⁾. Shown as a thick red line.

A new sidewalk is proposed which will involve demolition of existing sidewalk and curb and gutter. Arborist should be present at pre-construction meeting with Public Works.

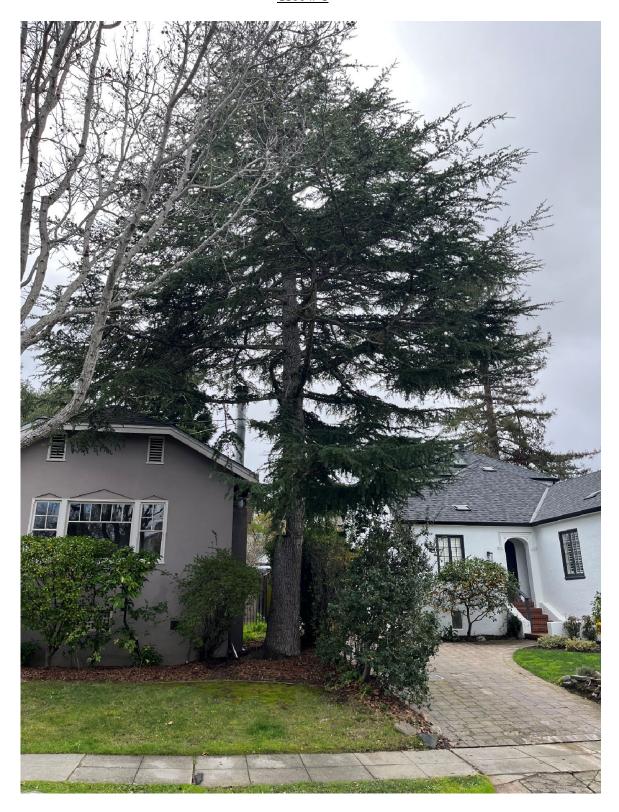
<u>Tree # 2</u>

Tree # 2 is a Private Protected deodar cedar in good health and condition that should be protected during construction.

Tree # 2: TPZ should be at 20 feet radius from the trunk in accordance with Type I Tree Protection as outlined and illustrated in image 2.15- 1 and 2 ⁽⁶⁾. Shown as a thin red line. This can be reduced to edge of demolition and edge of construction. Shown as a thick red line.

Demolition of the existing house within the TPZ should be done with hand tools only.

Excavation for the foundation of the new home should be done with hand tools. No roots greater than 2" in diameter should be cut.

Excavation for the pathway to the front door should be done with hand tools only. No roots greater than 2" in diameter should be cut.

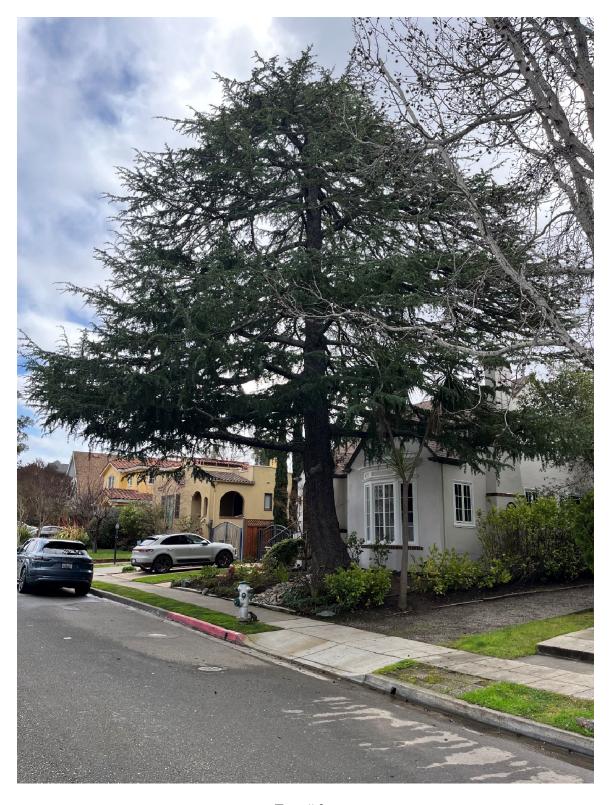
<u>Tree # 3</u>

Tree # 3 is a Private Protected deodar cedar on the neighbor's property, in good health and condition that should be protected during construction.

Tree # 3: TPZ should be at 30 feet radius from the trunk. Shown as a thin red line. Fencing is not practical here since it would block access up the existing/proposed driveway. The tree stands on the neighbor's property behind permanent fencing. No tree protection is needed.

Excavation for the proposed driveway should be done with hand tools only within the TPZ. No roots greater than 2" in diameter should be cut.

Permeable pavers will be used for the new driveway. I suspect minimal compaction is needed since the new driveway is in the same location as the existing. Compaction should be kept to a minimum. This can be achieved by laying a biaxial geogrid beneath the pavers to achieve sub base stability if needed.

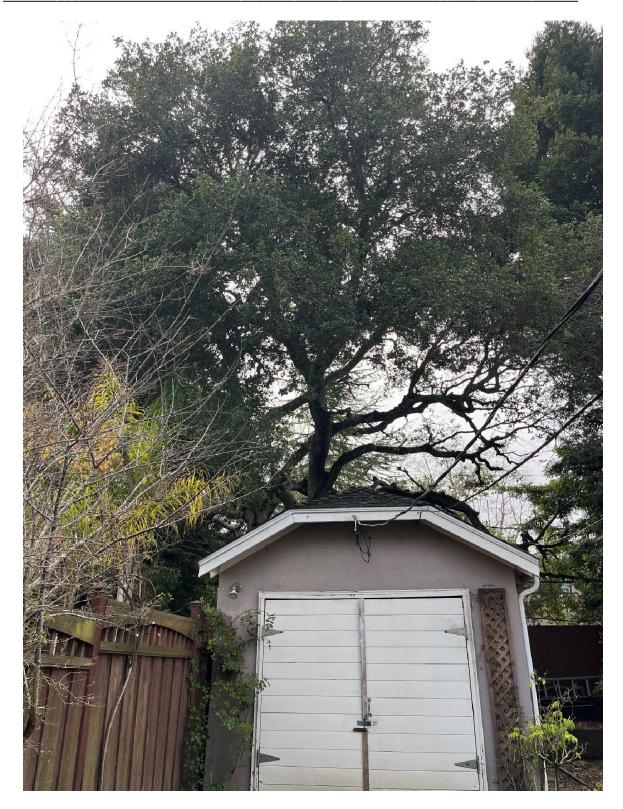
<u>Tree # 5</u>

Tree # 5 is a Private Protected coast live oak on the neighbor's property. The tree has been pruned to accommodate the utility lines that run in the easement behind the property. The tree should be protected during construction.

Tree # 5: TPZ should be at 30 feet radius from the trunk. Shown as a thin red line. Fencing is not practical here since it would block access to the proposed garage and ADU. The tree stands on the neighbor's property behind permanent fencing. No tree protection is needed.

Excavation for the proposed garage and ADU foundations should be done with hand tools only within the TPZ. No roots greater than 2" in diameter should be cut.

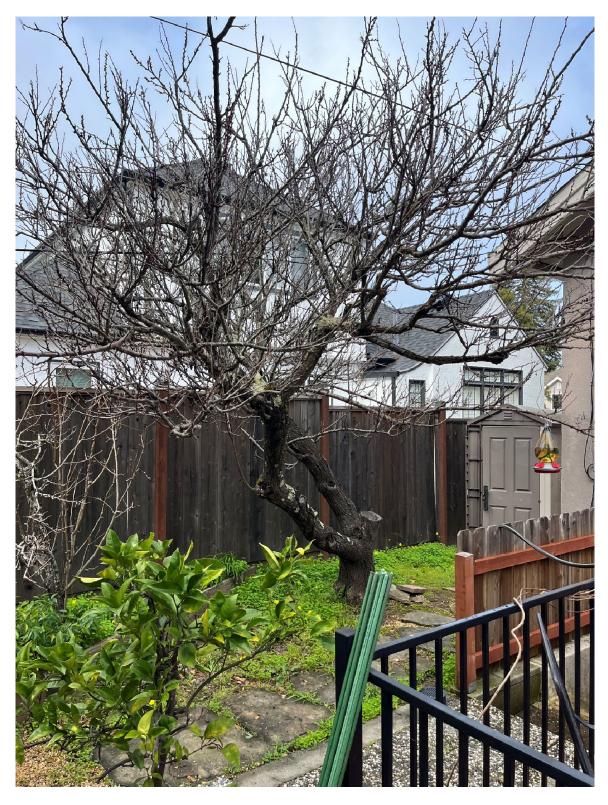
<u>Tree # 8</u>

Tree # 8 is a non Regulated fruit tree that can be removed if desired.
