**Subject:**       **ARBORIST REPORT**  
Mr. Jeffrey Chan  
1113-1115 Paloma Ave.  
Burlingame, CA. 94010

You own the property at 1113-1115 Paloma Avenue in Burlingame. You plan to develop the site with the demolition of two (2) existing residential units, and the construction of three (3) condominiums.

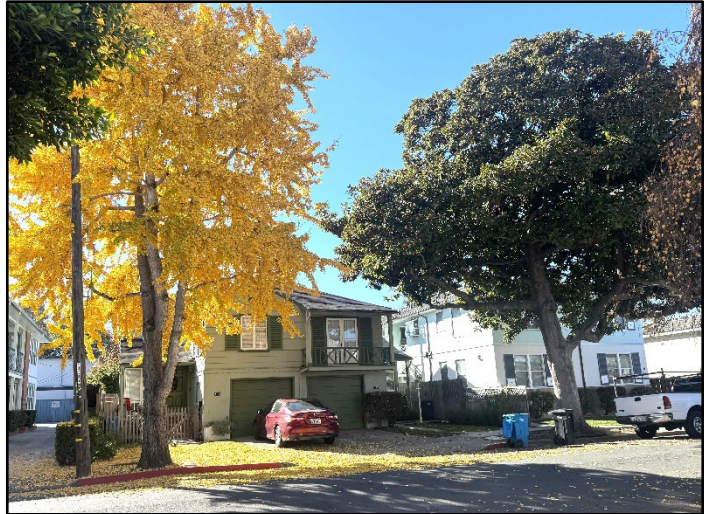
There are three (3) trees that will be impacted by development activities; two (2) off-site street trees (photo 1), and one (1) on-site backyard tree.

**Photo 1.** The subject property was located on Paloma Avenue in the Burlingame Terrace neighborhood. Two (2) city street trees located in a planting strip in front of the property (pictured), and one (1) on-site backyard tree will be impacted by development activities.

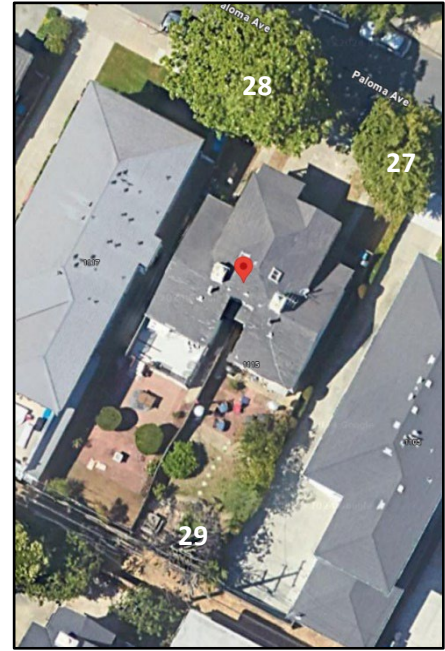
The lot was rectangular in form with the northeast-facing residence closer to the frontage. Subject street trees #27 and 28 were located in a planting strip between Paloma Avenue and the public sidewalk, with backyard tree #29 along the southwestern fenceline (photo 2).

**Photo 2.** The rectangular lot faced to the northeast with street trees #27 and 28 at the frontage, and backyard tree #29 at the southwestern property line fence.

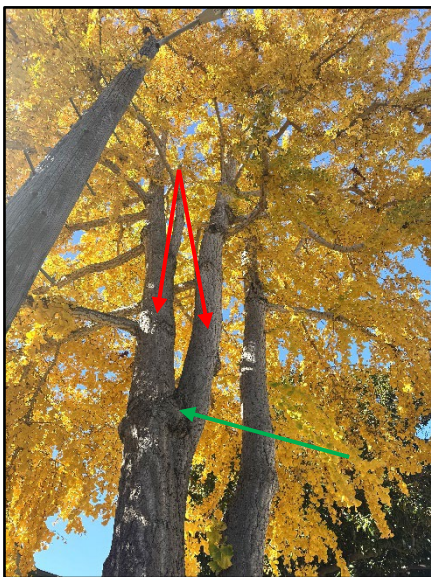
**Maidenhair tree #27** (*Ginkgo biloba*) was a street tree located in a planting strip to the northeast of the property line. It was a semi-mature specimen, 21" in trunk diameter (DBH) with poor structure. Two (2) upright codominant stems of approximately equal diameter arose from the same location on the trunk with bark included between the stems. There was less overlapping branch tissue in the attachment as a result of the inclusion which weakened the union (photo 3).

Overall, the Maidenhair tree was in 2.5 fair-poor condition with moderate vigor.

Photo 3 (left). Codominant stems arose from the same location on the trunk (red arrows) with included bark between the attachment (green arrow).

1. It is recommended that the contractor and consulting arborist meet to map the TPZ for Maidenhair tree #27 and Southern magnolia #28.

5. Wrap the trunk of Maidenhair tree #27 and Southern magnolia #28 with straw wattle to the lowest branch or 6', whichever is higher.
6. Remove concrete by hand within the TPZ of Maidenhair tree #27 and Southern magnolia #28 to avoid damage to tree roots.

12. Perform crown reduction pruning to shorten branches of Maidenhair tree #27 and Southern magnolia #28 to balance the canopy over the root system. All tree pruning work shall be performed by a certified Arborist or Tree Worker, and comply with *ANSI Standard Practices – Pruning*, and companion *Best Management Practices – Pruning*, and comply with the Migratory Bird Treaty Act and California Fish and Wildlife Code 3503-3513 to avoid nesting bird disturbance.

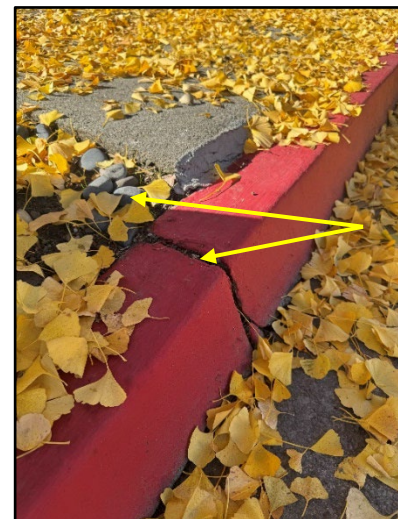
Lower laterals were removed along the stems which created an upright habit with attenuated stems which reduced resistance to windthrow and put more stress on the weak unions. Decay developed at the wounds and weakened the stems. The branches were headed to the east, there were epicormic shoots at old wound sites, and the sidewalk and curb sections were displaced by tree roots within the critical root zone <3' from the trunk (photo 4).

Photo 4 (right). The curb and sidewalk sections were displaced by tree roots (yellow arrows).

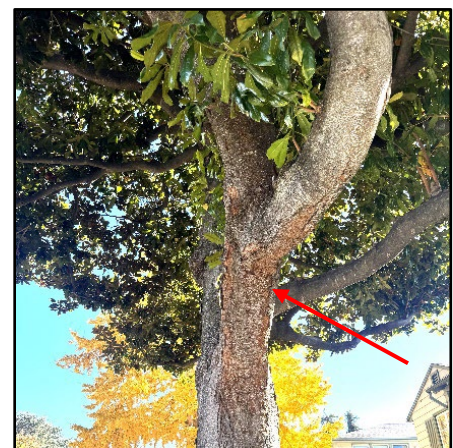
Typical of the species, the bark of Southern magnolia #28 was thin. There was evidence of damage to the bark from fungal decay with separation and shedding at branch unions and along lateral stems (photo 5). There were wounds along the trunk from lateral branch removal where decay developed and compromised wood strength within the stem.

Photo 5. Bark separation on Southern magnolia #28 was from decay from a fungus or other pathogen (red arrow).

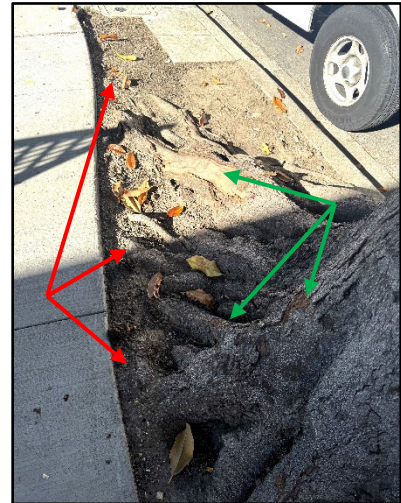
The sidewalk between the planting strip and the property line was recently replaced and curved to provide more room for the massive surface roots. There was evidence that critical roots approximately 2" or greater in diameter were pruned on the south side of the planting strip, most likely for sidewalk repair. The bark was scraped off some of the surface roots and bark was separating from the roots and trunk (photo 6).

There were epicormics along the lateral branches, a symptom of stress. The magnolia was compromised in health and structure with a condition rating of 2.5 fair-poor, and fair-moderate vigor.

Photo 6. Roots within the critical root zone of Southern magnolia #28 were most likely pruned at the time of sidewalk repair (red arrows). Bark was scraped from a large root and separated from the trunk and roots by decay (green arrows).

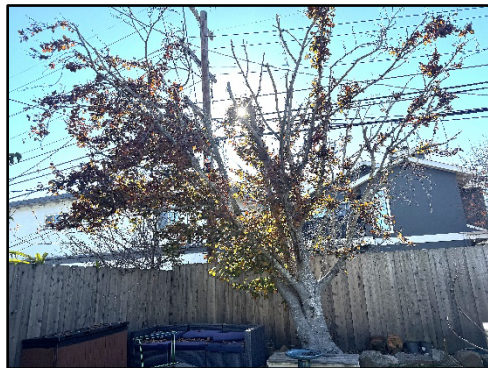
**European beech #29** (*Fagus sylvatica*) was a multi-trunked (13", 8", 7") semi-mature specimen in the backyard at the southwestern perimeter fence. It had poor structure with a straight trunk lean to the southeast (photo 7) and hollow buttress roots to the northwest (photo 8). The tree had dead stems and epicormic shoots in the crown. Mycelial fungal sheets of *Armillaria* root rot had progressed to the south stem (photo 9). The tree was almost dead and failing at the base with compromised root strength. It had a condition rating of 1.0 poor with low vigor.

Photo 7 (left). European beech #29 had a straight trunk lean to the southeast.

1. Site disturbance from irrigation system installation, grading, soil preparation, and planting within the TPZ is outside tree tolerance. It is recommended that the tree be removed and replaced per the City of Burlingame Municipal Code Chapter 11.06 Urban Forest Reforestation and Tree Protection Section 11.06.090.

1. Remove and dispose of all wood off-site.
2. Remove and dispose of all wood and roots in the soil from European beech #29 to the greatest extent possible. Plants susceptible to *Armillaria* root rot can become infected from decayed roots.
3. Replant with species resistant to *Armillaria* root rot.
4. No herbicides shall be used as a stump treatment as roots are cojoined with neighboring roots underground. Herbicides use this connected pathway to translocate to adjacent trees and plants and can result in severe damage or tree death.

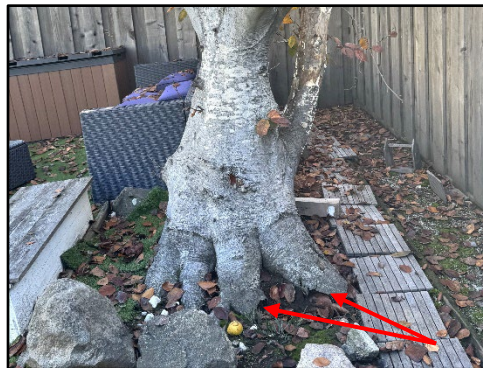
Photo 8 (center). Buttress roots on the west side of the tree were hollow (red arrows).

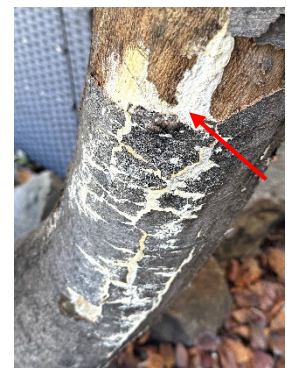
Photo 9 (right). Flat fungal sheets of mycelium were present under the bark, symptomatic of *Armillaria* root rot disease (red arrow).
