**Kielty Arborist Services LLC**  
Certified Arborist WE#10724A TRAQ Qualified  
P.O. Box 6187  
San Mateo, CA 94403  
650-532-4418

Site: 1385 Hillside Circle, Burlingame, CA

As requested on December 4<sup>th</sup>, 2023, Kielty Arborist Services visited the above site to provide a Tree Inventory Report/Tree Protection Plan for the proposed construction. 3 new homes are proposed for this site, and your concern as to the future health and safety of the tree has prompted this visit. Preliminary landscape plans L1 through L7 dated January 2024, lot 1 site plans A.1 through A.6 dated 10/26/22, lot 2 site plans A.1 through A.6 dated 10/26/21, and lot 3 plans A.1 through A.8 dated 10/26/21 were also reviewed for writing this report. This Tree Inventory Report is not a Tree Risk Assessment. As such, no trees were assessed for risk in accordance with industry standards, nor are there any tree risk ratings or risk mitigation recommendations provided within this preservation plan.

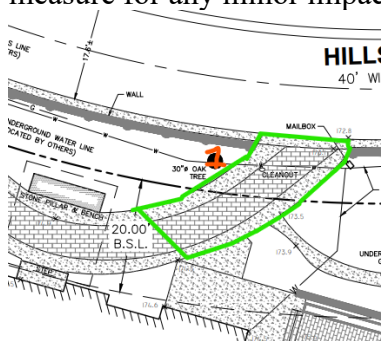
Oak tree #1 is to be retained. The tree is adjacent to an existing driveway. It is recommended to temporarily retain the existing driveway near this tree when underneath the dripline of the tree during the building phase of the project. Temporarily retaining the driveway will act as a tree protection measure and will help to increase staging and access to the site, as removing the driveway at the beginning of the project would make for a larger tree protection zone needed with the fencing being located at the tree's drip line. The existing grade within the tree's dripline is recommended to be retained as is where possible. No grading or excavation is recommended to take place within 10' from this tree (6x diameter) except for the removal of the driveway. At the end of the project, when it is time to demolish the existing driveway near this tree, the Project Arborist is

**Showing portion of driveway recommended to be retained until the landscape phase of the project.**

recommended to be on-site to document and witness the removal of the driveway. A jackhammer is recommended to be used when working within the tree's dripline to break the concrete material into hand manageable-sized pieces. Once broken down the driveway material is recommended to be removed by hand. Exposed roots during the process are recommended to be wrapped in layers of wetted-down burlap to avoid root desiccation. The existing driveway area is recommended to be filled back in once the driveway has been removed so that no roots are exposed to the elements. When backfilling the soil in this area, the area is also to be irrigated. The proposed driveway is further from the tree than the existing driveway and outside of the 10' range and is not expected to have impacts on the tree. The tree is recommended to be deep water fertilized with Nutriroot once the work near the tree has taken place as a mitigation measure for any minor impacts that may take place.
