900 Peninsula Tree Tree Photographs

Re: Tree protection for proposed commercial remodel at 900 Peninsula Ave, Burlingame, CA 94010

VOLVO CARS BURLINGAME

900 PENINSULA AVE,  
BURLINGAME, CA 94010  
APN #029-244-070

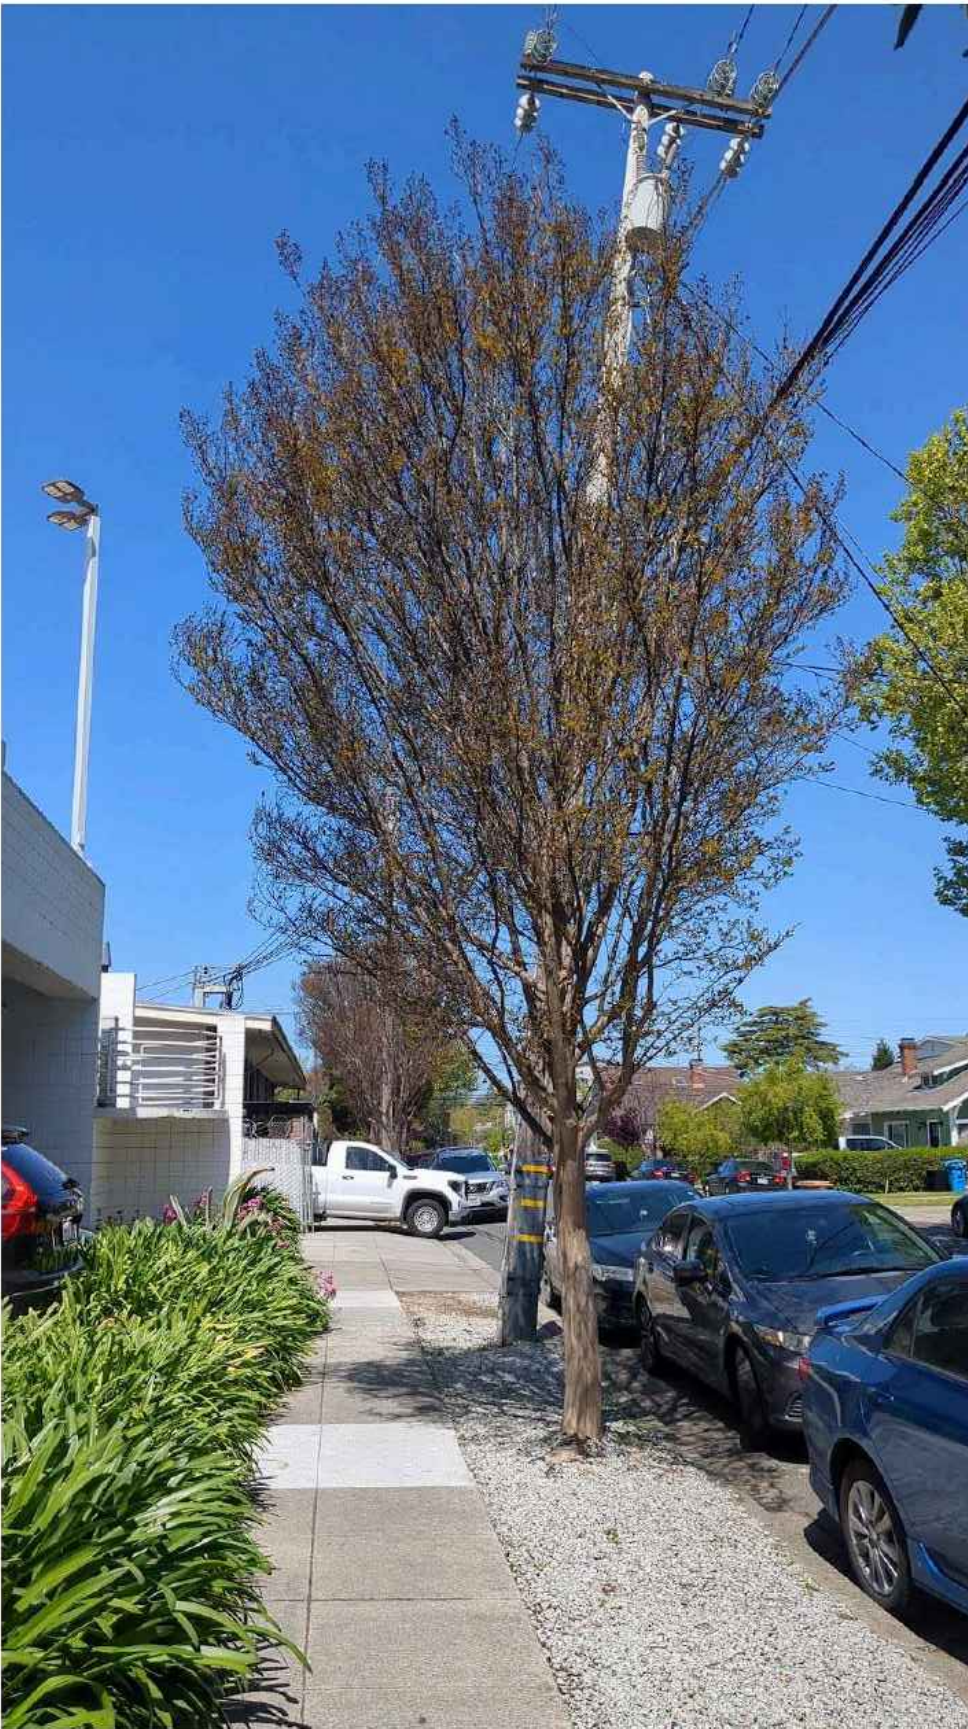
Image 1: crape myrtle #1

| Tree # (6 total) | | Common Name | Species | DBH (in.) | Vitality Rating (%) | Structure Rating (%) | Form Rating (%) | Suitability for Preservation (%) | Protected Tree - 0 | Street Tree - 6 | Off-Site Tree - 0 | Protected Removals - 0 | CRZ radius (ft. from center of trunk) | TPZ radius (ideal; ft. from center of trunk) | Expected Impacts (with recommended protection) | Notes |
|---|---|---|---|---|---|---|---|---|---|---|---|---|---|---|---|---|
| 1 | crape myrtle | Lagerstroemia indica | | 7.3 | 90 | 70 | 90 | 80 | <input type="checkbox"/> | <input checked="" type="checkbox"/> | <input type="checkbox"/> | <input type="checkbox"/> | 2.1 | 5.5 | Minimal | measured below breast height due to low branching |

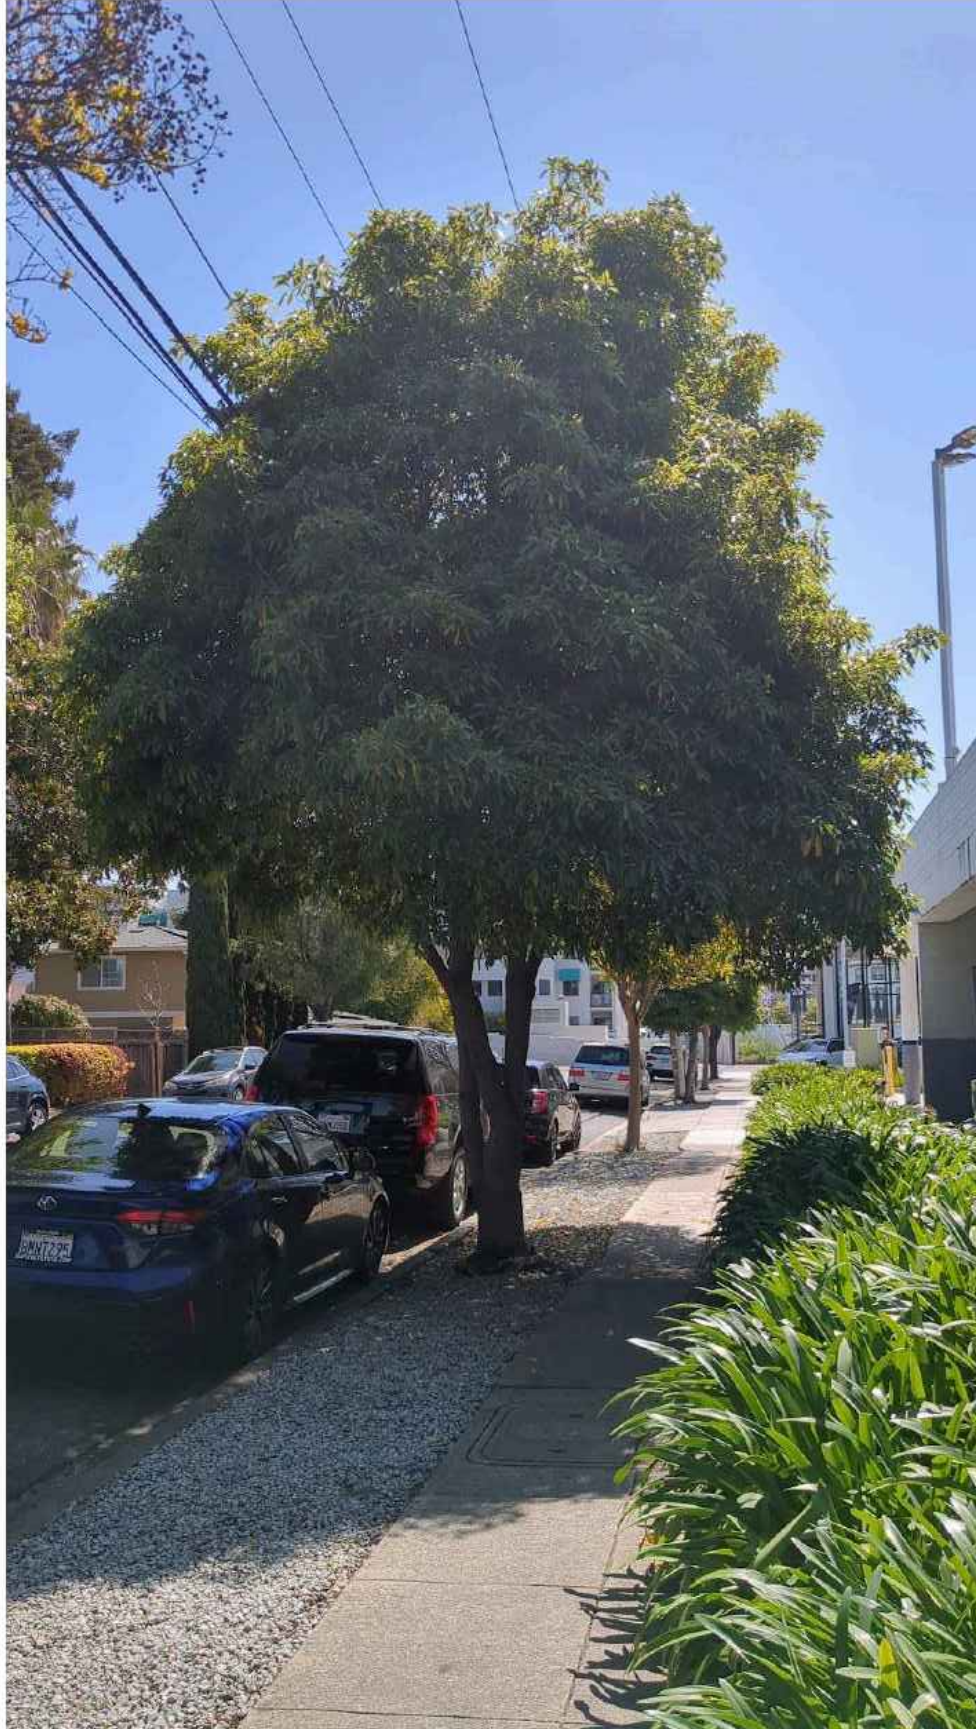
Image 2: pittosporum #2

| Tree # (6 total) | | Common Name | Species | DBH (in.) | Vitality Rating (%) | Structure Rating (%) | Form Rating (%) | Suitability for Preservation (%) | Protected Tree - 0 | Street Tree - 6 | Off-Site Tree - 0 | Protected Removals - 0 | CRZ radius (ft. from center of trunk) | TPZ radius (ideal; ft. from center of trunk) | Expected Impacts (with recommended protection) | Notes |
|---|---|---|---|---|---|---|---|---|---|---|---|---|---|---|---|---|
| 2 | pittosporum | Pittosporum sp. | | 13.7 | 90 | 40 | 80 | 65 | <input type="checkbox"/> | <input checked="" type="checkbox"/> | <input type="checkbox"/> | <input type="checkbox"/> | 4.0 | 6.9 | Minimal | measured below breast height due to low branching; multiple leaders, some with bark inclusions |

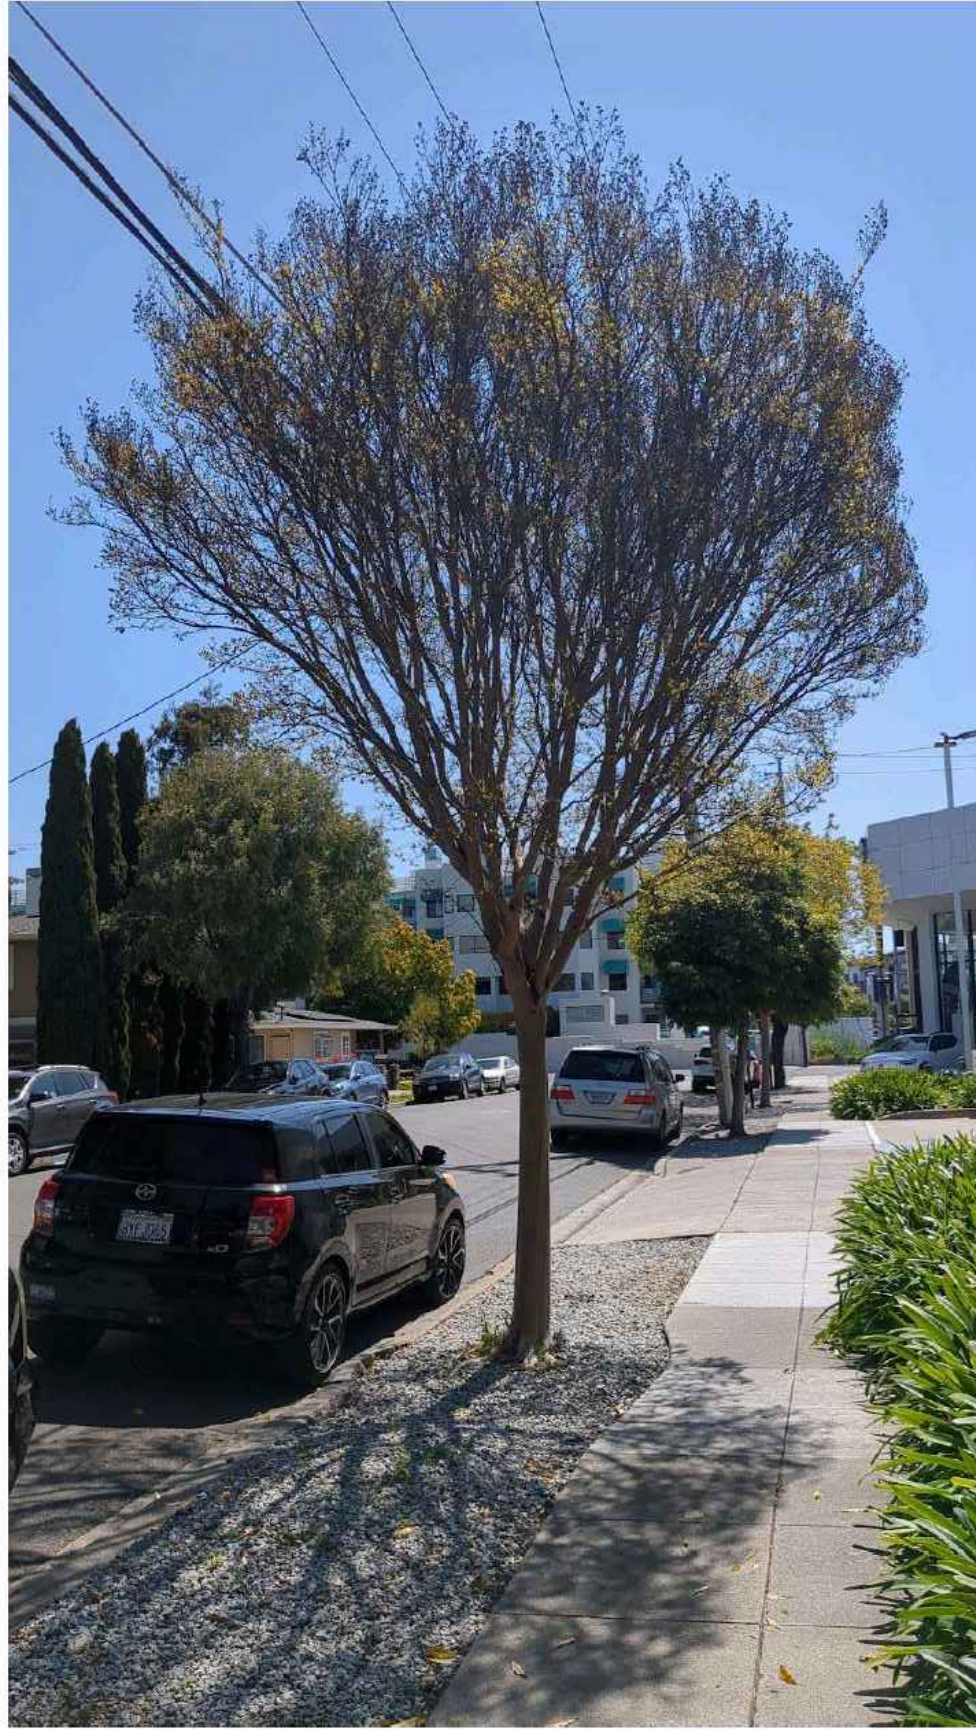
Image 3: crape myrtle #3

| Tree # (6 total) | | Common Name | Species | DBH (in.) | Vitality Rating (%) | Structure Rating (%) | Form Rating (%) | Suitability for Preservation (%) | Protected Tree - 0 | Street Tree - 6 | Off-Site Tree - 0 | Protected Removals - 0 | CRZ radius (ft. from center of trunk) | TPZ radius (ideal; ft. from center of trunk) | Expected Impacts (with recommended protection) | Notes |
|---|---|---|---|---|---|---|---|---|---|---|---|---|---|---|---|---|
| 3 | crape myrtle | Lagerstroemia indica | | 6.4 | 90 | 70 | 90 | 80 | <input type="checkbox"/> | <input checked="" type="checkbox"/> | <input type="checkbox"/> | <input type="checkbox"/> | 1.9 | 4.8 | Minimal | - |

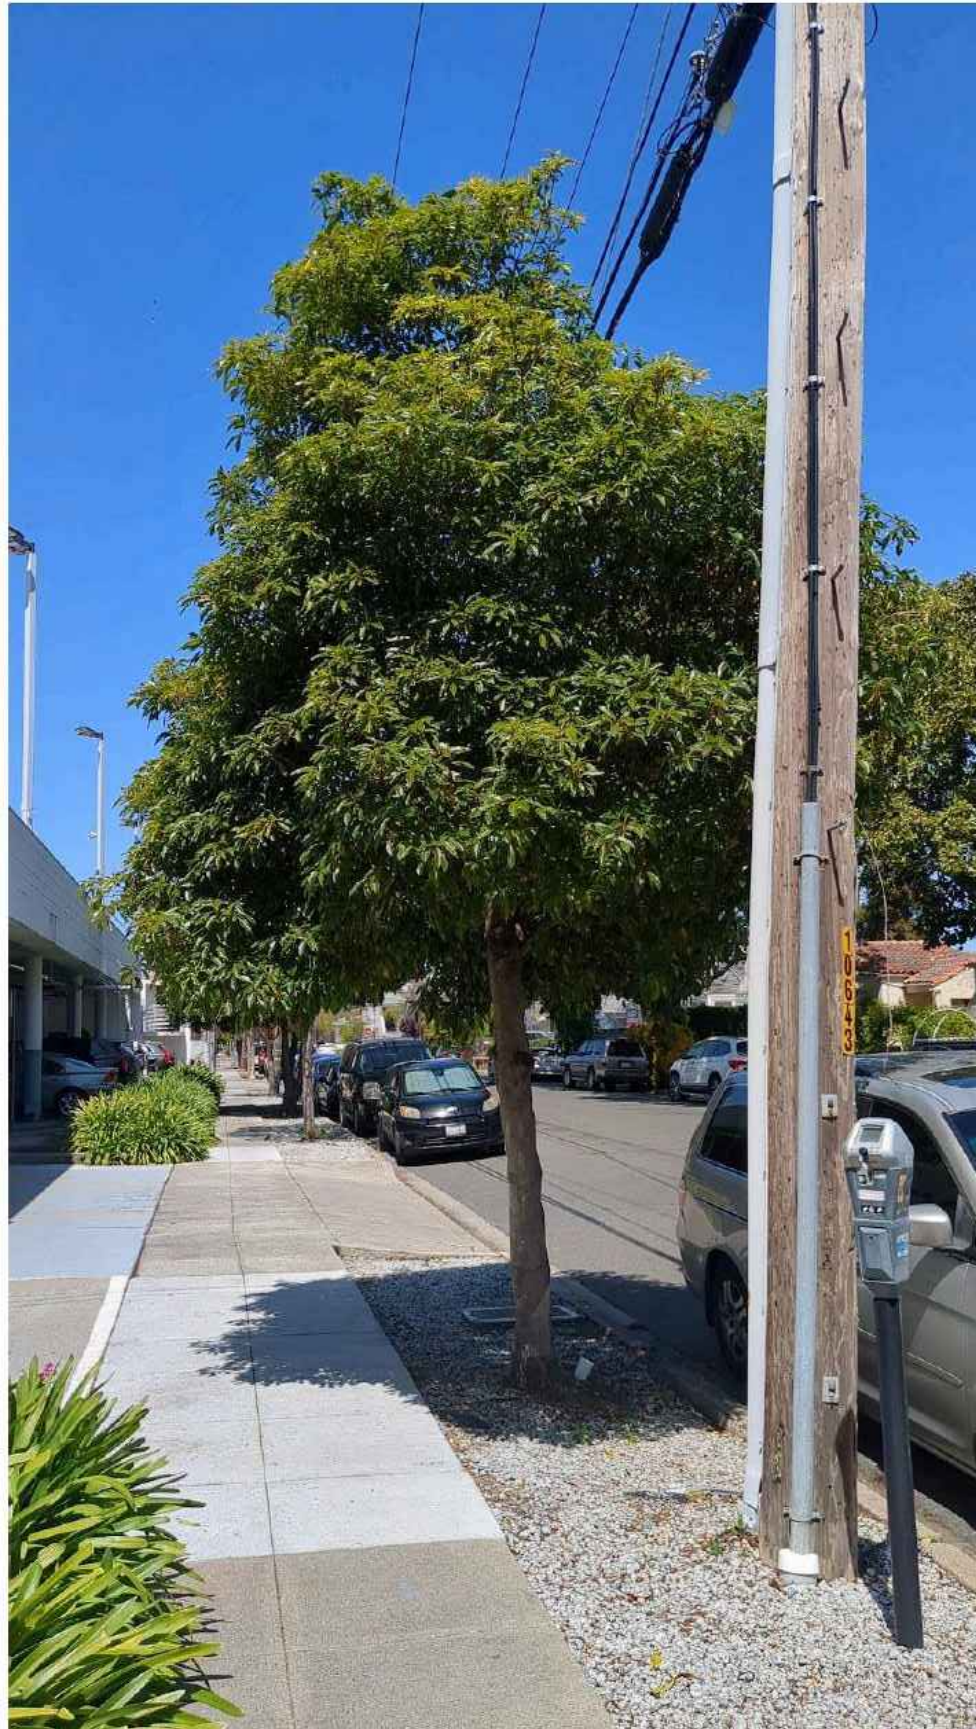
Image 4: pittosporum #4

| Tree # (6 total) | | Common Name | Species | DBH (in.) | Vitality Rating (%) | Structure Rating (%) | Form Rating (%) | Suitability for Preservation (%) | Protected Tree - 0 | Street Tree - 6 | Off-Site Tree - 0 | Protected Removals - 0 | CRZ radius (ft. from center of trunk) | TPZ radius (ideal; ft. from center of trunk) | Expected Impacts (with recommended protection) | Notes |
|---|---|---|---|---|---|---|---|---|---|---|---|---|---|---|---|---|
| 4 | pittosporum | Pittosporum sp. | | 6.4 | 90 | 70 | 90 | 80 | <input type="checkbox"/> | <input checked="" type="checkbox"/> | <input type="checkbox"/> | <input type="checkbox"/> | 2.0 | 3.5 | Minimal | - |

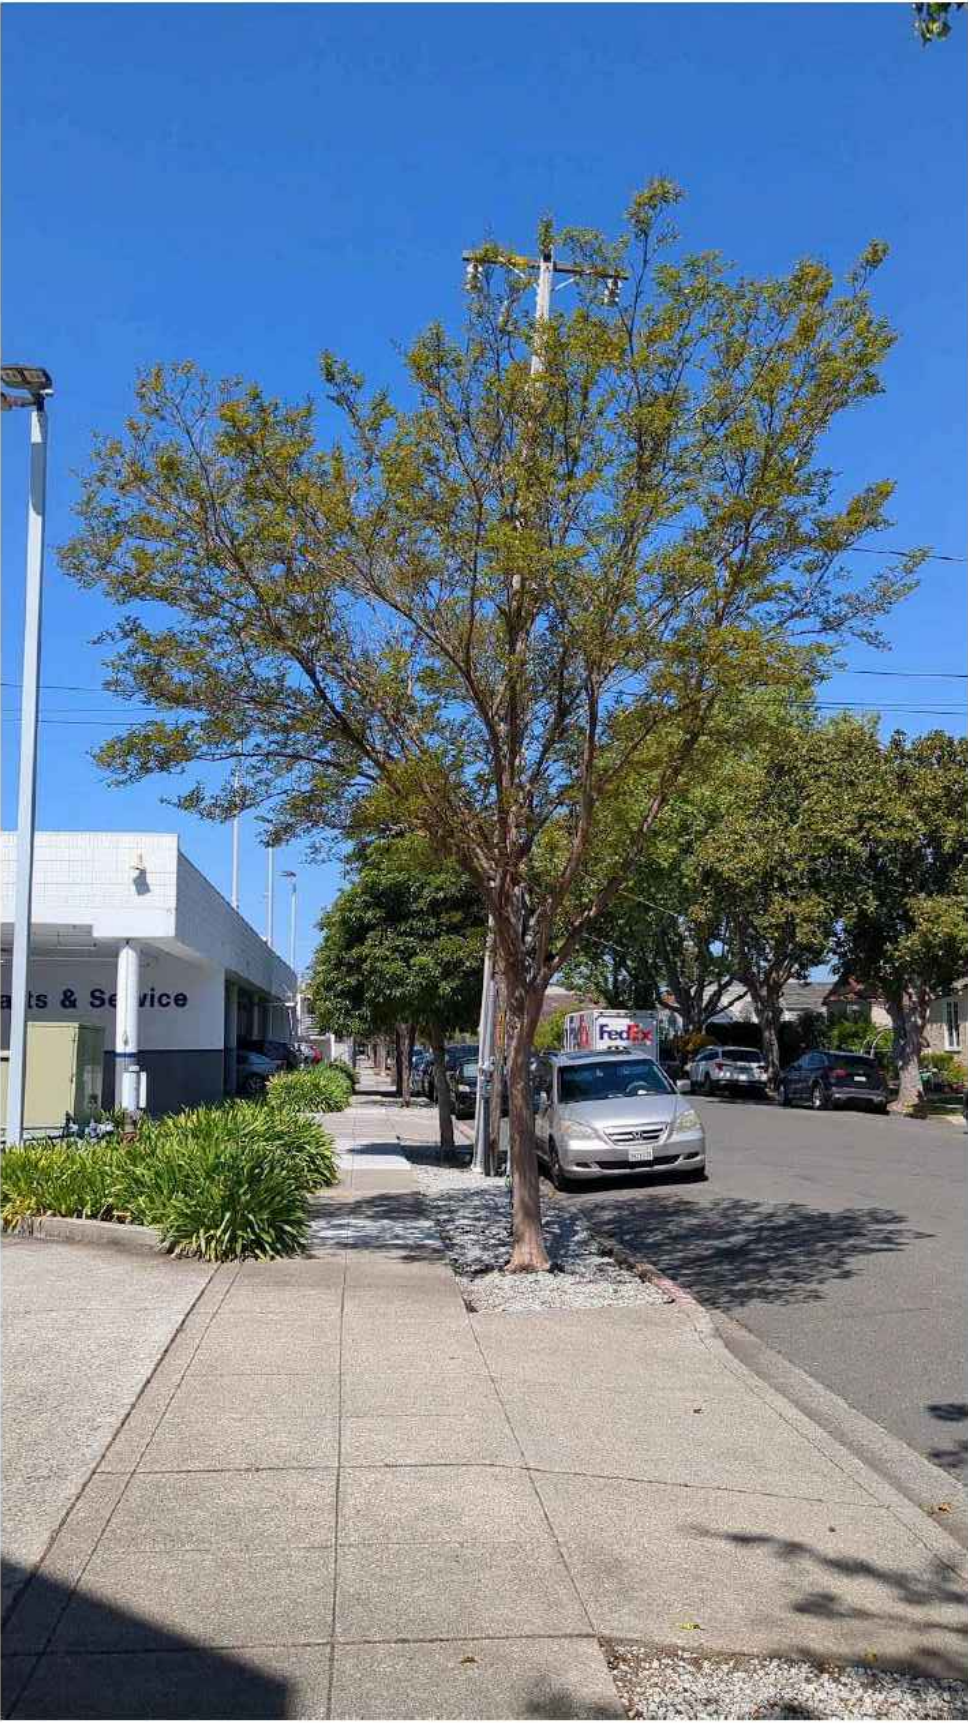
Image 5: crape myrtle #5

| Tree # (6 total) | | Common Name | Species | DBH (in.) | Vitality Rating (%) | Structure Rating (%) | Form Rating (%) | Suitability for Preservation (%) | Protected Tree - 0 | Street Tree - 6 | Off-Site Tree - 0 | Protected Removals - 0 | CRZ radius (ft. from center of trunk) | TPZ radius (ideal; ft. from center of trunk) | Expected Impacts (with recommended protection) | Notes |
|---|---|---|---|---|---|---|---|---|---|---|---|---|---|---|---|---|
| 5 | crape myrtle | Lagerstroemia indica | | 7.1 | 90 | 70 | 90 | 80 | <input type="checkbox"/> | <input checked="" type="checkbox"/> | <input type="checkbox"/> | <input type="checkbox"/> | 2.1 | 5.3 | Minimal | - |

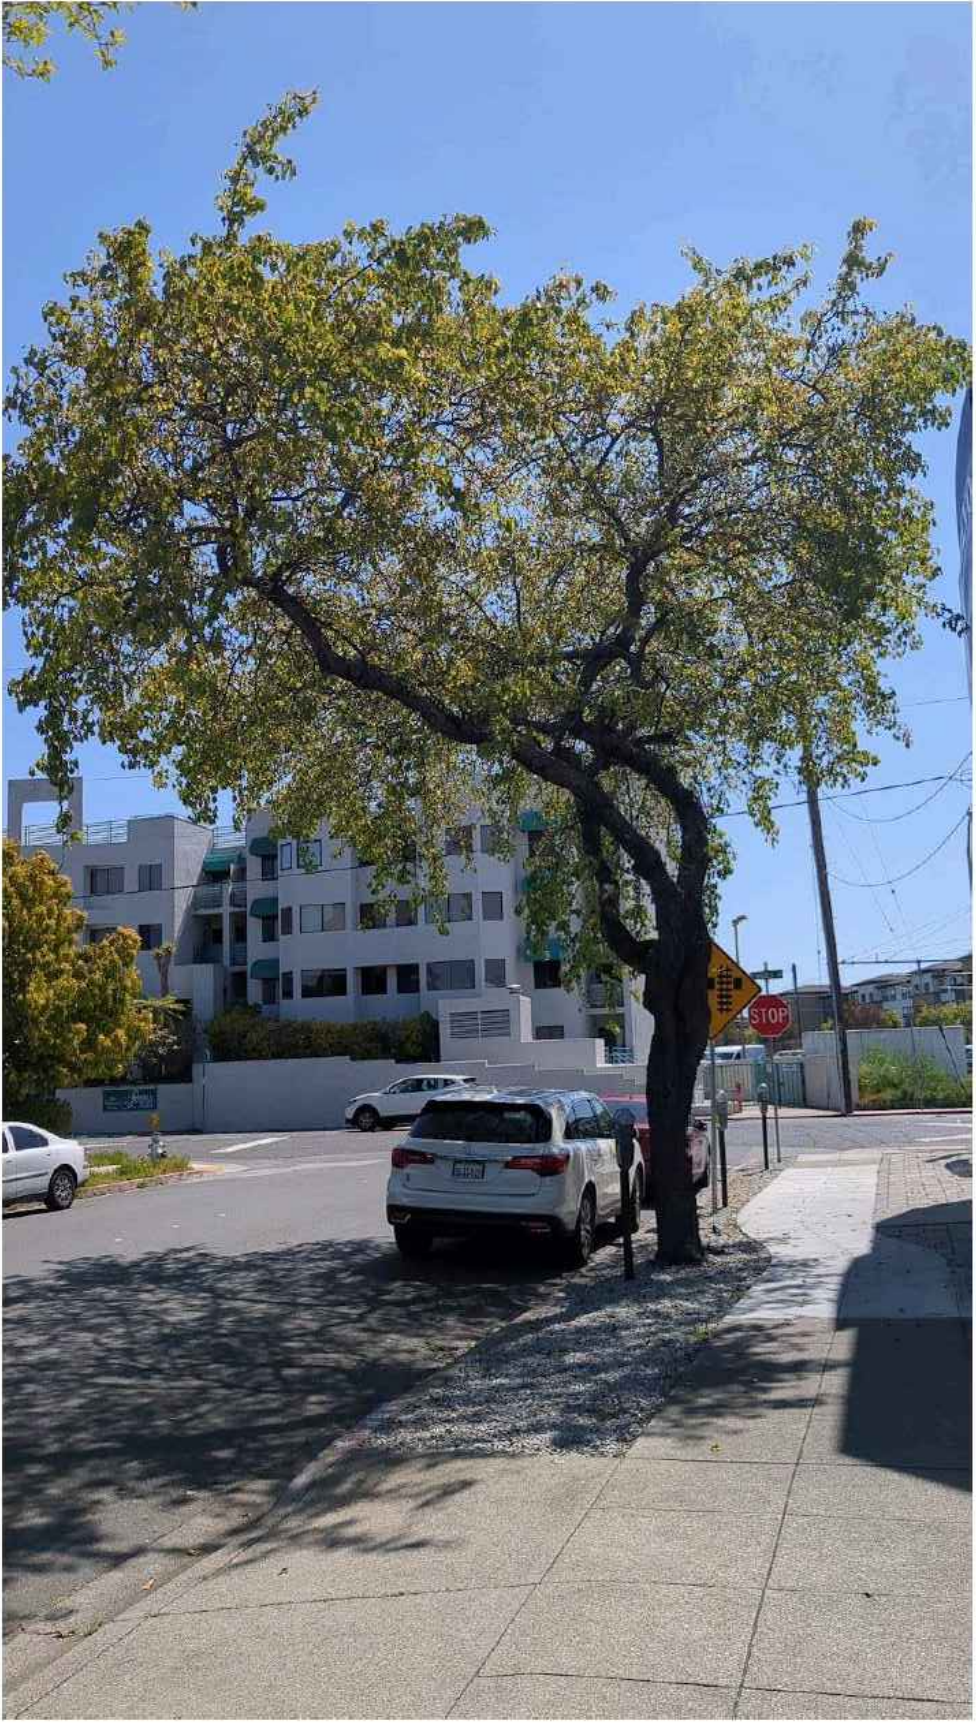
Image 6: evergreen pear #6

| Tree # (6 total) | | Common Name | Species | DBH (in.) | Vitality Rating (%) | Structure Rating (%) | Form Rating (%) | Suitability for Preservation (%) | Protected Tree - 0 | Street Tree - 6 | Off-Site Tree - 0 | Protected Removals - 0 | CRZ radius (ft. from center of trunk) | TPZ radius (ideal; ft. from center of trunk) | Expected Impacts (with recommended protection) | Notes |
|---|---|---|---|---|---|---|---|---|---|---|---|---|---|---|---|---|
| 6 | evergreen pear | Pyrus kawakami | | 14.5 | 70 | 40 | 50 | 55 | <input type="checkbox"/> | <input checked="" type="checkbox"/> | <input type="checkbox"/> | <input type="checkbox"/> | 4.2 | 14.5 | Minimal | multiple leaders, some with bark inclusions |
