CERTIFIED ARBORIST REPORT

October 15, 2021
Rev. February 1, 2022
Rev. June 2, 2022
5985.43

912 Linden Avenue
Burlingame, CA

HMH
1570 Oakland Road
San Jose, CA 95131
William Sowa
ISA Certified Arborist #WE-12270A

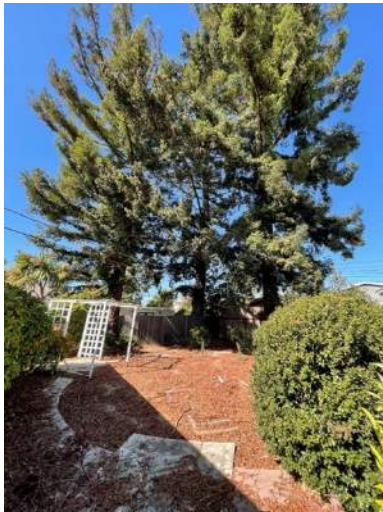
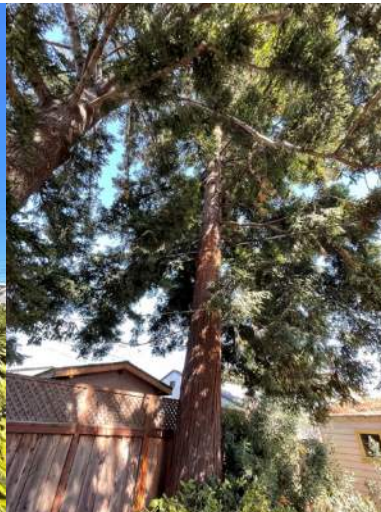
Tree 1

The redwood tree is a large specimen located at the back of the lot and makes up a very large canopy cluster of conifer trees include on large cedar tree that is offsite and tree #2 that is over the lot line. The tree is in good health however due to it's proximity to the others it has structural defects in the crown. If the cedar tree is removed there will be an obvious lopsidedness to this tree. The root structure is also very large so any construction activity could weekend the tree. Redwood trees are higher water use plants and if this tree is to be retained it should receive supplemental irrigation until regular irrigation can be established around the root zone.

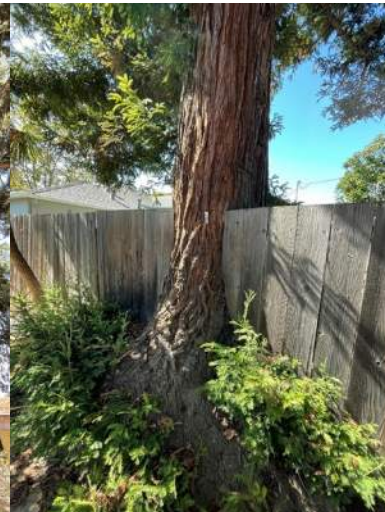
Tree 2

Tree # 2 is the other large specimen that makes up the three large canopy space along with the cedar and tree #1. This tree is probably technically offsite as most of the trunk and root mass is on the adjacent project. However, there is a portion of the root crown that encroaches into the project. If there is any construction activity around this area it could weekend the tree. Redwood trees are higher water use plants and if this tree is to be retained it should receive supplemental irrigation until regular irrigation can be established around the root zone.

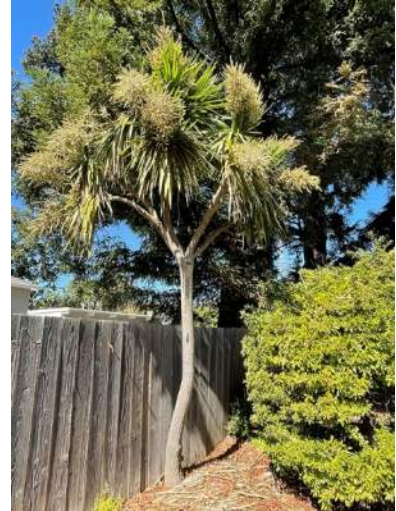
Tree 3

The yucca tree is in moderate shape. It is planted close to the fence and had developed a lean and misshapen trunk. There is low value for this tree from an ornamental point of view and removal is recommended.

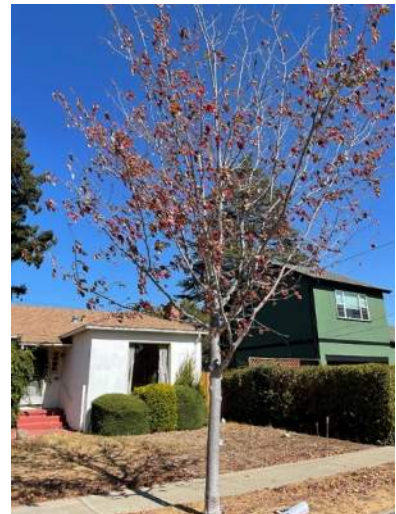
Tree 4

The maple tree is a street tree and looks like it has been planted as a replacement tree awhile back. The tree is in good shape and good health. Tree protection and supplemental irrigation through construction is recommended.

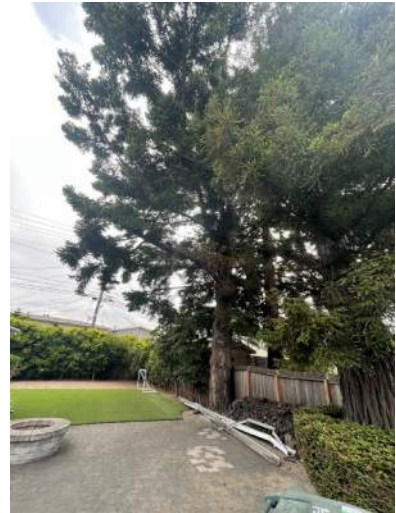
Tree 5

This spruce tree is on an adjacent property. It is in good health and moderate condition. It is being crowded by the redwood trees surrounding it and therefore has developed some structural defects in the canopy. The critical root zone beneath the canopy should be protected and grading and excavation in this area should be avoided if possible.

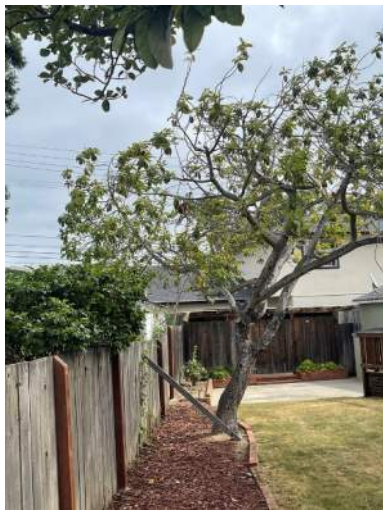
Tree 6

These ficus trees are on an adjacent property. They are in moderate shape and health. Both canopies are overhanging the property by just a couple feet. The critical root zone beneath the canopy should be protected and grading and excavation in this area should be avoided if possible.
