PUTNAM AUTOMOTIVE GROUP 900 PENINSULA AVE BURLINGAME, CA 94010

Re: Tree protection for proposed commercial remodel at 900 Peninsula Ave, Burlingame, CA 94010

Prepared for Putnam Automotive Group by Aesculus Arboricultural Consulting on 4/22/2025 1 of 12

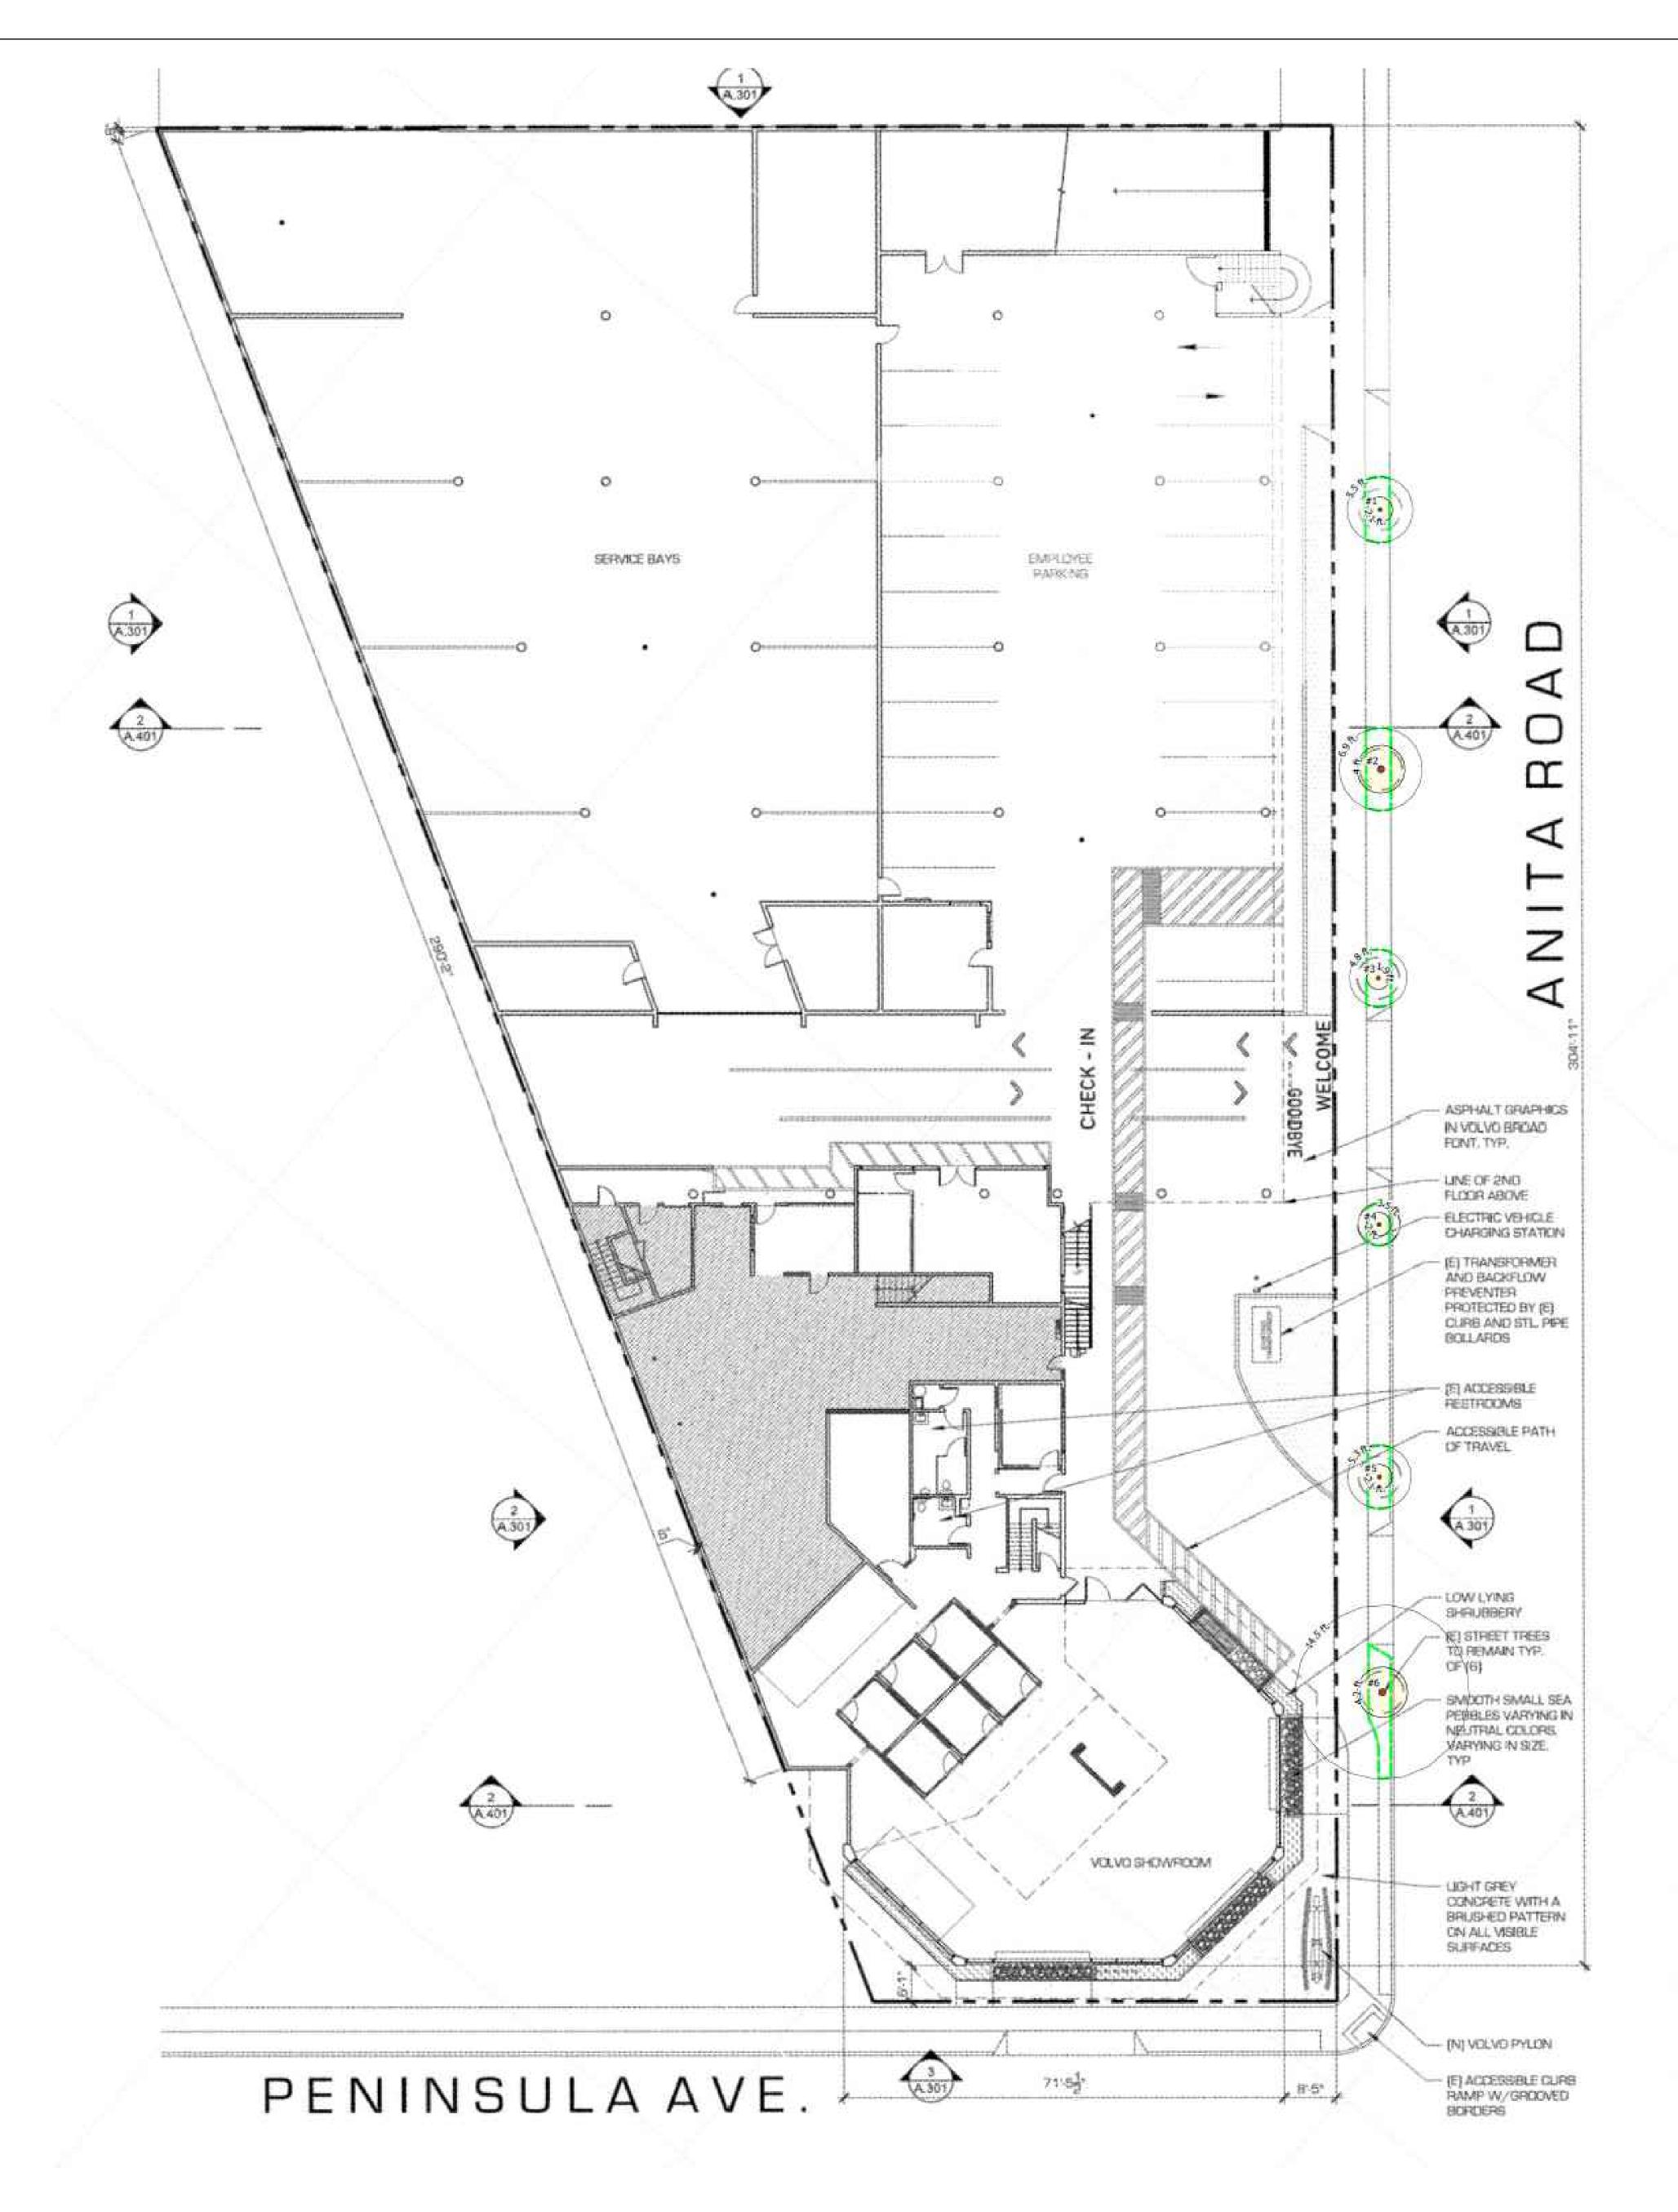
TREE PROTECTION MAP

Trees # 1-6 - all proposed project features and logical access routes thereto are outside these trees' TPZs.³

Trees #1-6 - **minimal** impacts to these trees are likely from the project as proposed. Tree protection fencing is still recommended, however, to prevent unintended damage from construction equipment, materials, and personnel movement.

- a. Minimum fencing distances are shown on the Tree Map. Fencing should be installed at or beyond these distances, or in the case of this project, at the edge of the pavement. Note that the TPZs of some offsite trees may extend onto this property and require fencing.
