State of California — The Resources Agency
DEPARTMENT OF PARKS AND RECREATION
PRIMARY RECORD

Page 1 of 15 Resource name(s) or number (assigned by recorder) 1629 Howard Avenue

1629 Howard Avenue is located on a 50-by-100-foot lot on the south side of Howard Avenue between Occidental and Costa Rica avenues in the Burlingame Park neighborhood. Built in 1919-1920, 1629 Howard Avenue is a 1,600-square-foot one-story-over-basement wood-frame residence in the Craftsman style. The rectilinear-plan building, clad in stucco siding, sits on a concrete foundation and features a side gabled roof. A covered entry porch at the northwest corner of the residence features a cross-gabled roof supported by battered columns. The asphalt shingle-clad roof forms include overhanging eaves with wood soffits, decorative knee braces, and exposed purlin tails with elaborated ends. Exposed rafter tails are visible on the north and south facades. The gable ends of the roof forms have a simple wood fascia. The residence contains an interior chimney clad in stucco located at the northeast end of the building. All windows on the main residence are non-original vinyl-sash windows set in narrow vinyl frames. The p

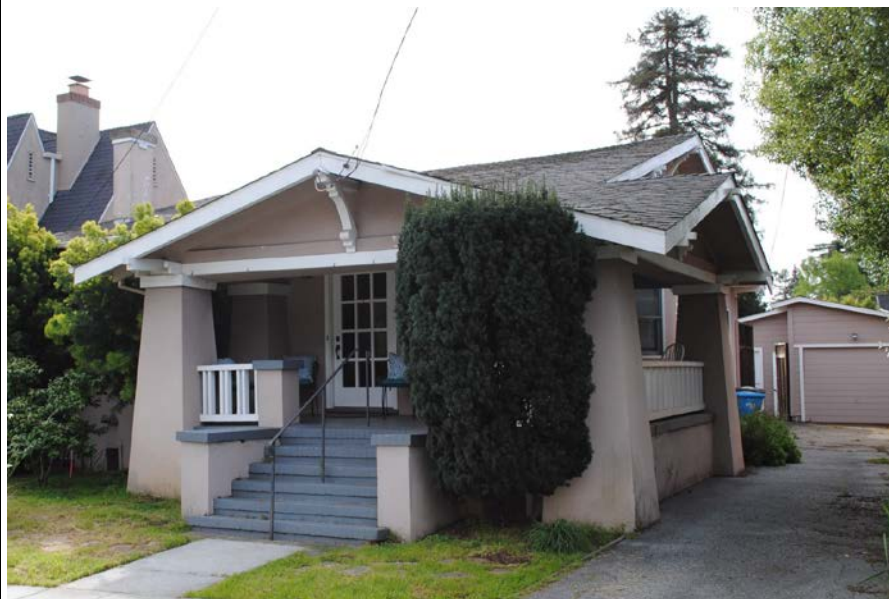
P5b. Photo: (view and date)

View of the primary (north) façade,
April 9, 2018.

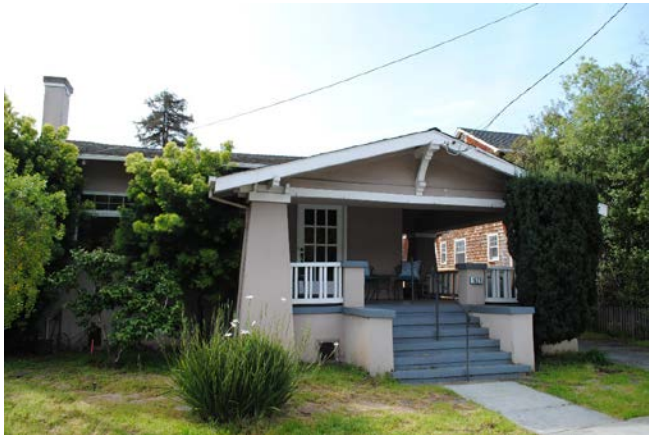
Figure 2. Primary (north) façade, looking south. The window at the east end of the façade is largely obscured by trees.

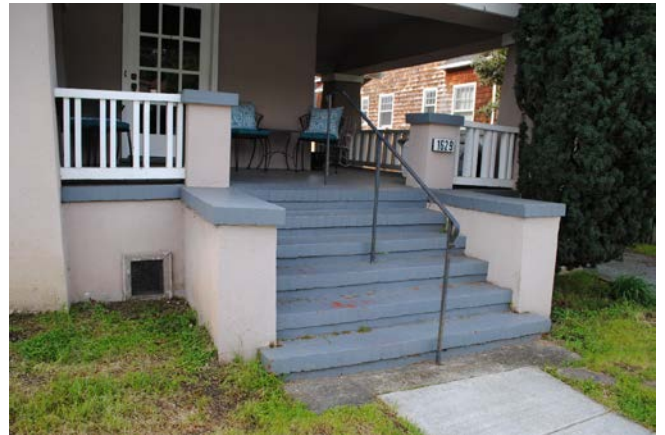
Figure 3. Detail of stairway leading to the entry porch on the primary façade, looking southwest.

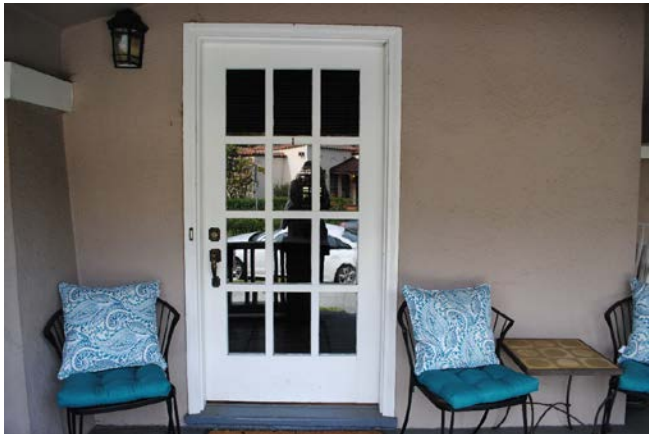
Figure 4. Primary entry door, located on the primary (north) façade, looking south.

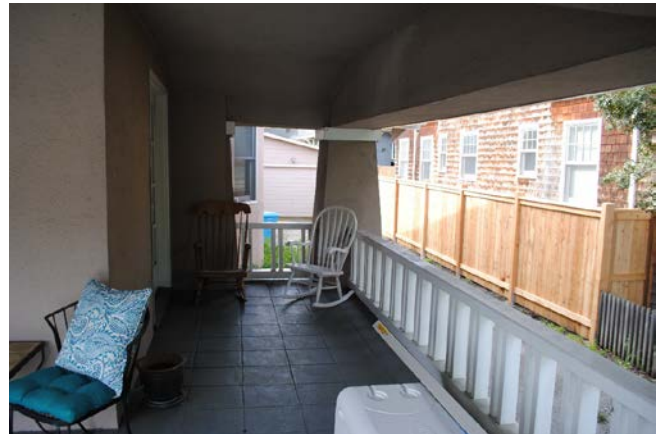
Figure 5. Entry porch, which wraps around to the west façade, looking south.

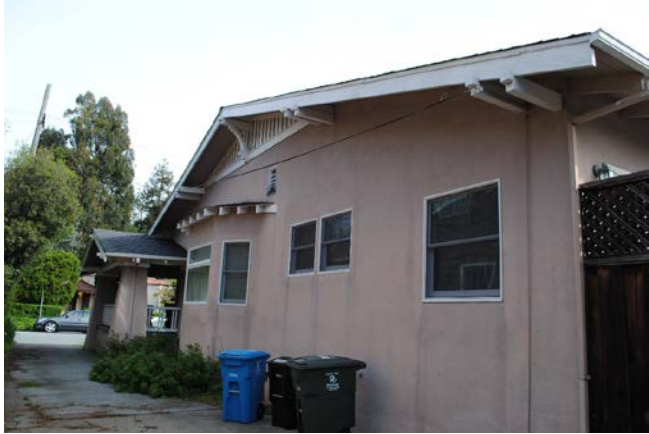
The west façade of the residence faces a driveway that leads to the detached rear garage (**Figure 6**). The west façade contains typical siding and typical overhanging eaves and wood fascia. The entry porch, which is located at the northwest corner of the residence, projects from the west façade (**Figure 7**). The porch includes typical features found on the primary (north) façade such as stucco-clad battered columns, wood railings spanning columns, infilled sections under the gable ends, and overhanging eaves with decorative knee braces. Leading out from the living room onto the porch on the west façade is a set of original double-doors (**Figure 8**). The wood doors are glazed with true divided lites and are set in a wood frame with molded surround.

Figure 6. Partial view of the west façade, looking northeast.

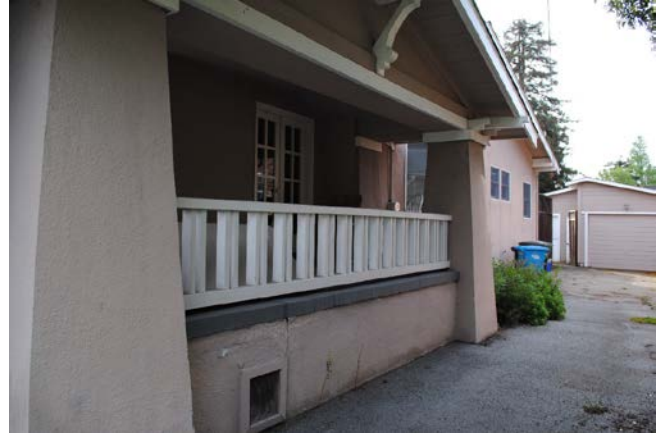
Figure 7. Partial view of the porch on the west façade and the driveway leading to the detached rear garage, looking south.

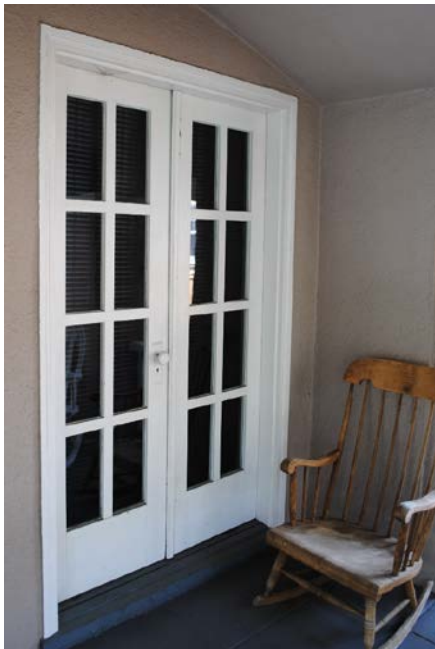
Figure 8. Glazed double-doors located on the west façade, leading to the entry porch.

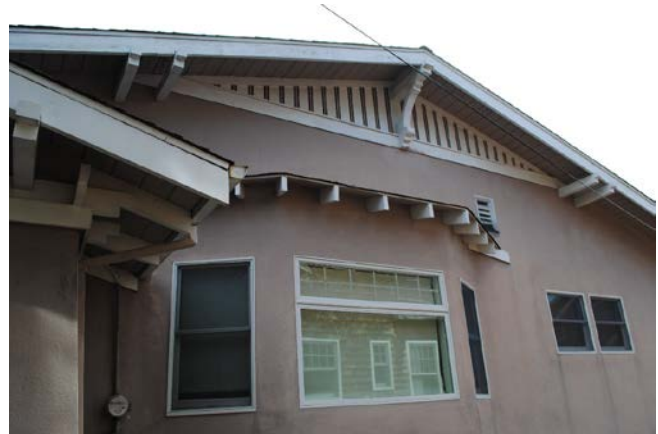
Exposed purlin tails with elaborated ends and decorative wood knee braces are located beneath the gable end of the primary roof form on the west façade (**Figure 9**). The main gable peak also includes decorative detailing with vertical wood boards. South of the porch, the west façade features an angled bay that extends down to the ground level, capped by an asphalt shingle-clad roof with exposed wood rafter tails. The angled bay contains a fixed picture window with a simulated divided-lite transom flanked by double-hung windows. Above the south end of the angled bay is a small wood vent. South (right) of the angled bay is a pair of two double-hung windows and one larger double-hung window. All double-hung windows on the west façade vinyl-sash and include screens.

Figure 9. Decorative detailing, wood knee braces, and exposed purlin tails with elaborated ends under the gable of the west façade.

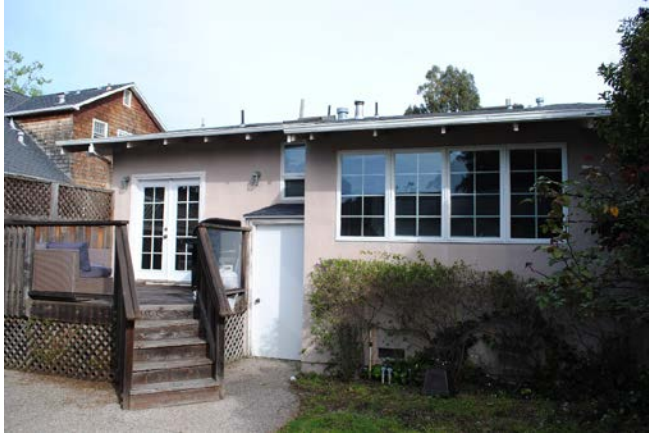
The rear (south) façade faces a small yard and contains typical cladding and typical overhanging eaves with exposed rafter tails (**Figure 10**). At the west end of the rear façade is a set of glazed, vinyl double-doors set in a wood frame that lead to an elevated wood deck (**Figure 11**). The wood deck is accessed by wood steps and includes a wood railing with wood balusters and clear plastic panels. The area below the elevated deck is enclosed by wood lattice panels. East of the wood deck is a projecting, partial-height volume capped with an asphalt shingle-clad shed roof with a synthetic slab door leading down to the basement of the residence. Above the basement door is a fixed-over-awning window. At the east end of the rear façade is a projecting bay enclosed by an extension of the primary roof form. The projecting bay contains a set of four casement windows with simulated divided lites.

Figure 10. Rear (south) façade, looking north.

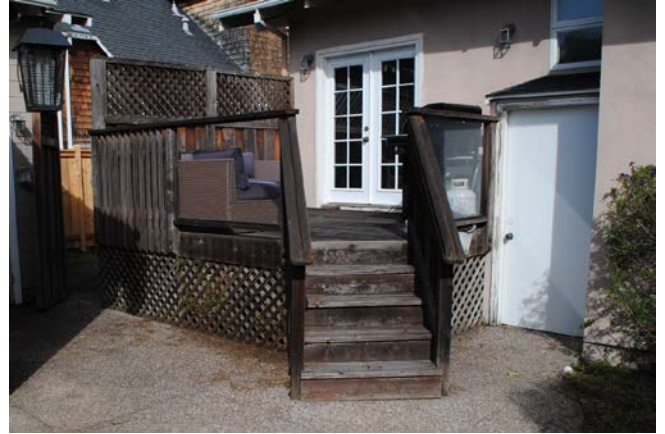
Figure 11. Wood deck at the west end of the rear façade, looking northwest.

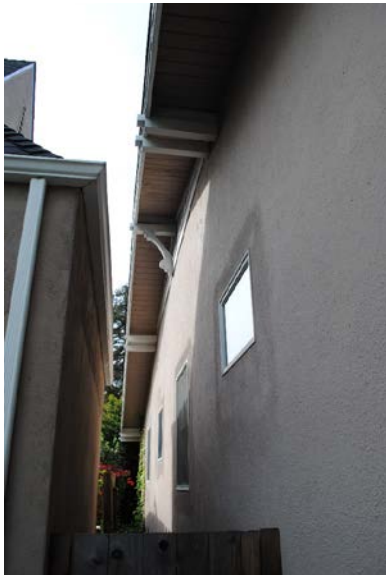
The east façade faces a very narrow side setback and the adjacent home at 1625 Howard Avenue (**Figure 12**). The east façade has typical siding, as well as the typical elaborated purlin tails, knee braces, and decorative gable details found on the west façade. From south to north (left to right), the east façade features three double-hung windows and two fixed windows with simulated divided lites. All of the double-hung windows on the east façade include screens. Above the north end of the east façade is an interior chimney clad in stucco (**Figure 13**).

Figure 12. Partial view of east façade, looking south. Subject residence is on the right, and the neighboring home at 1625 Howard Avenue is on the left.

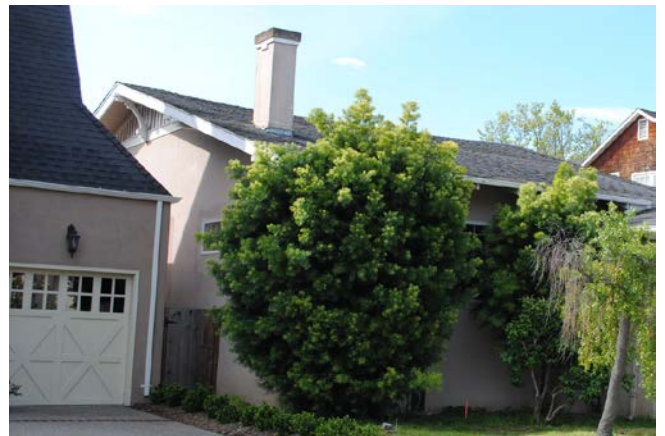
Figure 13. Partial view of the north end of the east façade, looking southwest.

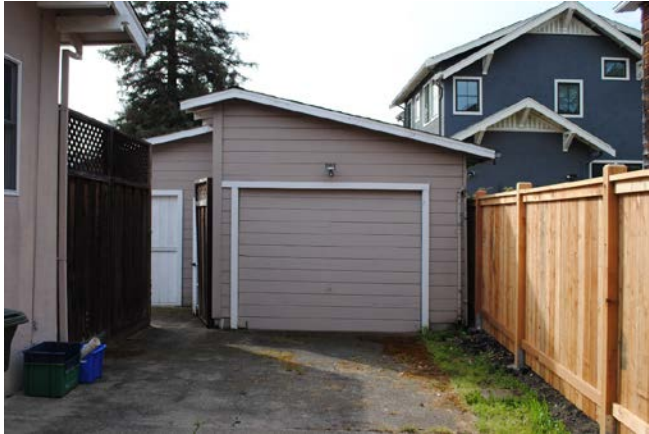
The detached garage is L-shaped in plan with horizontal wood channel siding and features a front-gabled roof with asphalt shingle cladding (**Figure 14**). The north façade of the garage contains a retractable garage door with horizontal wood channel siding and a wood Dutch door on the recessed wing. The east façade of the garage includes a fixed divided-lite wood-sash window set in a wood frame and sill (**Figure 15**). On the north, recessed portion of the east façade of the garage is a fully-glazed wood door with true divided lites (**Figure 16**).

Figure 14. North façade of the detached garage, looking south. Dutch door partially visible to the left.

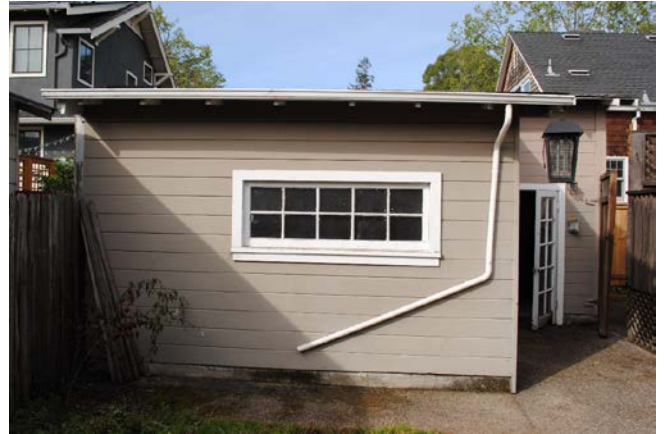
Figure 15. East façade of the detached garage, looking west.

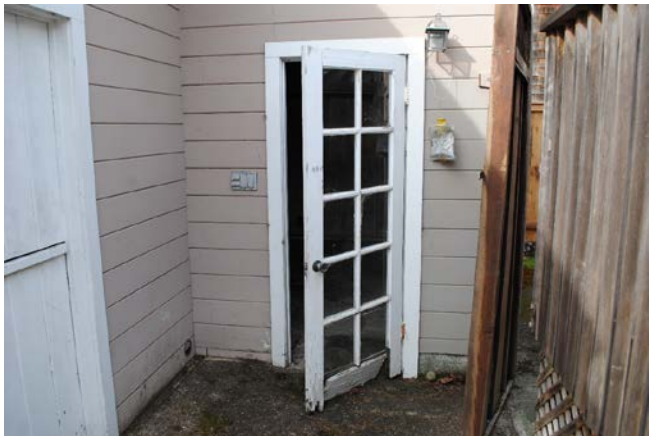
Figure 16. Fully-glazed door on the north end of the east façade of the garage, looking west.

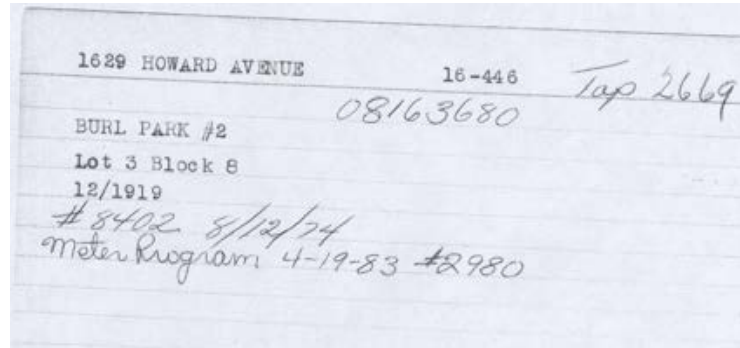
Figure 20. Water tap record for 1629 Howard Avenue. Source: Burlingame Historical Society.

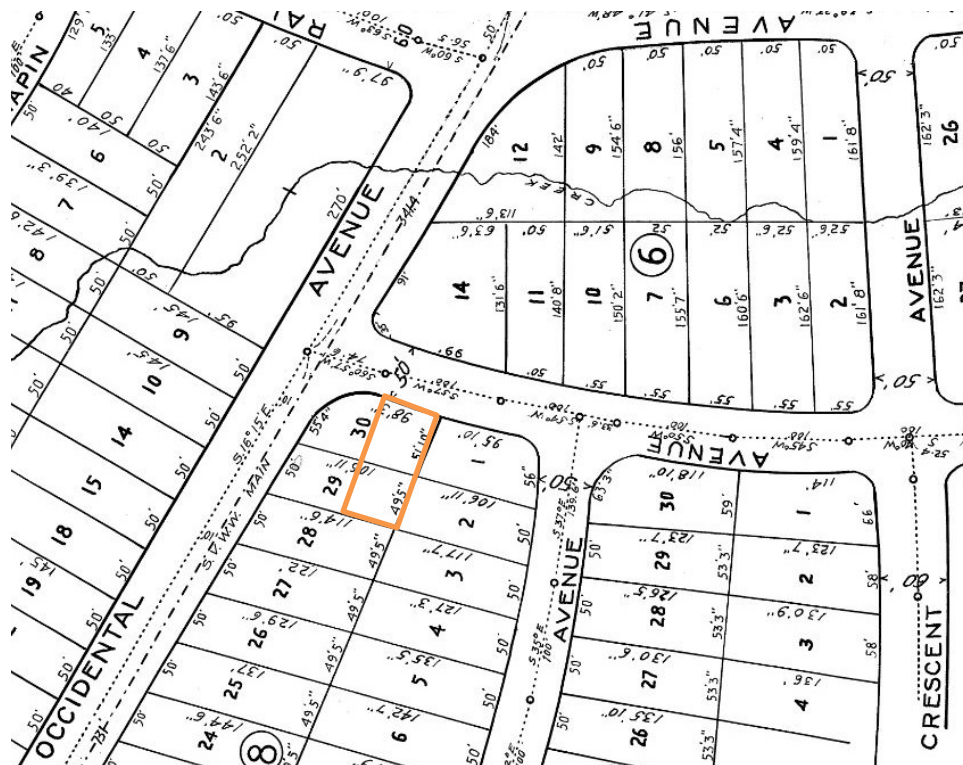
Figure 21. 1905 Map of Subdivision No. 2 of Burlingame Park. Subdivided by D. Bromfield in September 1905. Original Lots 29 and 30 of Block 8 were later reconfigured to create two lots fronting Howard Avenue. Subject property outlined in orange. Source: San Mateo County Property Maps Portal. Edited by Page & Turnbull.

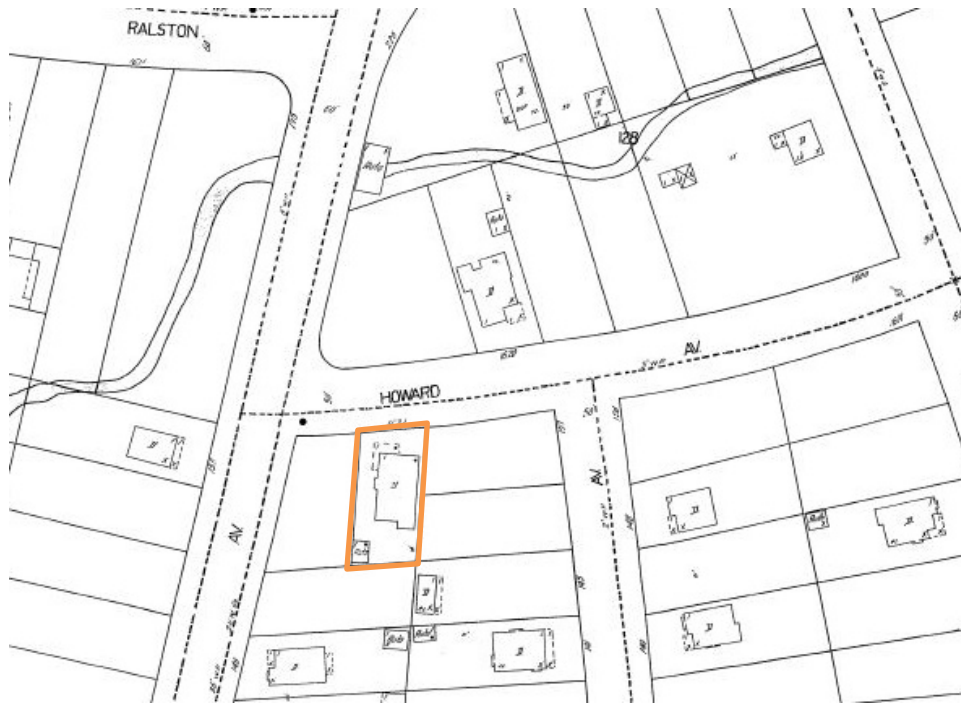
Figure 22. 1921 Sanborn Fire Insurance Company Map. Subject property outlined in orange.
Source: San Francisco Public Library. Edited by Page & Turnbull.

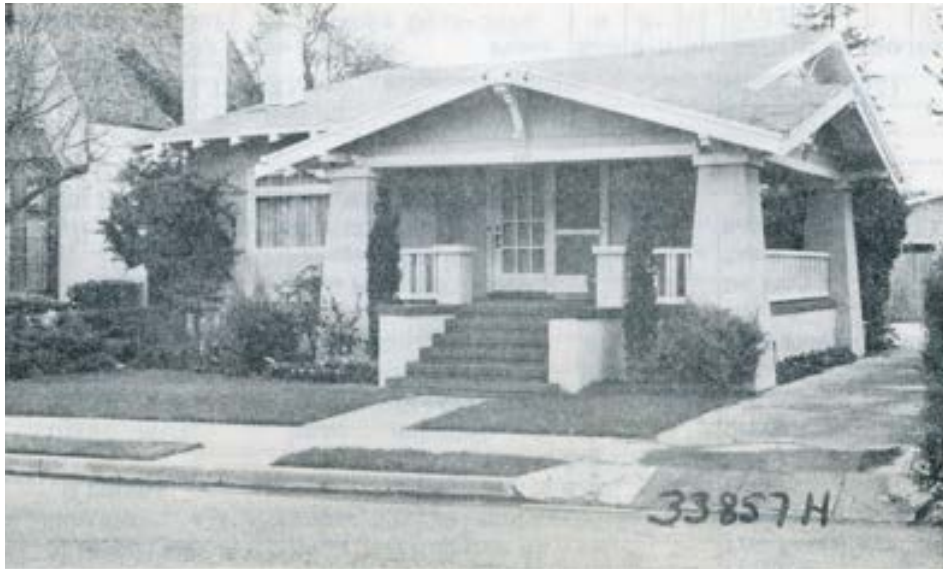
The earliest historic photograph of the Craftsman-style residence found during research dates to March 1962 (**Figure 24**). The photograph shows that the primary entry door once included a screen door and that the original wood-sash windows on the primary façade had a similar configuration to the replacement vinyl-sash windows that are extant today. A photograph dated June 1974 illustrates the rebuilt detached rear garage (**Figure 25**). In the historic photographs, the front yard contains a grass lawn with bushes along the north façade of the residence. Two Italian cypress trees flanking the stairway to the entry porch, which appear to have been recently planted in the 1962 photograph, are much taller in the later 1974 photograph.

Figure 24. 1629 Howard Avenue, primary façade (March 1962).
Source: Burlingame Historical Society.

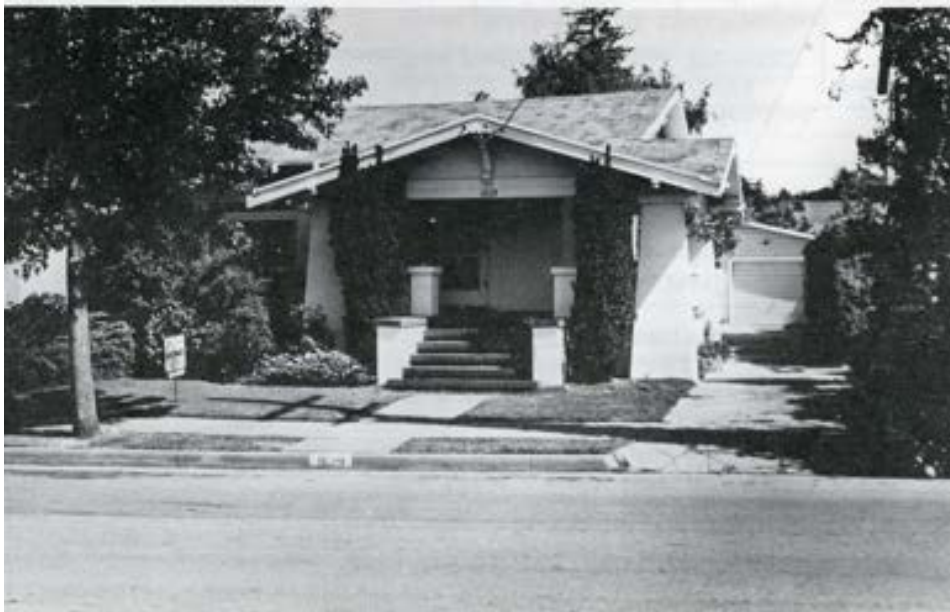
Figure 25. 1629 Howard Avenue, primary façade with detached rear garage visible (June 1974).
Source: Burlingame Historical Society.
