State of California – The Resources Agency  
DEPARTMENT OF PARKS AND RECREATION  
**PRIMARY RECORD**

\*Resource Name or # (Assigned by recorder) 601 California Drive

\*P11. Report Citation: ICF. 2020. CEQA Class 32 Infill Exemption. 601 California Drive Project. June. (ICF 00289.20.) San Francisco, CA. Prepared for City of Burlingame, Burlingame, CA.

**BUILDING, STRUCTURE, AND OBJECT RECORD**

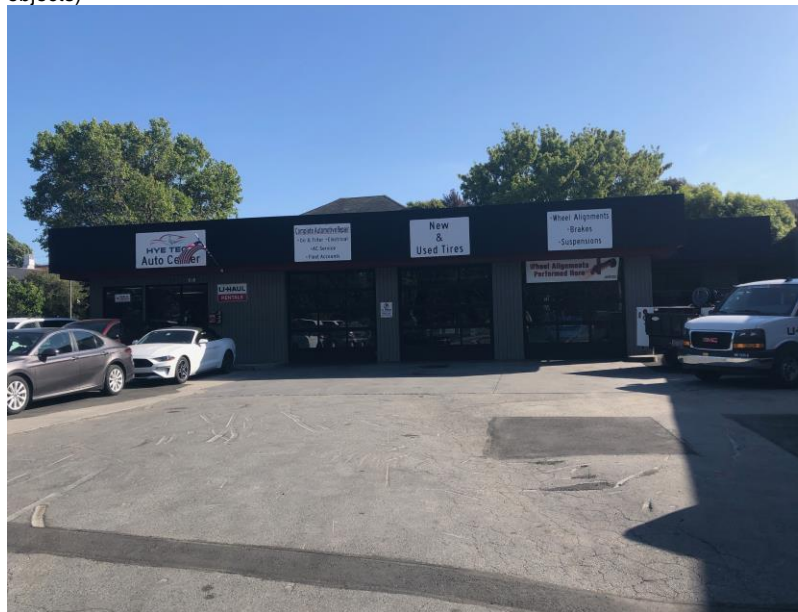
601 California is a one-story building constructed as a service station and currently housing an auto repair center and U-Haul rental location (**Figure 1**). The property is located at the intersection of California Drive and Floribunda Avenue in Burlingame, California, on a 10,350 square foot square, corner lot. The parcel contains a generally rectangular-plan building with a projection at the rear half of the west façade. The building is primarily clad in vertical U-groove metal siding with some brick near the west façade projection. Exhibiting general characteristics of the Midcentury Modern style (such as minimal ornamentation, flat roof with slight overhanging eave, and horizontal bands that wrap around the roofline), the building has a flat roof with no eaves and features a large metal fascia that resembles a mansard roof, with an additional fascia band fixed slightly lower. The two fascia wrap around most of the building at the primary (north), east, and west façades. The building faces north toward California Drive, a commercial thoroughfare in Burlingame. A residential neighborhood is to the property's immediate south, and the Jules Francard Grove of heritage eucalyptus trees line California Drive to the north of the subject building. North of the Jules Francard Grove are Caltrain railroad tracks and Burlingame High School. The parcel at 601 California Drive is also situated nearly equidistant (less than half a mile) from Bayshore Freeway/U.S. Route 101 to the north and El Camino Real/Highway 82 to the south. (See continuation sheet)

P5b. Description of Photo: (View, date, accession #) Figure 1: Primary (north) façade looking south, 5/6/2020

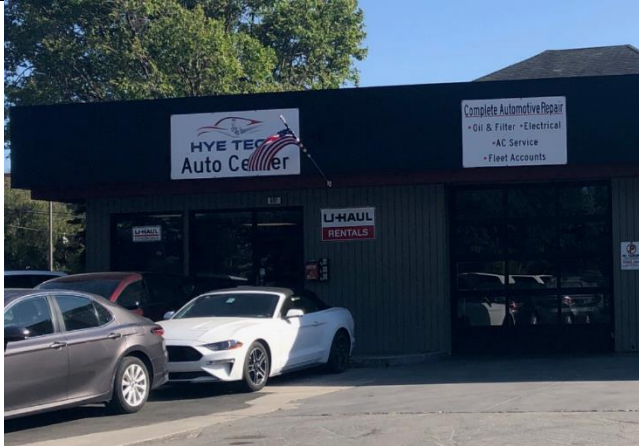
Figure 2. Close up of primary façade featuring main entrance bay (left) and vehicular bay (right), facing south. Source: ICF 5/6/2020.

The subject building's primary façade features four prominent architectural bays with a fifth recessed architectural bay located near the rear half of the west façade. Moving from east to west, the first bay is comprised of the main building entrance, the next three bays are vehicular entrances, and the fifth bay contains windows. The main building entrance is a single pedestrian, fully glazed door with metal framing and a transom window and large side lite. An identical fixed window with metal casing is adjacent to the entrance's large side lite (**Figure 2**). The adjacent three vehicular bays contain metal roll-up doors with three-over-four glazing and metal casing. Vertical U-groove metal siding clads the portions of exterior wall that divide the four bays. The fifth recessed bay at the west end of the façade contains what appears to be two small fixed or sliding rectangular windows below the fascia (**Figure 3**). These windows are primarily above an area of vertical siding and adjacent to a brick-clad corner of the façade. The portion of façade below the windows on the fifth bay was not visible for inspection during field survey due to a stack of ties. The address "601" is located on a small sign above the main entrance. A rectangular "U-Haul Rentals" sign is located on the building, immediately west of the main entrance. Mounted to the large fascia projection are four rectangular signs, each spaced above the first four architectural bays that identify the services of the building's auto repair center tenant.

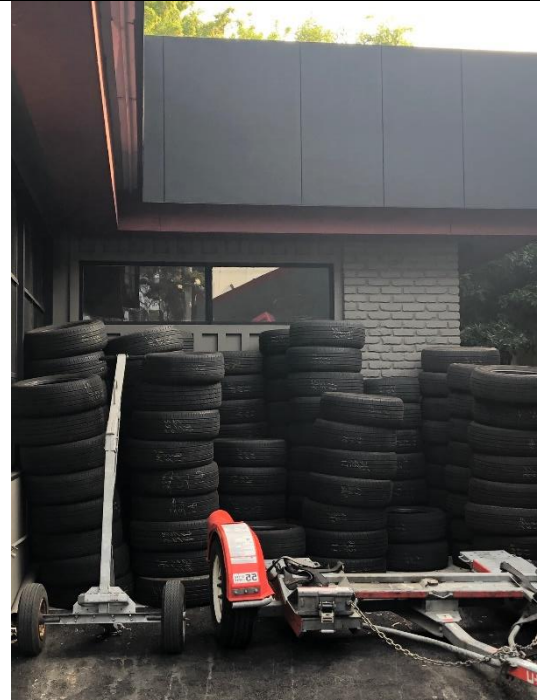
Figure 3. View of primary and west façades, facing south. Source: ICF 5/13/2020.

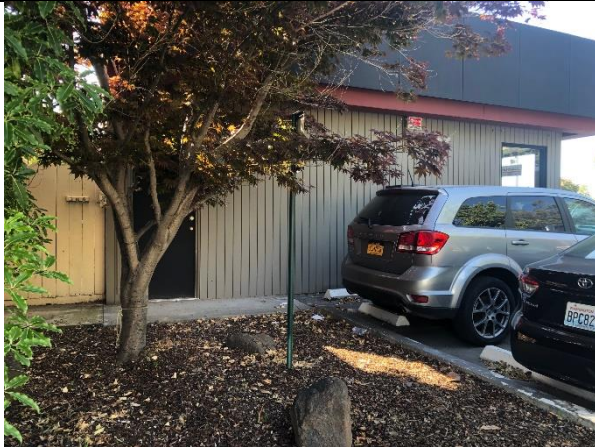
Figure 4. View of east façade, facing west. Source: ICF 5/6/2020.

The building's east façade features vertical U-groove metal siding on most of the façade. A single, unglazed pedestrian door is at the south of the façade, and one rectangular fixed window is located to the north (**Figures 4 and 5**). The north portion of the west façade appears to also contain vertical U-groove metal siding and one large multiplane window (**Figure 6**). The south portion of the west façade, which is located on the building's west projection, is not visible from the public right-of-way. The rear (south) façade is constructed of fire-proof concrete block and lacks fenestration or ornamentation (**Figure 7**).

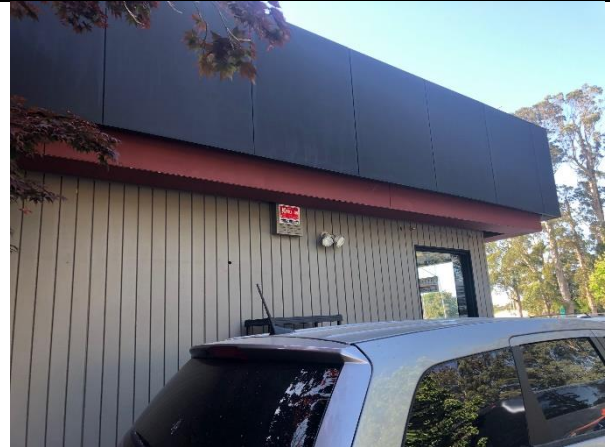
Figure 5. Close up of east façade, facing west. Source: ICF 5/6/2020.

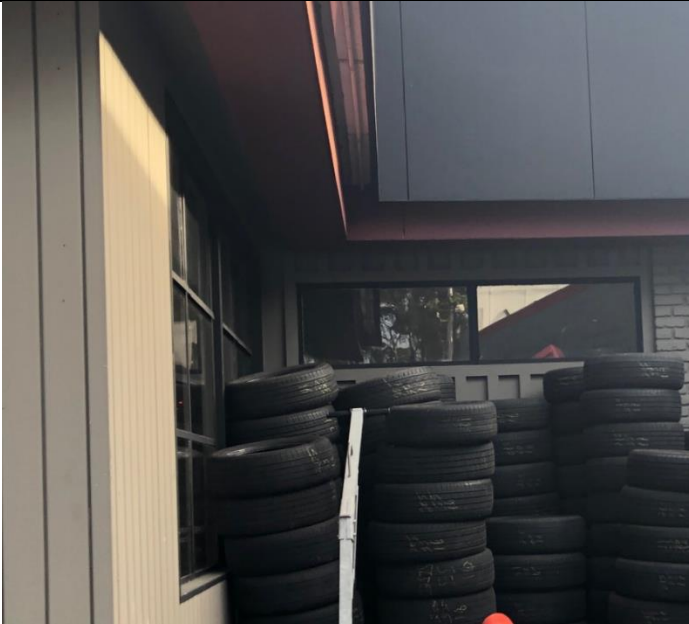
Figure 6. View of the west façade and west building addition, facing south. Source: ICF 5/13/2020.

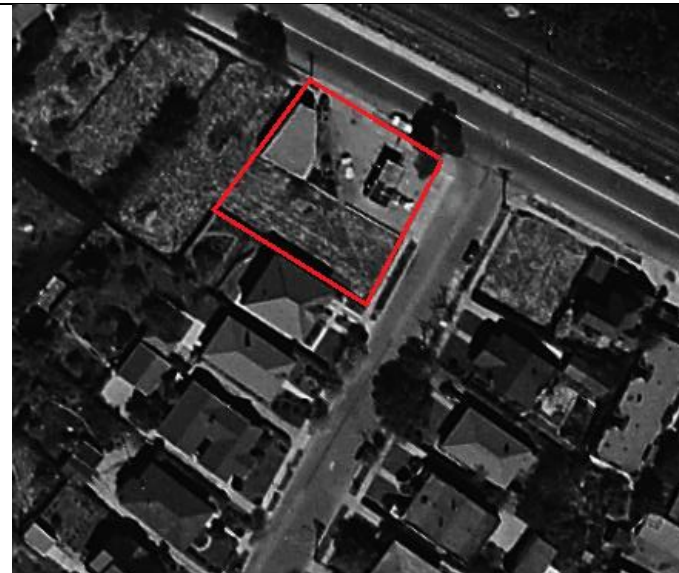
Figure 9. 1941 historic aerial, subject parcel outlined in red. Source: UC Santa Barbara 2020a.

The earliest permit available for the subject property is dated 1921 but contains very little information. It is possible that the 1921 building permit is associated with the construction of a service station in this location, as the next available permit, dated 1932, notes the parcel’s use as a service station. 1941 is the earliest dated historic aerial photograph that shows the subject property. The photograph shows at least one building with a rectangular footprint, which housed a Shell Oil Company service station (as indicated by a 1941 building permit), located on the parcel fronting San Mateo Drive/California Drive (**Figure 9**) (UC Santa Barbara 2020a).

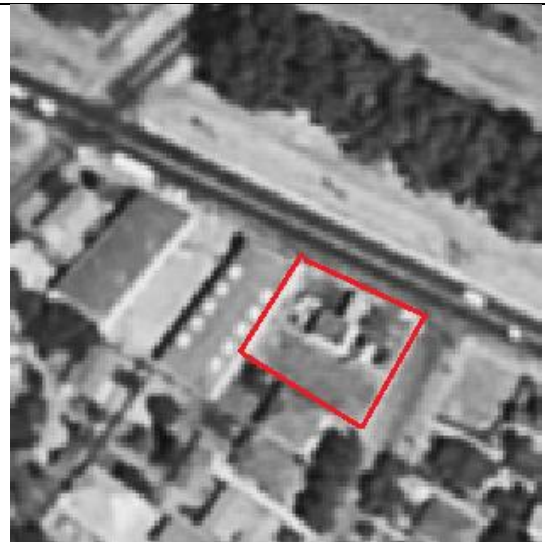
Figure 10. 1956 historic aerial, subject parcel outlined in red. Source: UC Santa Barbara 2020b.

By 1946, the site’s earlier service station was demolished, and a new service station was built with an L-shaped footprint (NETR 2020a). A 1956 aerial photograph shows the L-shaped building footprint remained unchanged (**Figure 10**). However, a plot plan dated 1956-1957 includes a rendering of the footprints for a rectangular-shaped canopy structure at the northern portion of the parcel (with an adjacent “cover over tanks” referring to rectangular ground cover for the underground tanks), and a rectangular building to the south of it, situated perpendicularly and serving as an office and greasing station (**Figure 11**). The next available aerial photograph, dated 1965, shows the property was built to the 1956-1957 plot plan specifications, showing the subject building with a rectangular footprint located on the south parcel for the first time (**Figure 12**). Therefore, the build date of the subject building is 1957. Upon its completion in 1957, the subject service station was occupied by Shell Oil Company, which had been the tenant of the previous buildings on the site since at least 1941 (City of

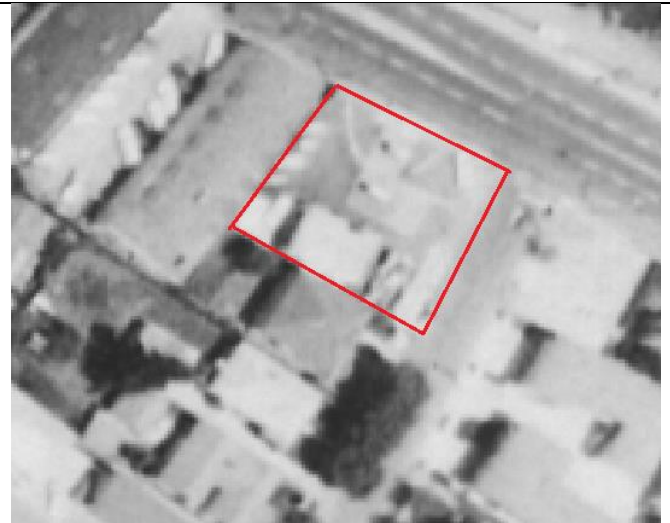
Figure 12. 1965 historic aerial, subject parcel outlined in red. Source: UC Santa Barbara 2020c.

Historic aerial photographs indicated that the 1957 service station, as originally constructed, was not as wide as the building is currently; specifically, it was originally built with a smaller footprint and lacked the projection from the west façade (UC Santa Barbara 2020c). The following permits were issued for the subject building under Shell Oil Company, who occupied the property until circa 1978: multiple sign permits in 1960; pole sign in 1964; "alterations to service station" including "modernization of service station at 601 California" in 1968 in which engineer Carl J. Kuntz contributed; addition of a firewall to the building's south façade in 1968; repair permit for tanks in 1970; and replacement of shingles with aluminum parapet in 1976. A 1980 aerial photograph shows that the west projection had been constructed by that time (NETR 2020d). This west projection was possibly a result of the permitted 1968 modernization effort. (See continuation sheet.)
