Heartwood Consulting Arborists

-----ARBORIST REPORT-----

RE: TREE PRESERVATION - 728 NEWHALL ROAD, BURLINGAME, CALIFORNIA

Report Date: May 22, 2025

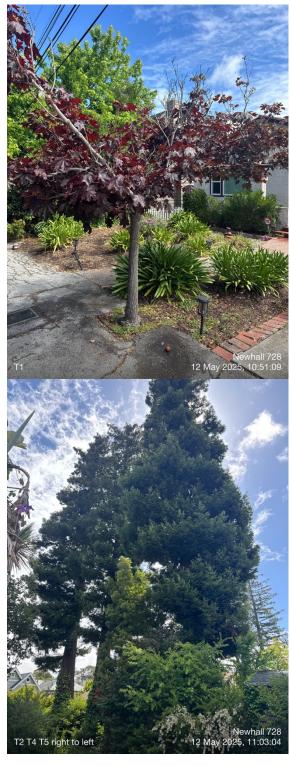
Tree #1 is a Norway Maple (red/purple cultivar) street tree in poor condition.

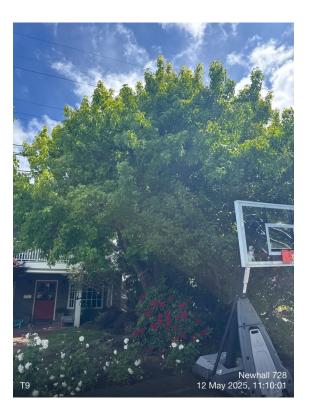
Tree #9 is a sweetgum on the neighboring property that has been severely headed to address conflict with the overhead utility lines.

Tree #9 will be impacted by the proposed driveway, which passes through a portion of its TPZ.

4. Tree #9 – Driveway Edge Root Management

At the edge of the new driveway adjacent to Tree #9, all demolition and excavation activities shall be performed by hand, to the full planned depth of the driveway, including subbase.

All roots encountered shall be cleanly cut using a sharp handsaw or reciprocating saw. Roots shall not be crushed or torn.

A root barrier is recommended along the driveway edge to reduce the potential for future root encroachment.

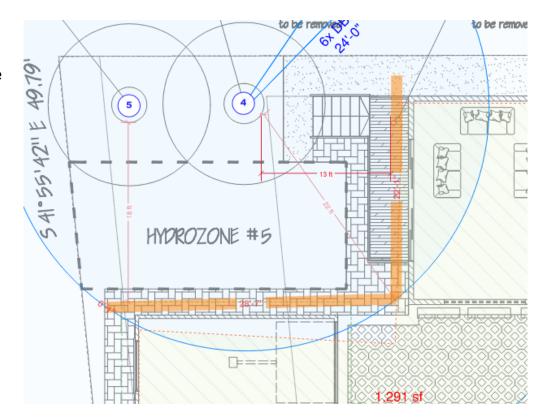
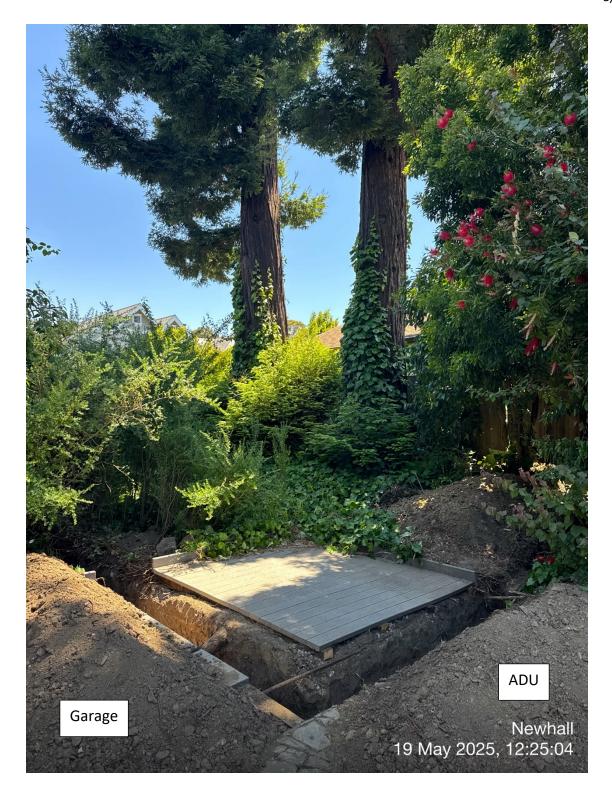
To evaluate potential impacts of the ADU and garage foundations on Trees #4 and #5, an L-shaped exploratory trench was manually excavated just outside the proposed foundation limits, on the side closest to the trees. The trench was dug to a minimum depth of 24 inches below the organic soil layer (Photo 1).

The orange line indicates the location of the exploratory excavation.

Photo 1. Root exploration for Trees #4 (right) and #5.

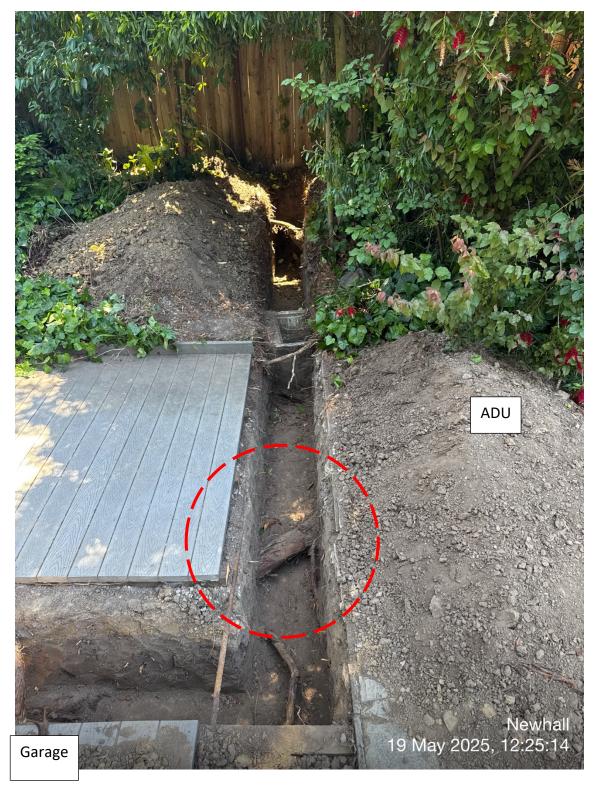
On the leg of the trench adjacent to the proposed ADU, no roots from Trees #4 or #5 were encountered. One large root was discovered and determined to belong to Tree #2, based on its orientation and taper relative to the three redwoods (Photo 2). No disturbance is permitted below 24 inches in this area to avoid impacting the root zones of Trees #4 and #5.

Photo 2. ADU side of "L" shaped excavation. One large root (red circle) was discovered and determined to belong to Tree #2, based on its orientation and taper relative to the three redwoods.

On the side of the ADU closest to Trees #4 and #5, no disturbance is permitted below 24 inches from the existing grade. This measure is required to preserve deeper roots that were not encountered in exploratory trenching.

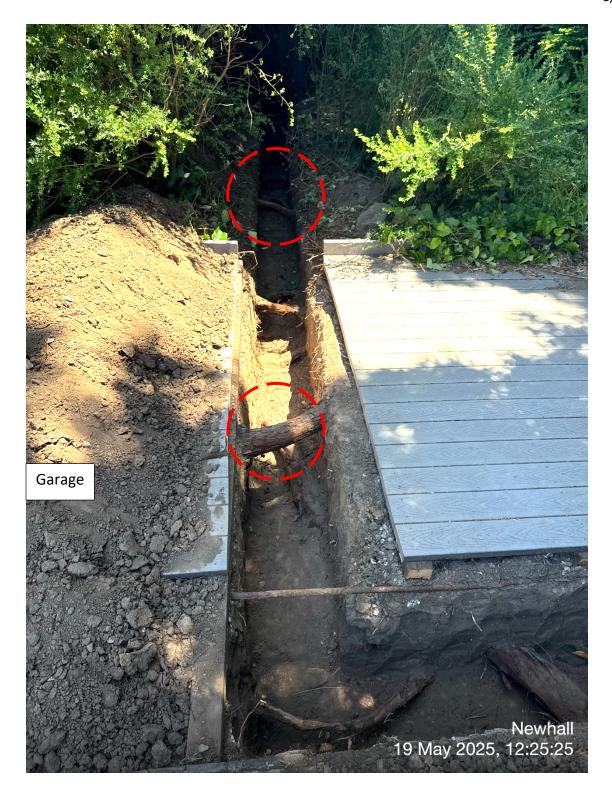
On the leg of the trench adjacent to the proposed garage, multiple roots were uncovered, with two roots (approximately 4 inches and 5 inches in diameter) located within the top 12 inches of soil, the anticipated depth of excavation for the garage foundation. Given the size of these roots, their distance from the tree trunks, and the species' known tolerance to root severance, I conclude that these roots can be cleanly cut to allow for construction, provided that no disturbance occurs deeper than 12 inches below existing grade in this area.

Photo 3. Garage side of "L" shaped excavation. Two roots (circles) in the top 12" of the soil profile must be severed to allow garage construction. Anticipated impact is minimal. Root at the bottom right is from Tree #2 (proposed for removal).

At the edge of the proposed garage footing adjacent to Trees #4 and #5, excavation shall be performed by hand to the full depth of the footing.

Roots encountered within the top 12 inches of the soil profile shall be cleanly cut using a sharp handsaw or reciprocating saw. Roots shall not be crushed or torn.

No disturbance is permitted below 12 inches in this area to avoid damaging critical structural roots.
