COVER SHEET

Residence

'ADHARE'
ADDITION TO EXI

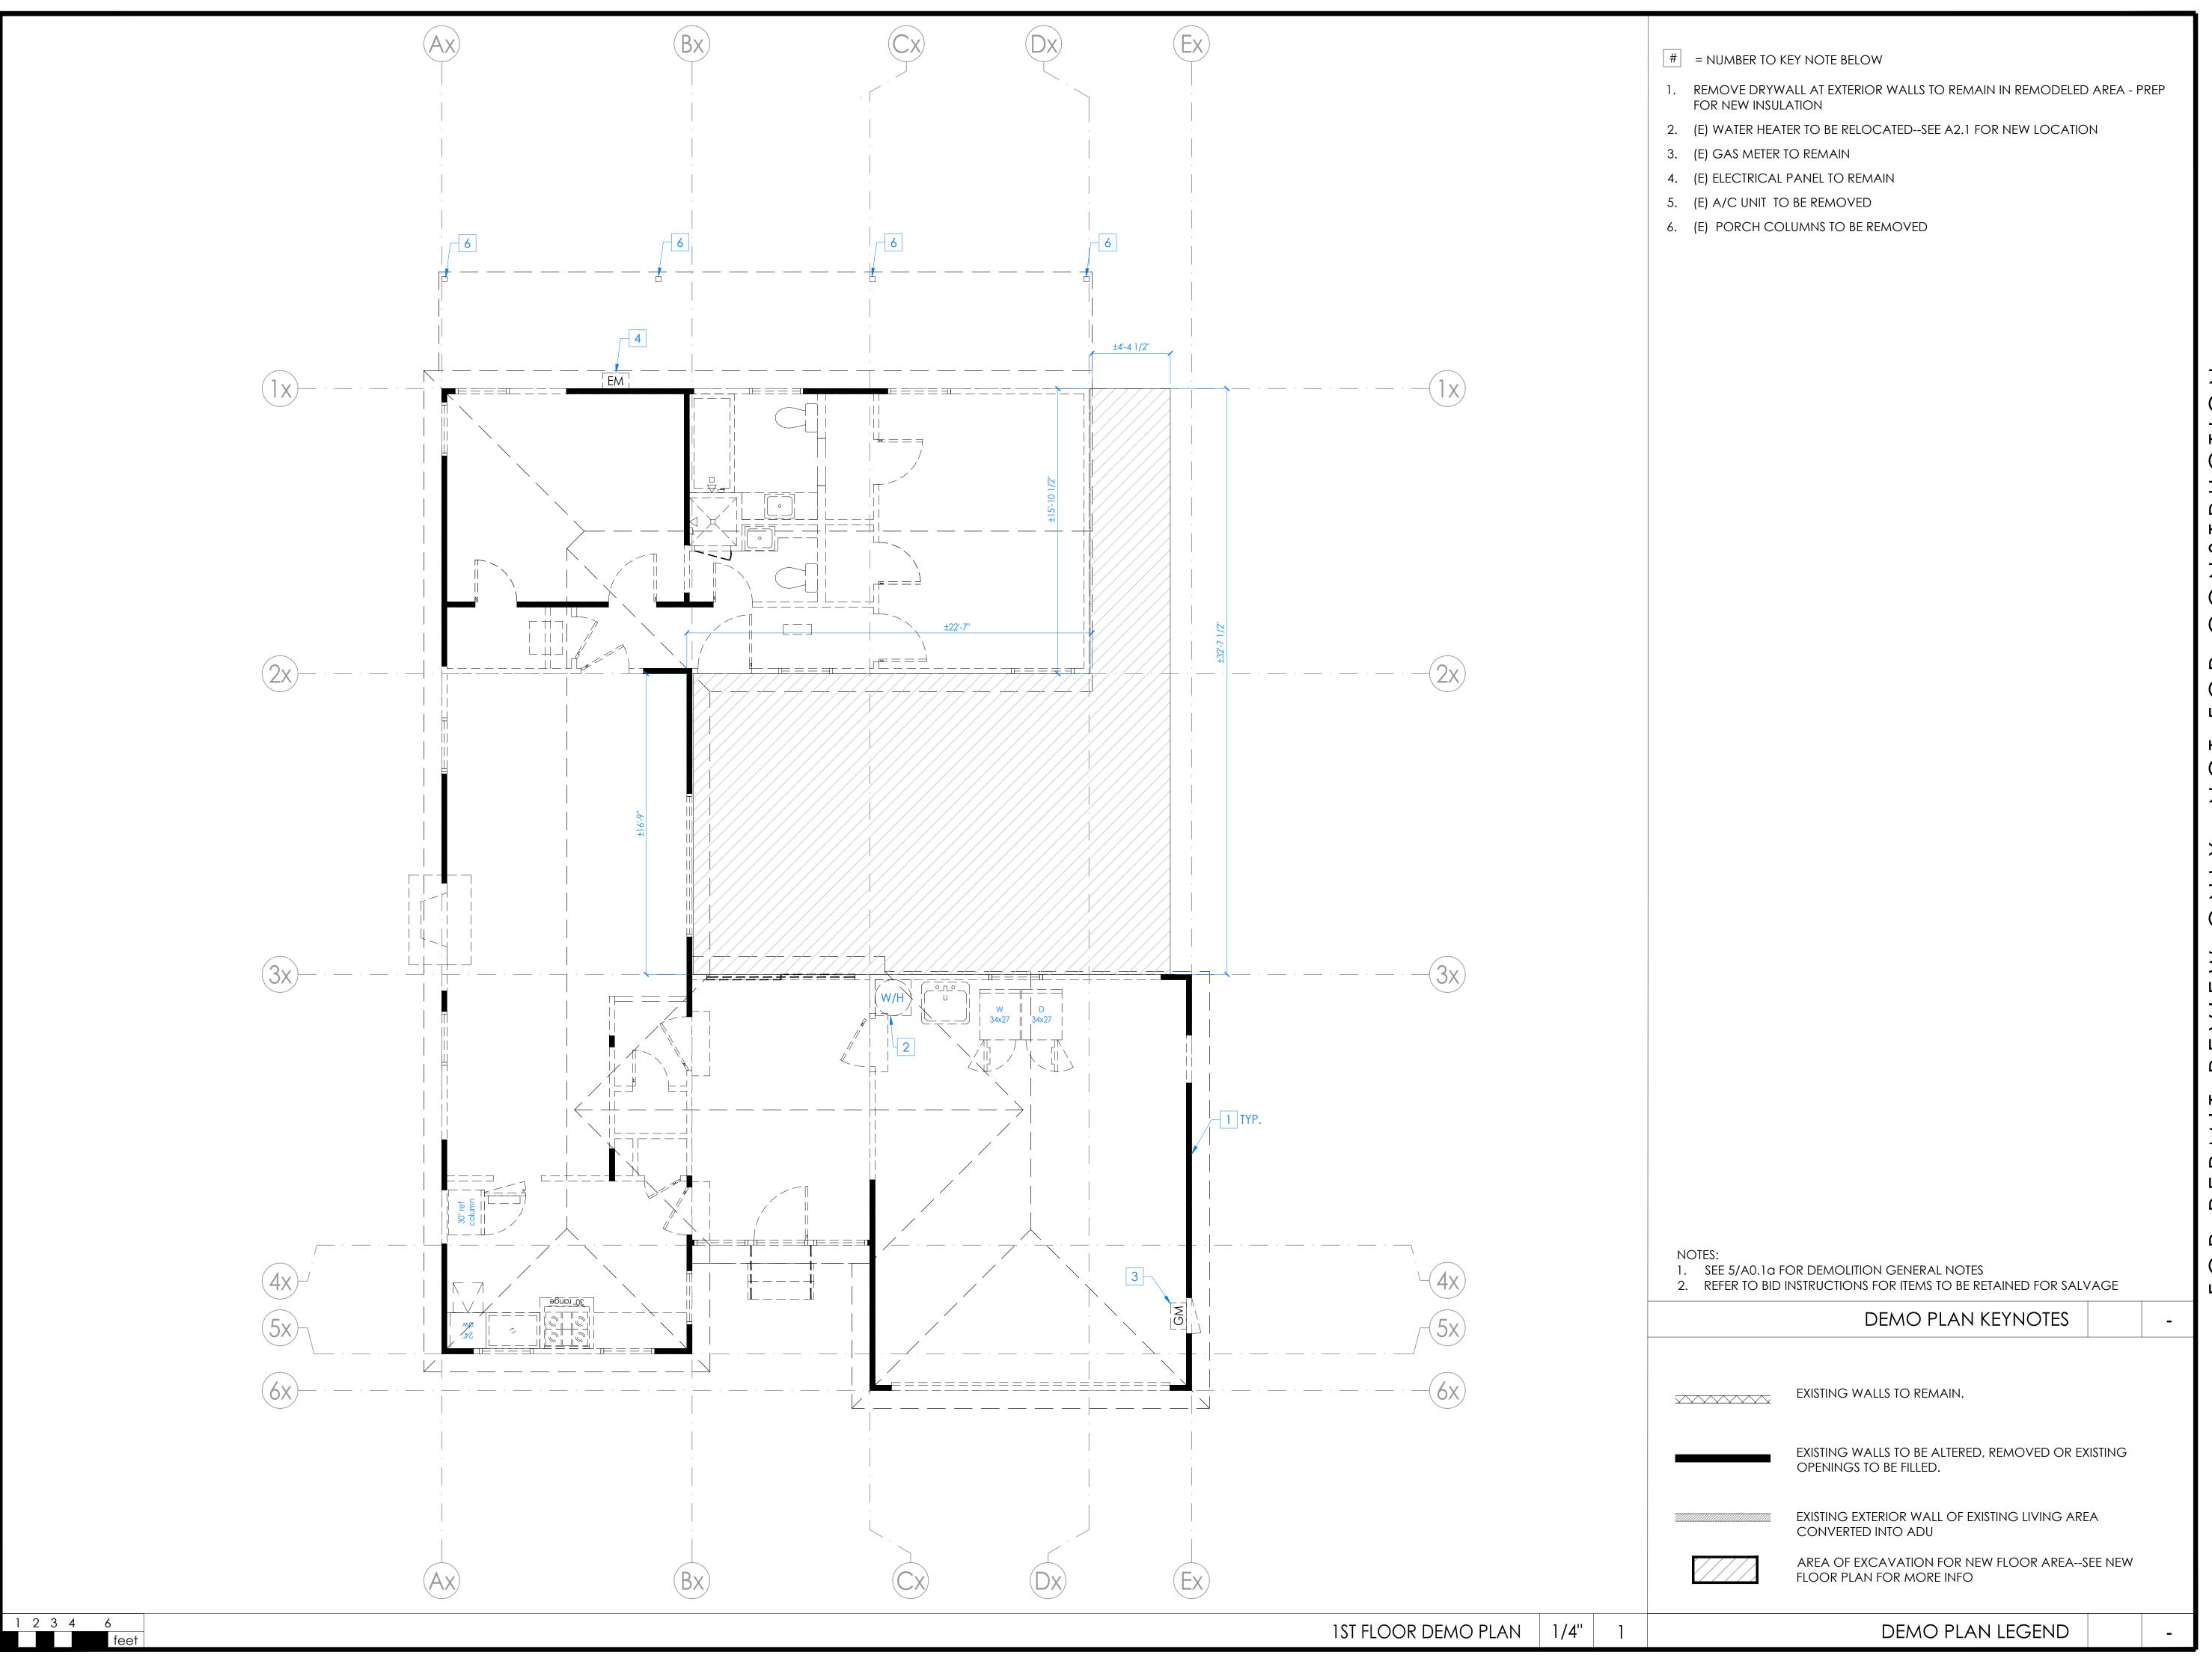
DEMO PLAN

1ST FLOOR

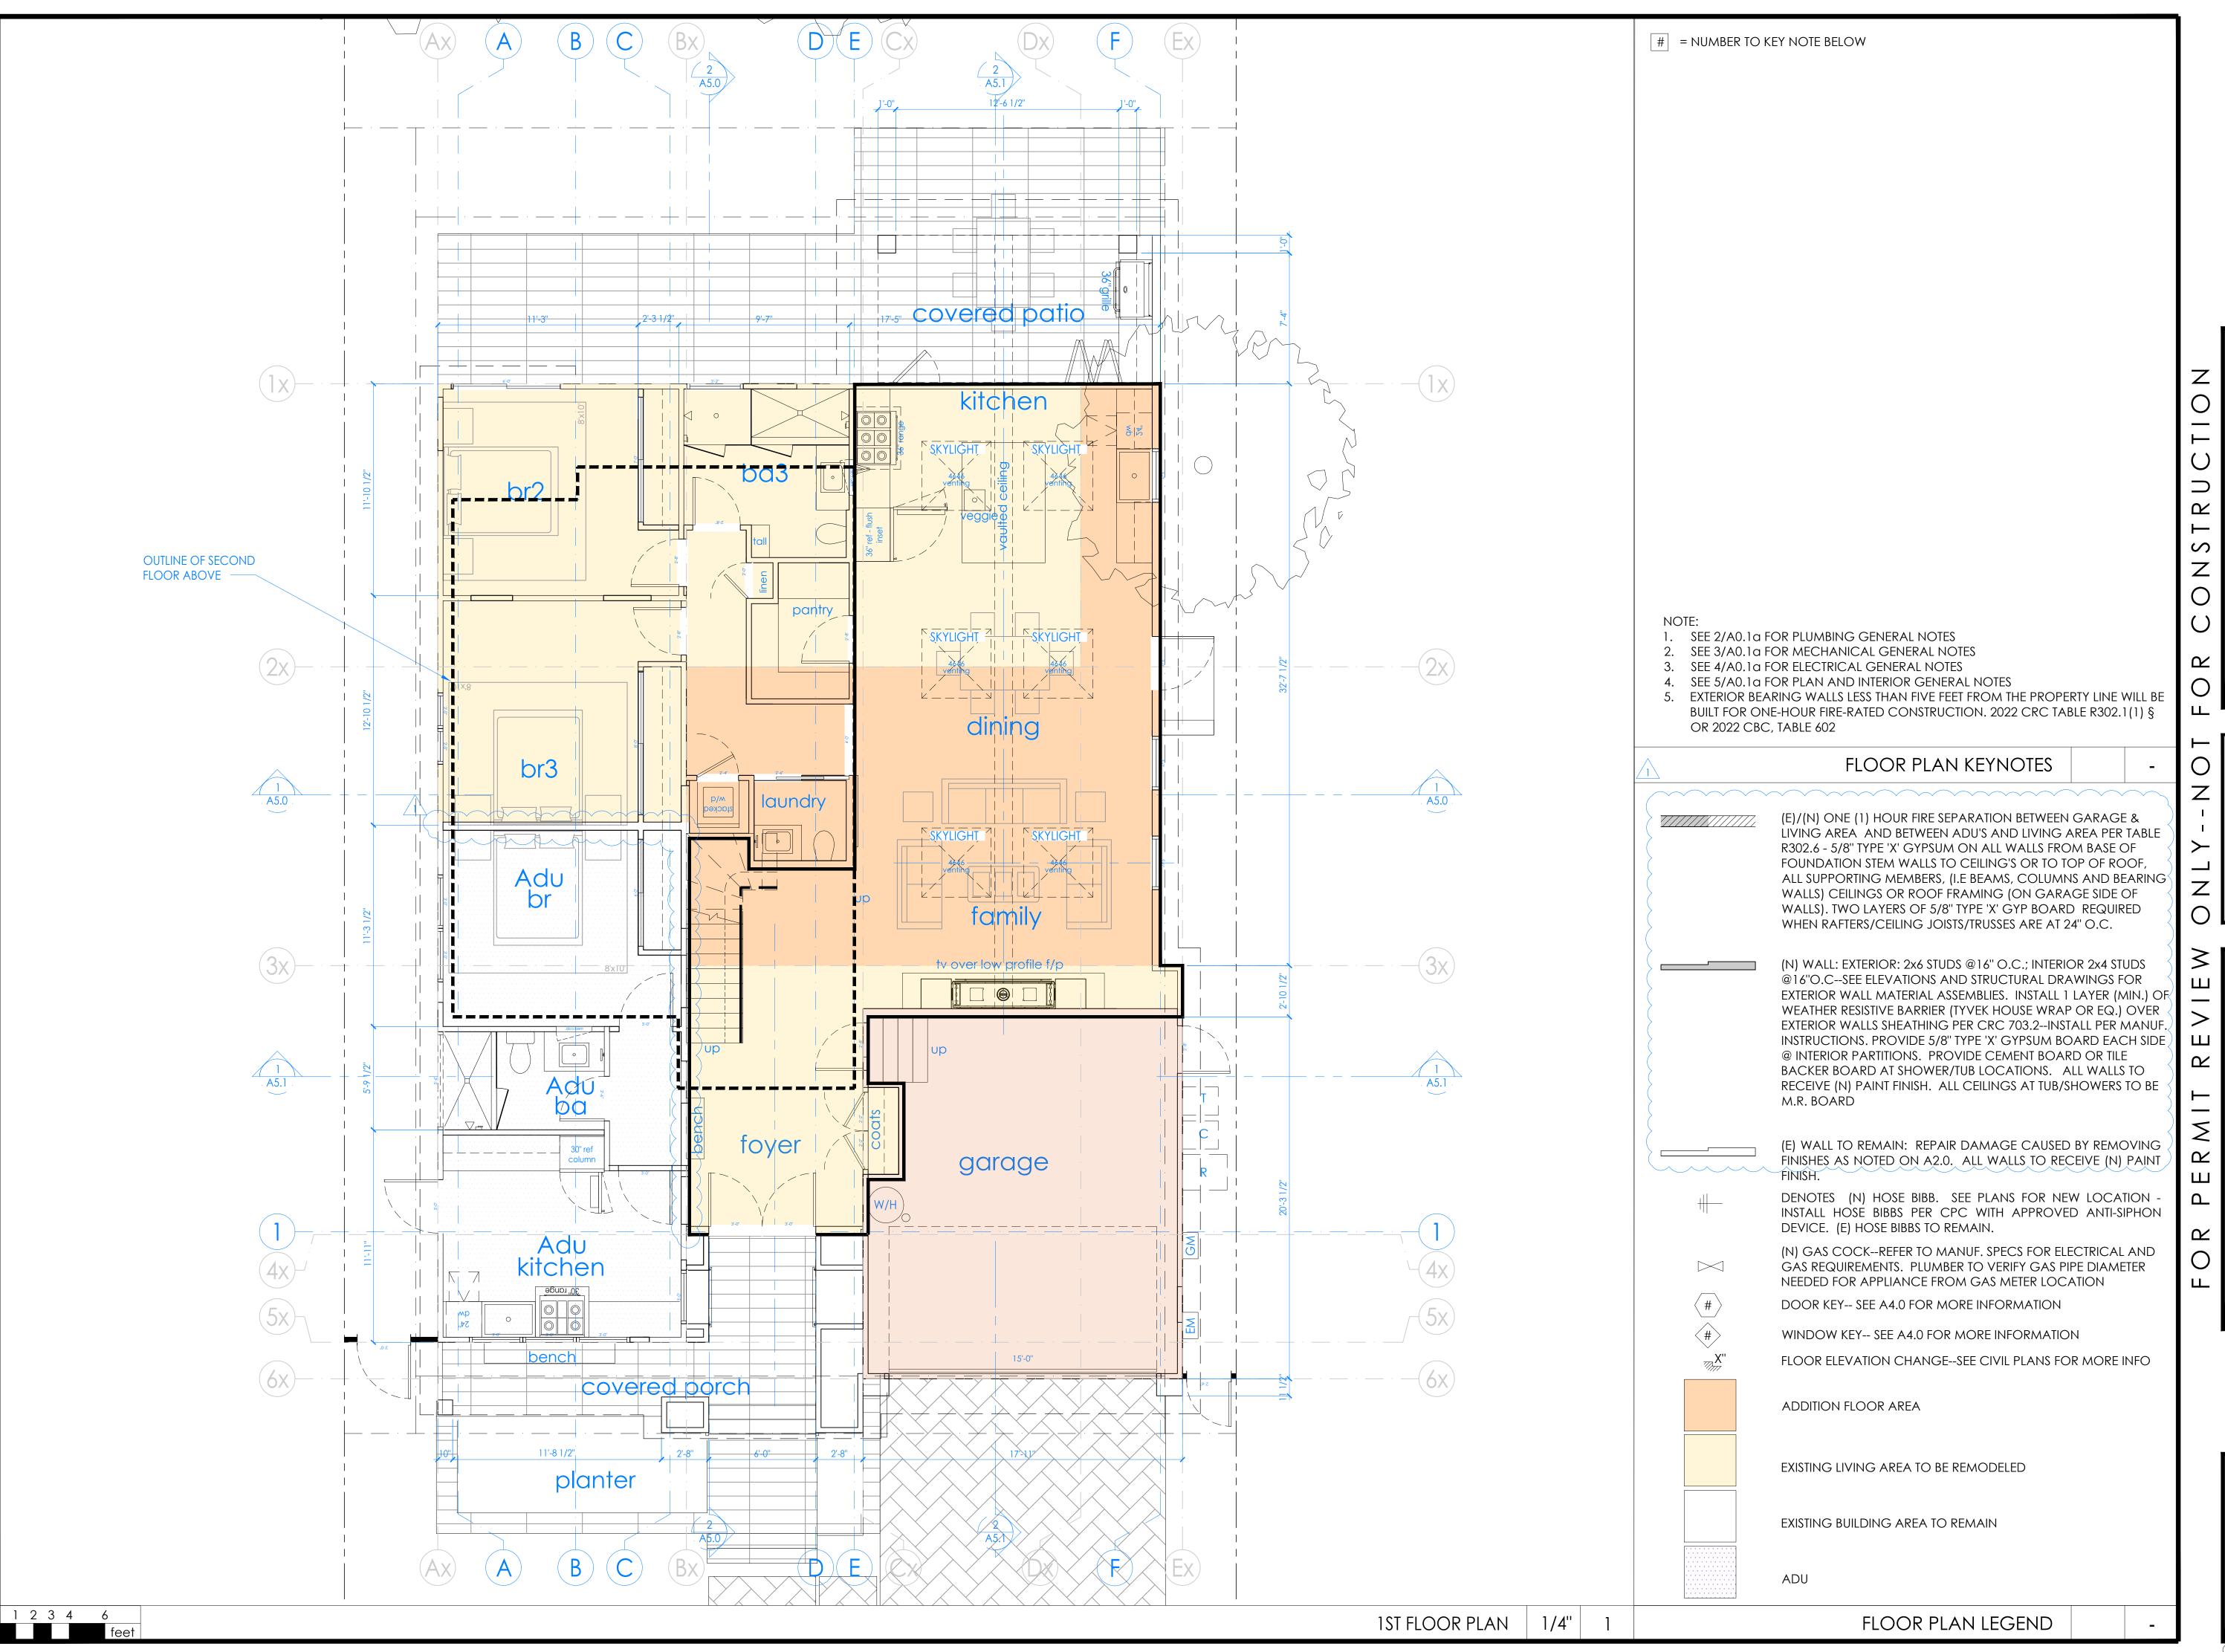
FLOOR PLAN

1ST

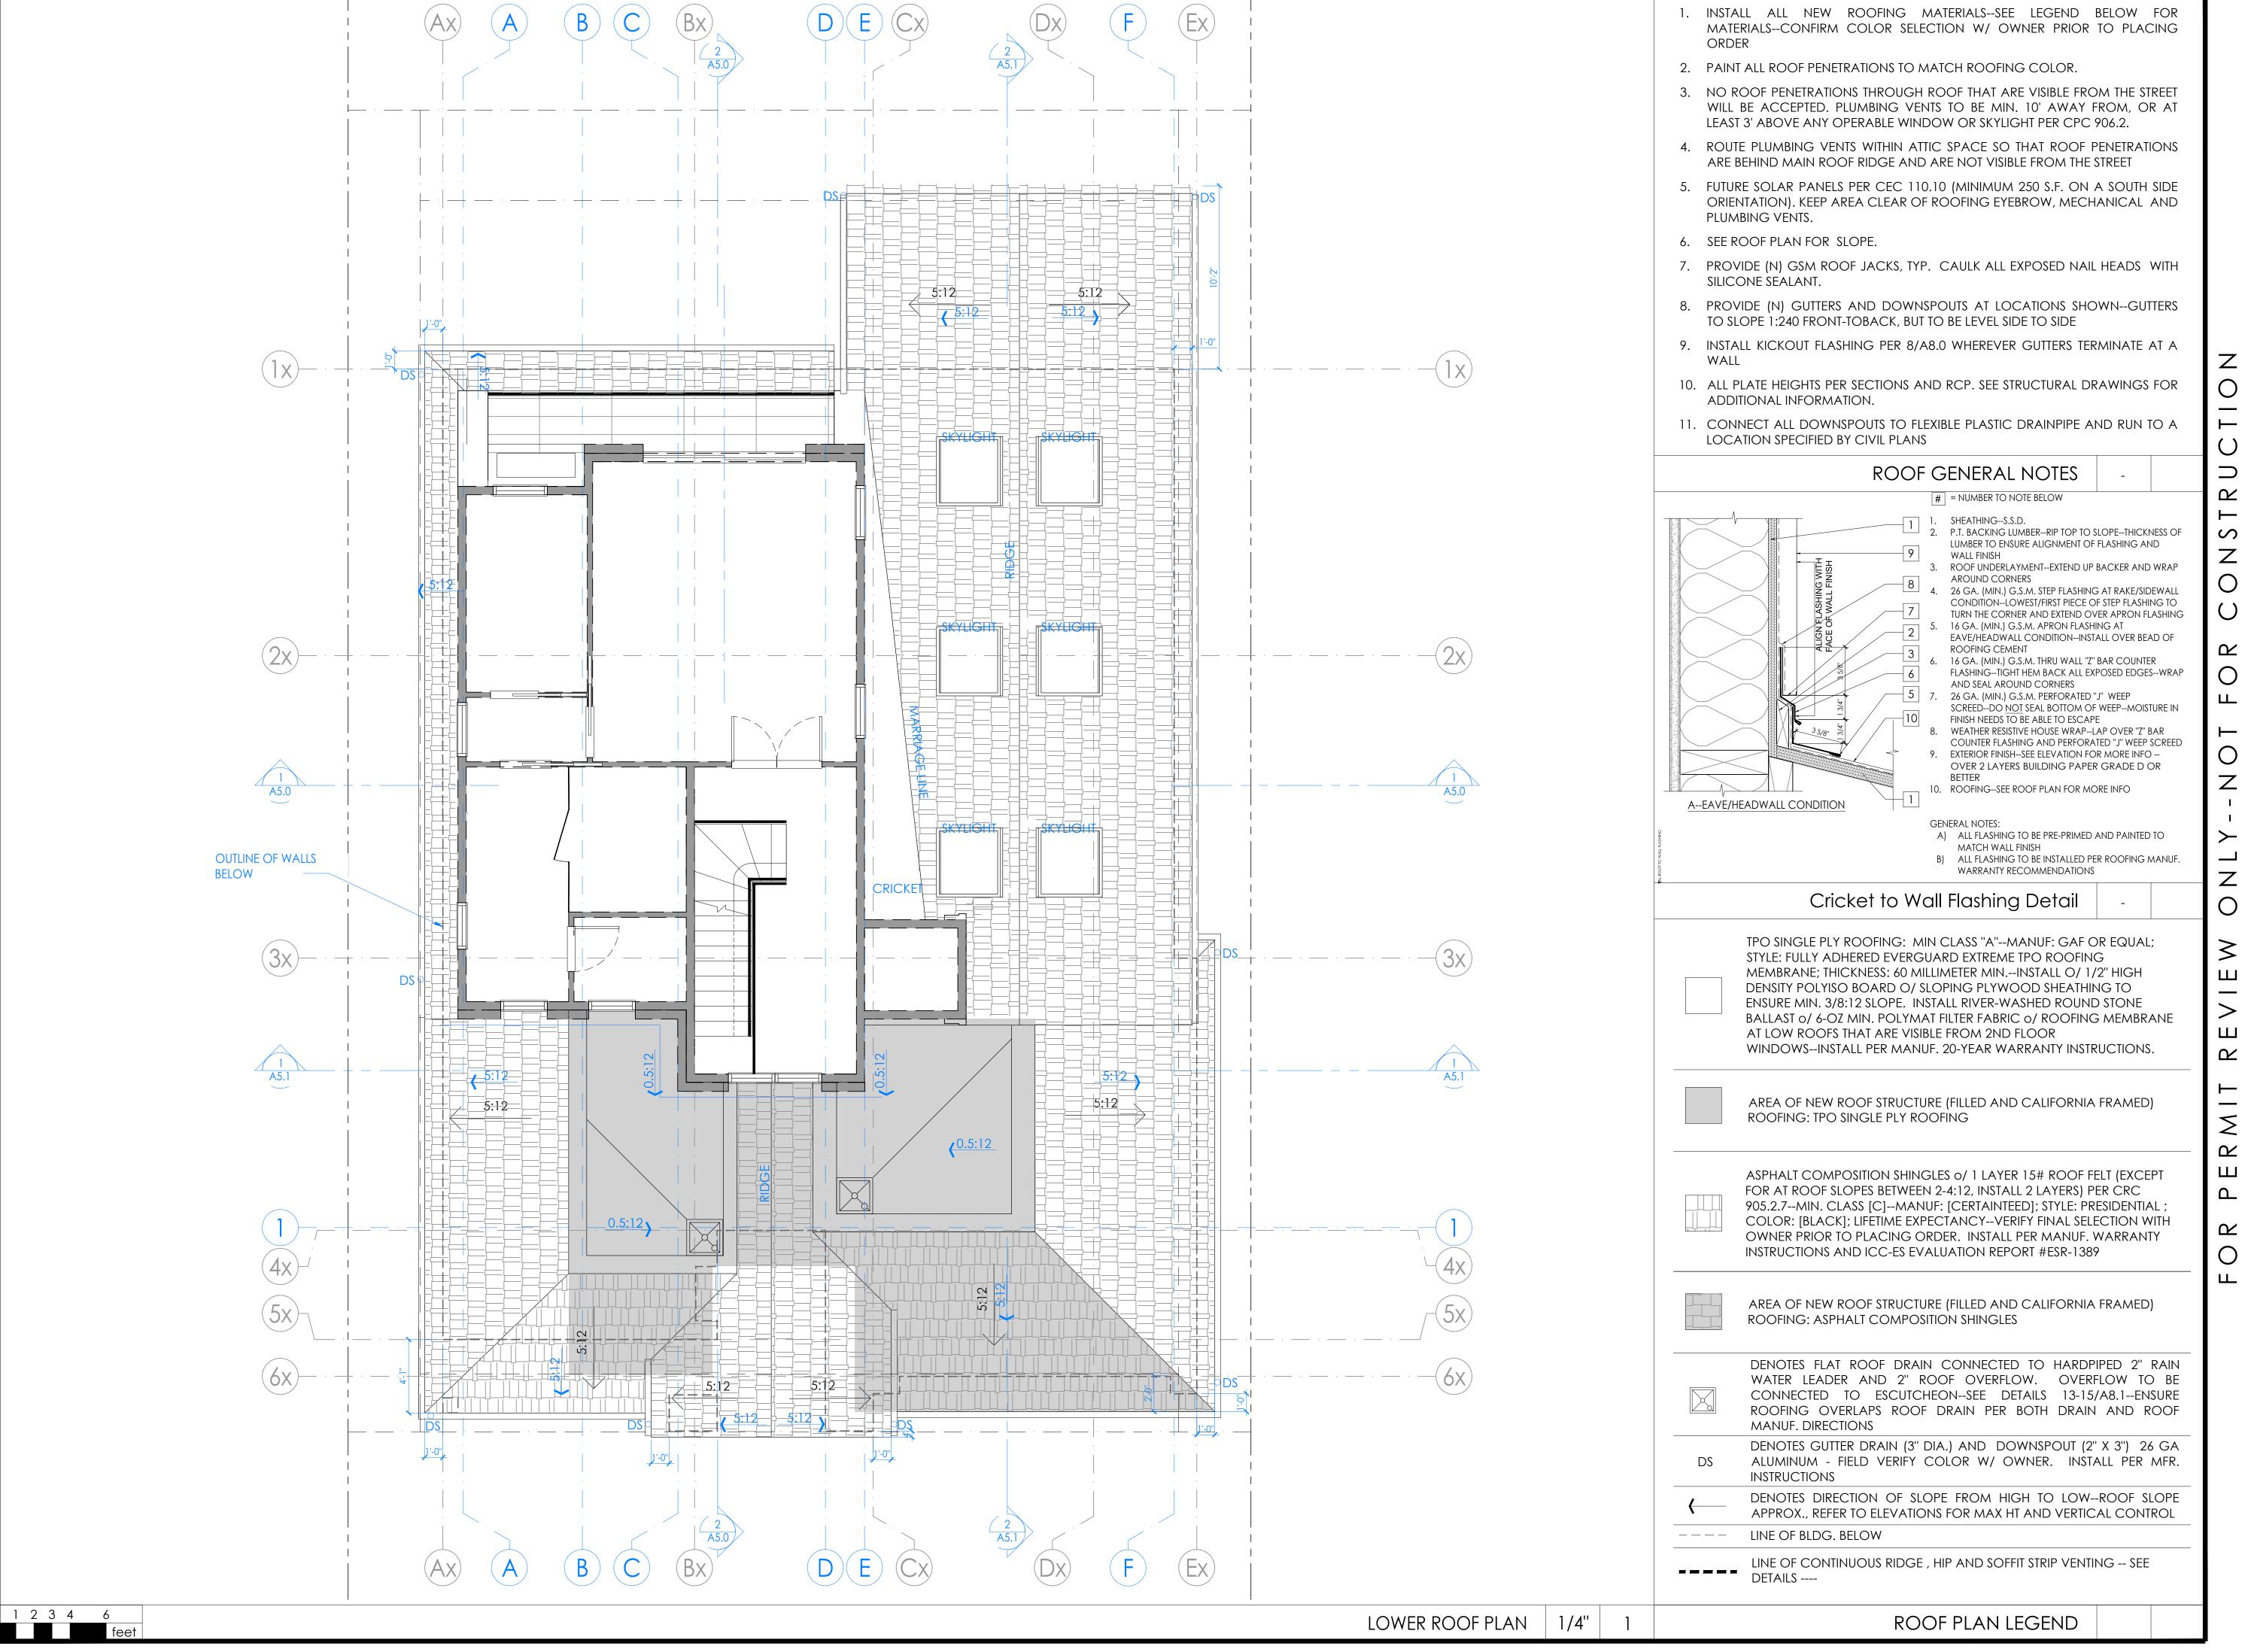
ROOF PLAN

LOWER

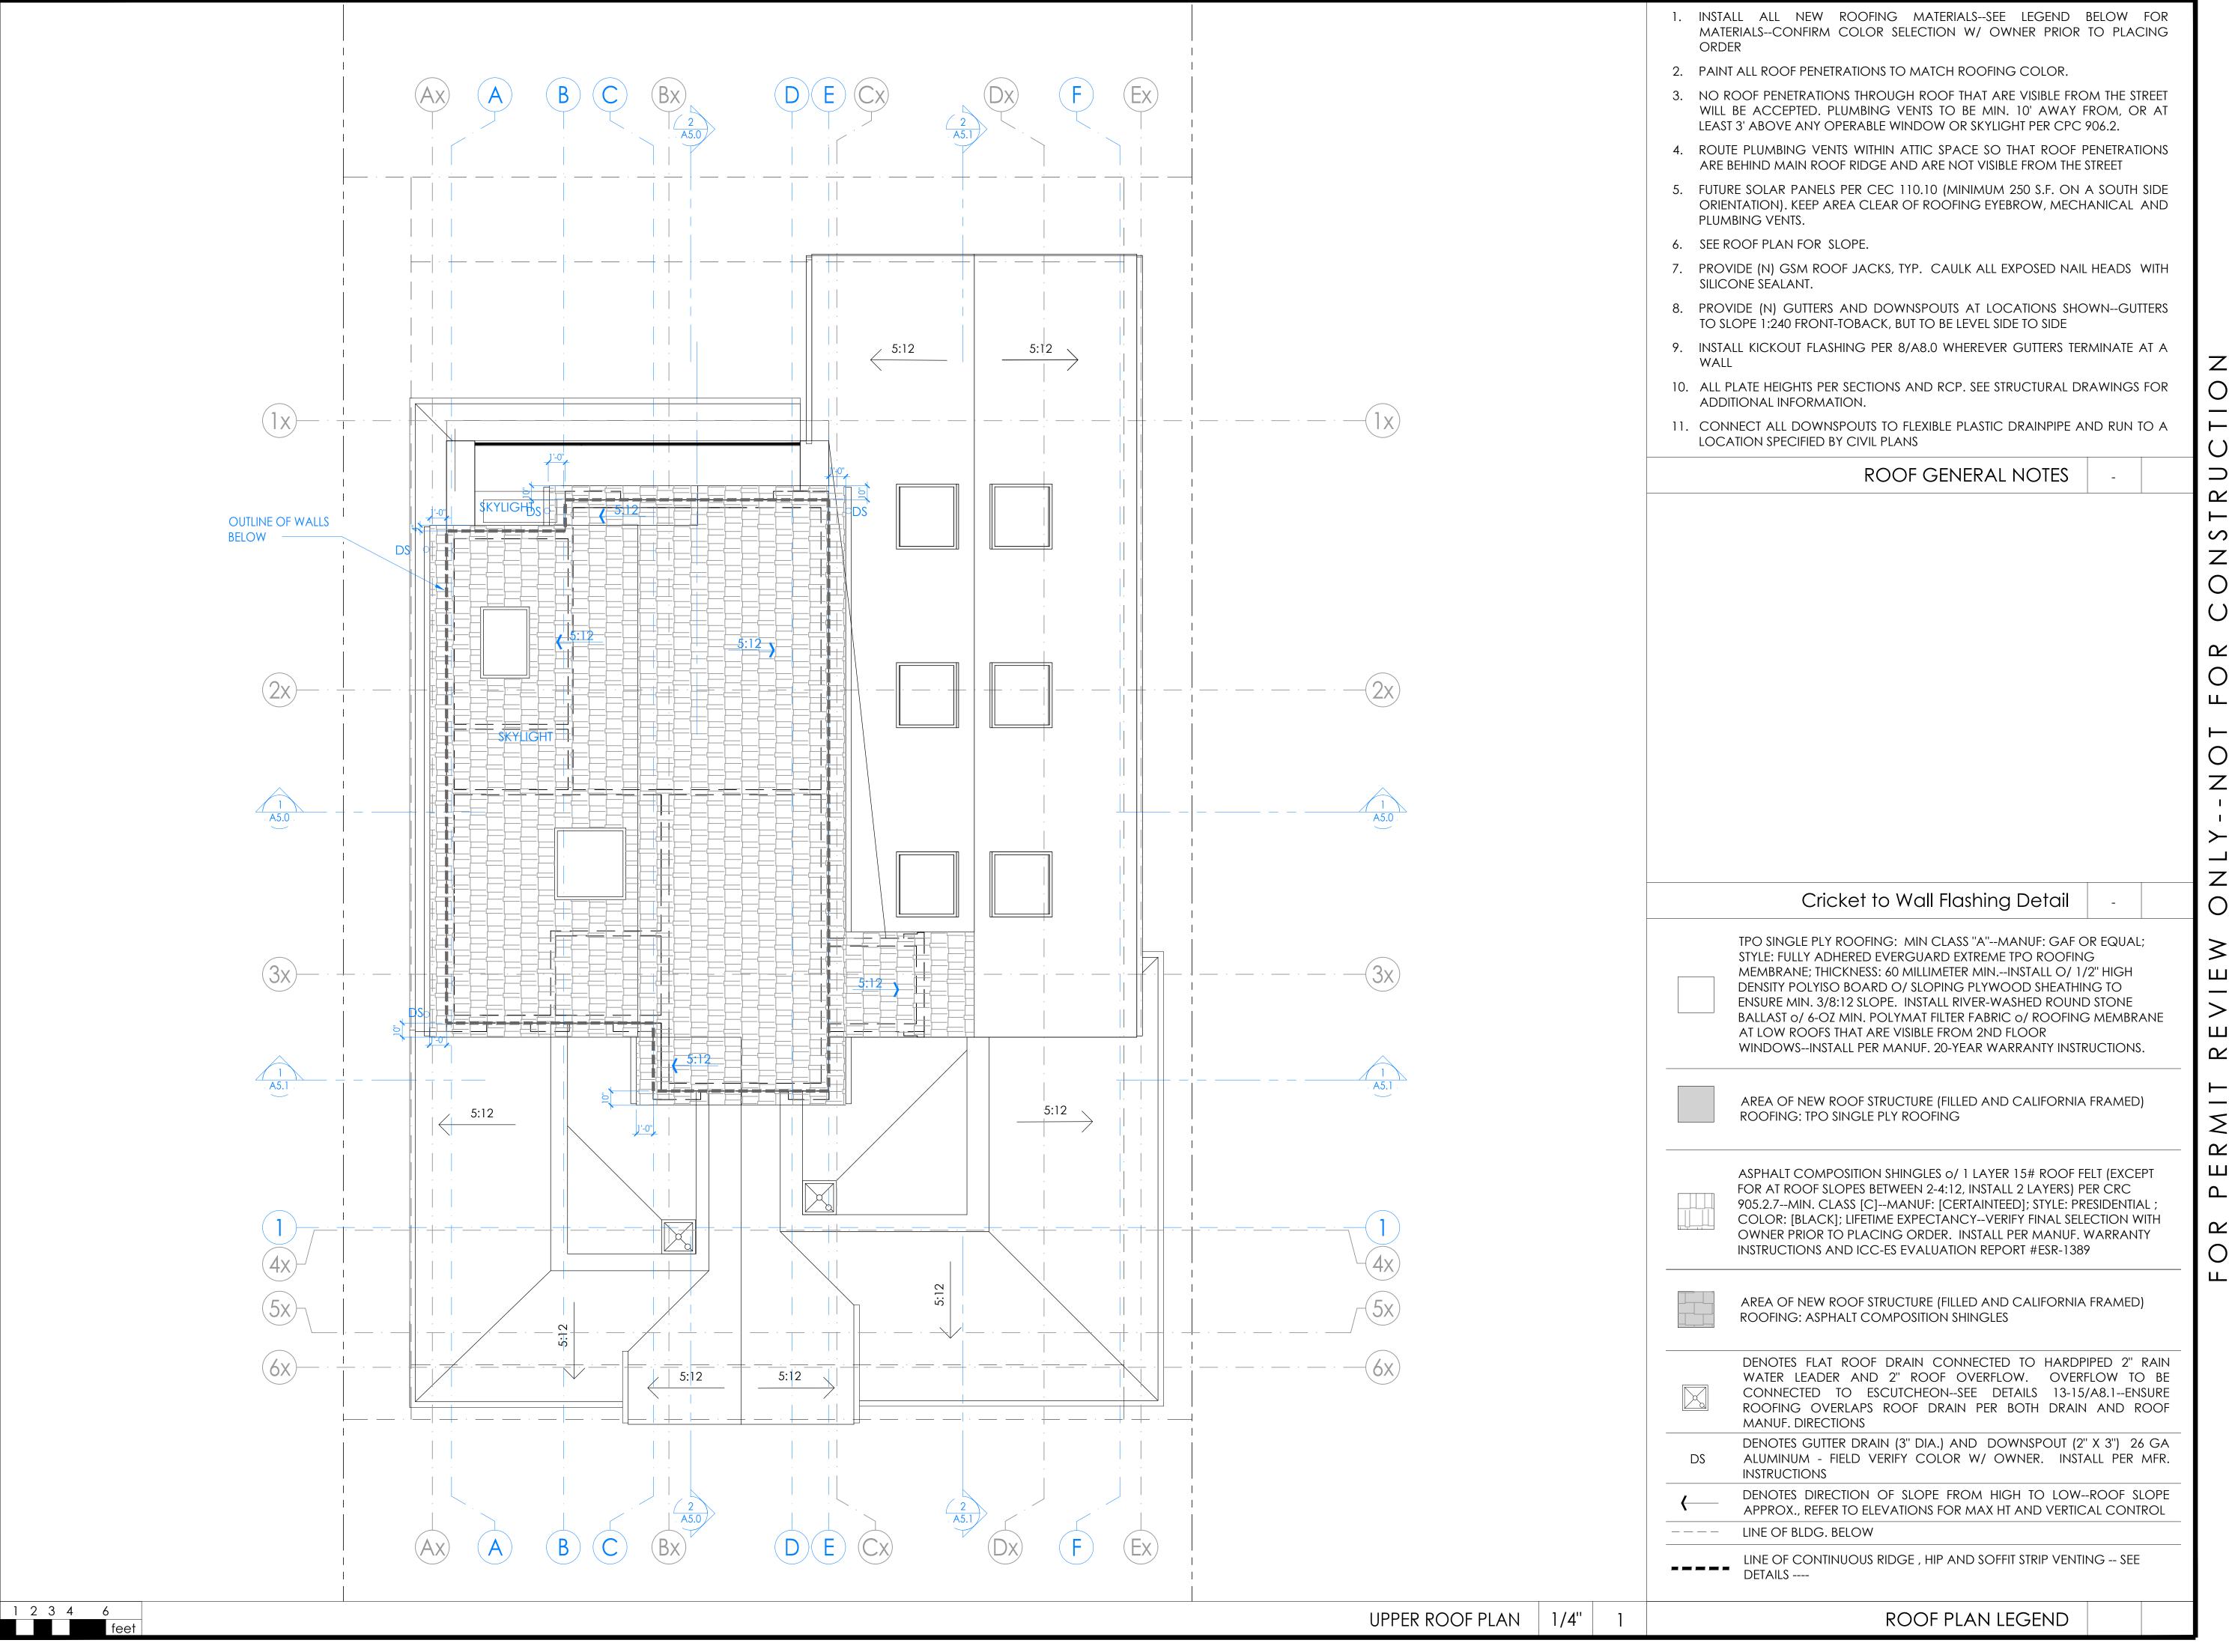
ROOF PLAN

UPPER

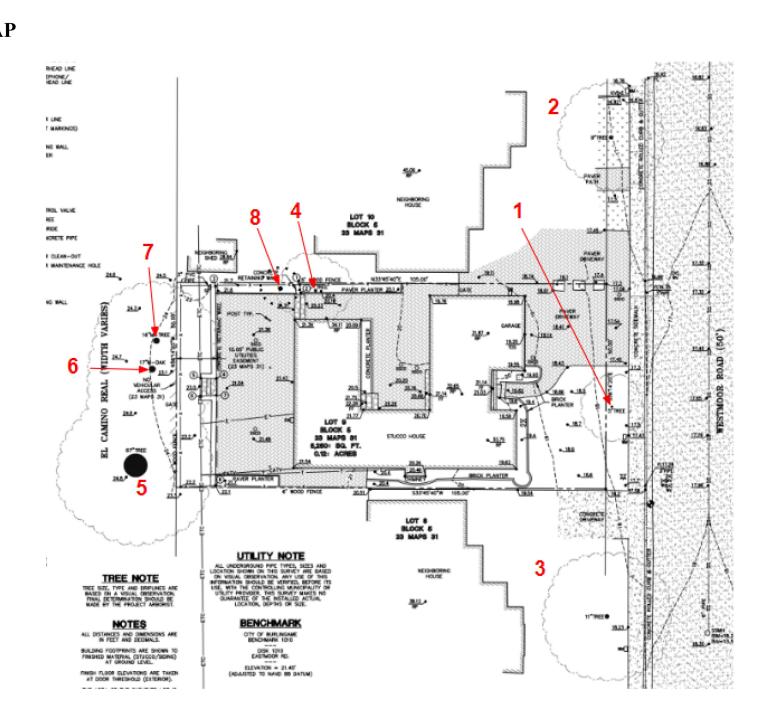
TREE MAP

ILL	2 II ()											
Tree Tag #	Protected Tree	Preserve or Remove	Common Name / Scientific Name	Trunk (in.)	Height (ft.) / Canopy Spread (ft.)	Health Rating	Structural Rating	Form Rating	Suitability for Preservation	Overall Condition (0-100%)	Summary	Tree Picture #1
1	Yes	(P)	red maple Acer rubrum	5	20/5	Good	Good	Good	Good	60	Street tree. Young tree. 5 feet from sidewalk.	
2*	Yes	(P)	Ornamental pear Pyrus calleryana	12	30/25	Good	Fair	Good	Good	65	Street tree. Neighboring tree. In front lawn.	
3*	Yes	(P)	red maple Acer rubrum	11	35/20	Good	Good	Fair	Good	60	Street tree. Neighboring tree. In front lawn.	
4	No	(P)	common pear Pyrus communis	6,7	20/10	Good	Fair	Fair	Good	55	At property boundary. 6 inches from patio hardscape. Codominant at 4.5 feet. Topped in past.	
5	Yes	(P)	Red iron bark eucalyptus Eucalyptus sideroxylon	53	65/55	Good	Poor	Fair	Fair	45	Behind property. In easement adjacent to El Camino Real.

6	Yes	(P)	coast live oak Quercus agrifolia	6,5,4,4, 3	25/12	Good	Poor	Fair	Good	45	Behind property. In easement adjacent to El Camino Real.

Tree Tag#	Protected Tree	Preserve or Remove	Common Name / Scientific Name	Trunk (in.)	Height (ft.) / Canopy Spread (ft.)	Health Rating	Structural Rating	Form Rating	Suitability for Preservation	Overall Condition (0-100%)	Summary	Tree Picture #1
7	Yes	(P)	common cotoneaster Cotoneaster integerrimus	1"x14	25/12	Fair	Poor	Fair	Good	45	Behind property. In easement adjacent to El Camino Real.	
8	Yes	(P)	European plum Prunus domestica	4,7	20/15	Fair- Poor	Poor	Poor	Fair	35	6 inches from patio hardscape. Codominant at 3.5 feet. Deadwood. Covered in ivy vine. Turkey tail fungi on lateral limbs. Die back. Topped in past.

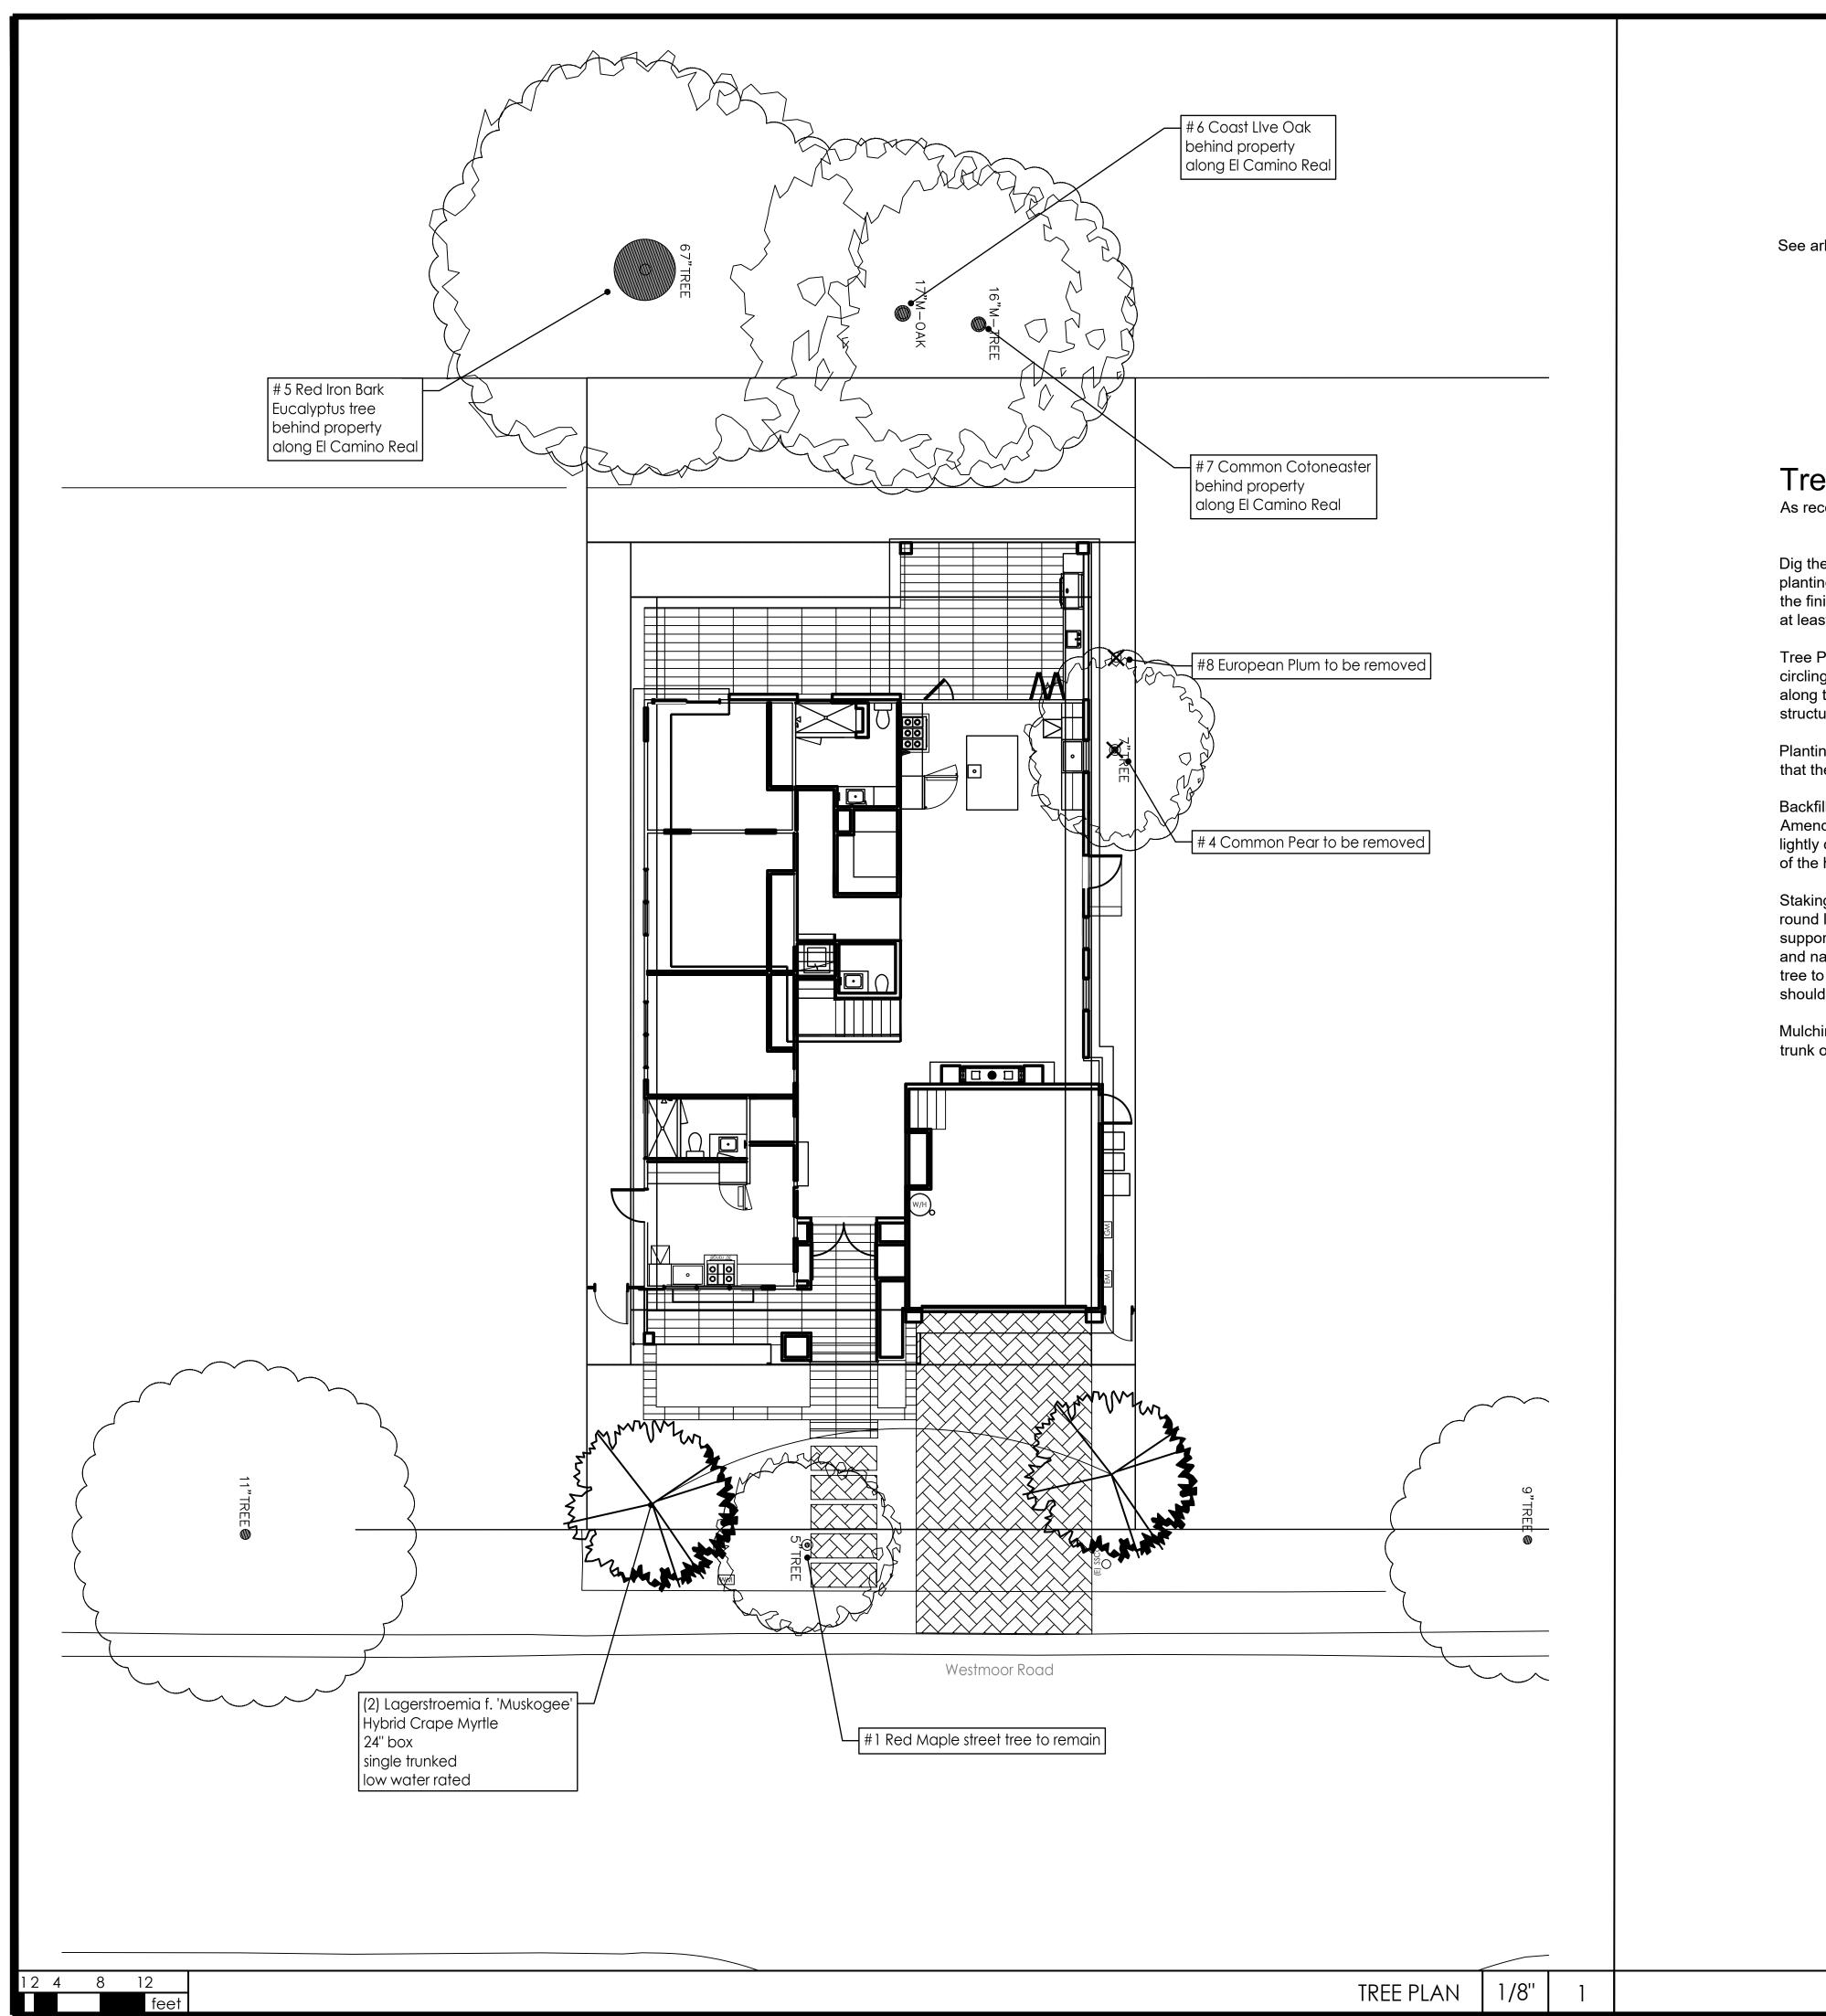
TREE PLAN

See arborist report by Kielty Arborists Services, LLC for existing trees.

Tree Planting

Dig the planting hole: Before digging locate all underground utilities and pipes such as water, gas and electrical. The planting hole needs to be only as deep as the container of the tree allowing for the root ball to sit 1 to 2 inches above the finished grade. The bottom of the hole should be compacted to ensure root ball will not settle. The hole should be at least twice the diameter of the container and the sides should be scored or sloped rather than vertical.

Tree Preparation: The tree purchased should be of good quality. Inspect the container before purchase for girdling, circling or twisted roots. Remove tree from container and prune any broken, circling or girdling roots. Roots matted along the sides and bottom of a container can be cut and spread apart. Remove any dead limbs and correct any structural defects such as multiple leaders.

Planting: Lightly compact bottom of the hole to avoid settling. Place tree in the hole and check depth to make sure that the final height of the root ball is 1 to 2 inches above grade. Check that the trunk is straight.

Backfilling: Soil from the hole should be satisfactory for backfill. If it is of poor quality, amendments may be added. Amended soil has not shown any significant benefits from native soil. Place backfill evenly around root ball and lightly compact and add water to eliminate air pockets. Any excess soil can be used to form a berm around the edge of the hole to hold in water.

Staking: Staking a newly planted tree protects the trunk, anchors the roots and supports the crown. Use a 2-inch round lodge pole stake (3 inch for 24" box size trees) and if possible, place it on the windward side of the tree for support. The stake should be place outside the root ball and 2 to 3 inch rubber ties should be installed with a twist and nailed back to the stake. Staking the tree too loosely will not support the tree; staking to tightly will not allow the tree to flex in the wind and develop a taper to support the tree. Staking is only a temporary treatment and the stake should be removed after 1 to 2 years.

Mulching: Place 3 to 4 inches of organic mulch around the tree to retain moisture. Avoid piling on mulch against the trunk of the tree.
