Kielty Arborist Services LLC
Certified Arborist WE#10724A TRAQ Qualified
P.O. Box 6187
San Mateo, CA 94403
650-532-4418

Site: 1385 Hillside Circle, Burlingame, CA

As requested on December 4th, 2023, Kielty Arborist Services visited the above site to provide a Tree Inventory Report/Tree Protection Plan for the proposed construction. 3 new homes are proposed for this site, and your concern as to the future health and safety of the tree has prompted this visit. Preliminary landscape plans L1 through L7 dated January 2024, lot 1 site plans A.1 through A.6 dated 10/26/22, lot 2 site plans A.1 through A.6 dated 10/26/21, and lot 3 plans A.1 through A.8 dated 10/26/21 were also reviewed for writing this report. This Tree Inventory Report is not a Tree Risk Assessment. As such, no trees were assessed for risk in accordance with industry standards, nor are there any tree risk ratings or risk mitigation recommendations provided within this preservation plan.

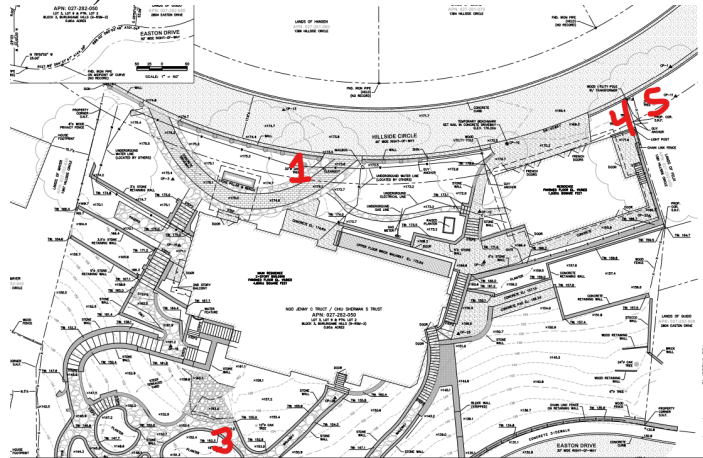
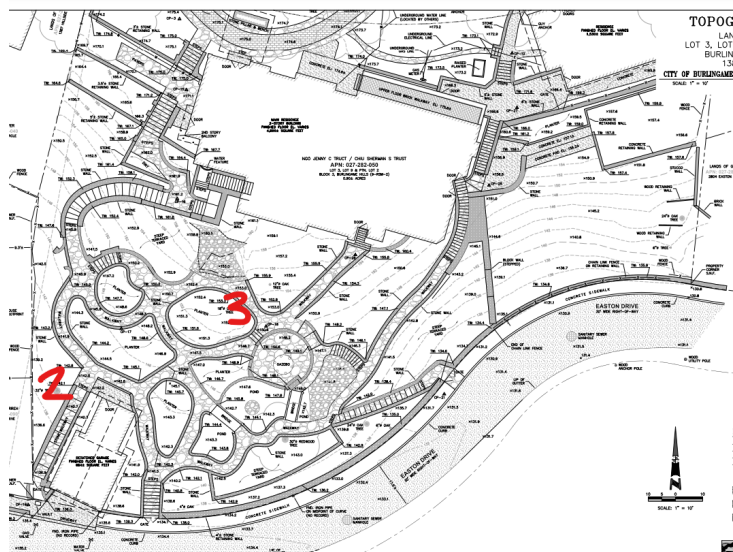
Tree Location Map

5 trees were surveyed. 3 native oak trees were observed as well as one invasive acacia tree and a neighboring African fern pine tree. All of the trees except acacia tree #4 are of a protected size in the city of Burlingame. Non-protected Black Acacia tree #4 is proposed for removal due to the tree's location near the proposed driveway/grading.
