CERTIFIED ARBORIST REPORT

October 15, 2021
Rev. February 1, 2022
Rev. June 2, 2022
5985.43

912 Linden Avenue
Burlingame, CA

HMH
1570 Oakland Road
San Jose, CA 95131
William Sowa
ISA Certified Arborist #WE-12270A

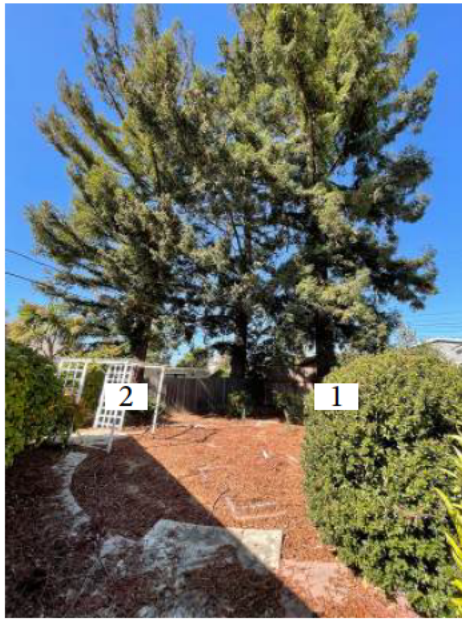
Redwood Tree

The redwood tree is a large specimen located at the back of the lot and makes up a very large canopy cluster of conifer trees include on large cedar tree that is offsite and tree #2 that is over the lot line. The tree is in good health however due to it's proximity to the others it has structural defects in the crown. If the cedar tree is removed there will be an obvious lopsidedness to this tree. The root structure is also very large so any construction activity could weekend the tree. Redwood trees are higher water use plants and if this tree is to be retained it should receive supplemental irrigation until regular irrigation can be established around the root zone.

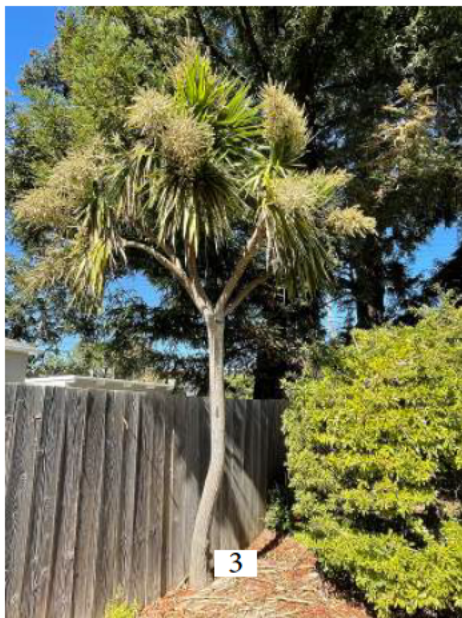
Yucca Tree

The yucca tree is in moderate shape. It is planted close to the fence and had developed a lean and misshapen trunk. There is low value for this tree from an ornamental point of view and removal is recommended.
