# Advanced Tree Care

Re: Coastal redwood at front of property

This letter provides the justification for the proposed removal of two redwood trees located at 1347 Montero Avenue, Burlingame, California. The evaluation is based on visual ground-level inspection and assessment of tree health, structural integrity, form, suitability for preservation, and site constraints. The findings are presented in alignment with the City of Burlingame ordinance criteria for public nuisance determinations and permit review factors.

TREE INVENTORY SURVEY

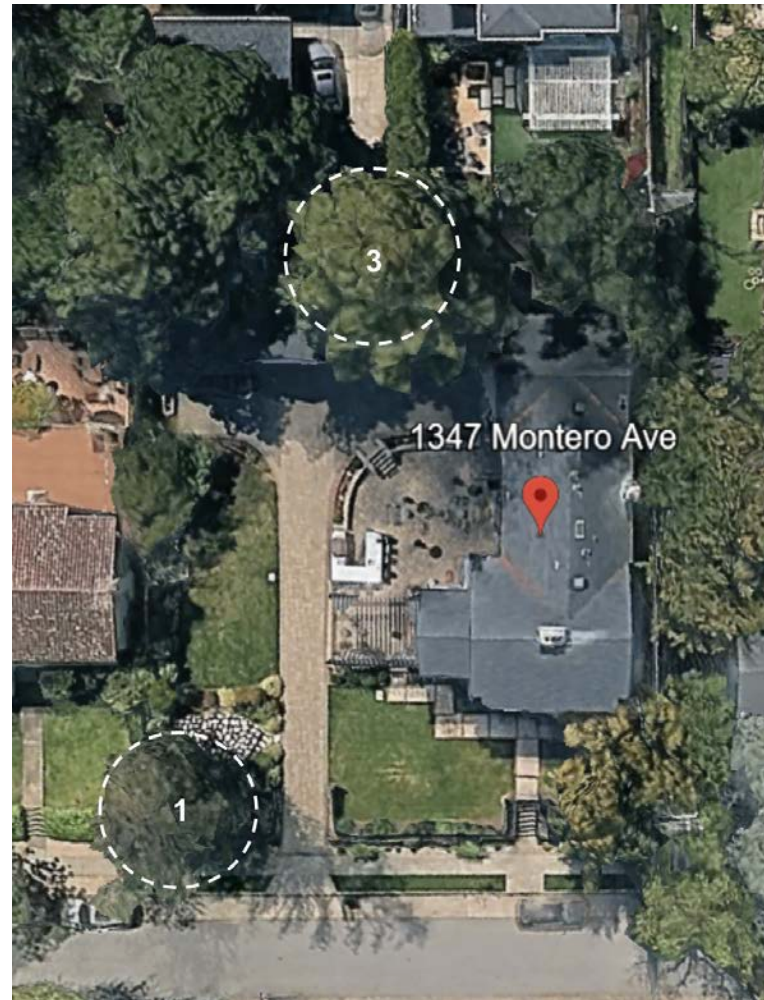
## TREE MAP

| Tree Tag Number | Protected Tree Status | Preservation or Removal Recommendation | Common Name / Botanical Name | Trunk Diameter at Breast Height (DBH, inches) | Tree Height (ft.) / Canopy Spread (ft.) | Overall Health Assessment | Structural Integrity Assessment | Form and Aesthetic Quality Assessment | Preservation Suitability Rating | Overall Condition Score (0-100%) | Arborist Observations and Tree Notes |
|---|---|---|---|---|---|---|---|---|---|---|---|
| 3 | Yes | (R) | Redwood<br><i>Sequoia sempervirens</i> | 66.7 | 90/45 | Fair | Poor | Fair | Poor | 45 | Codominant at 5' with seam running down to grade. Smaller leader closest to garage becomes codominant again at 40 feet. Weak attachments at codominant unions, 4 feet from existing garage. Swelling root flare up against garage foundation, causing damage to garage slab, covered in artificial turf. 5.5 feet from the brick retaining wall at the driveway, at risk of large leader failure damaging the garage and adjacent overhead utility lines. |
