**Kielty Arborist Services LLC**  
Certified Arborist WE#10724A TRAQ Qualified  
P.O. Box 6187  
San Mateo, CA 94403  
650-532-4418

February 16<sup>th</sup>, 2024

Site: 1385 Hillside Circle, Burlingame, CA

As requested on December 4<sup>th</sup>, 2023, Kielty Arborist Services visited the above site to provide a Tree Inventory Report/Tree Protection Plan for the proposed construction. 3 new homes are proposed for this site, and your concern as to the future health and safety of the tree has prompted this visit. Preliminary landscape plans L1 through L7 dated January 2024, lot 1 site plans A.1 through A.6 dated 10/26/22, lot 2 site plans A.1 through A.6 dated 10/26/21, and lot 3 plans A.1 through A.8 dated 10/26/21 were also reviewed for writing this report. This Tree Inventory Report is not a Tree Risk Assessment. As such, no trees were assessed for risk in accordance with industry standards, nor are there any tree risk ratings or risk mitigation recommendations provided within this preservation plan.

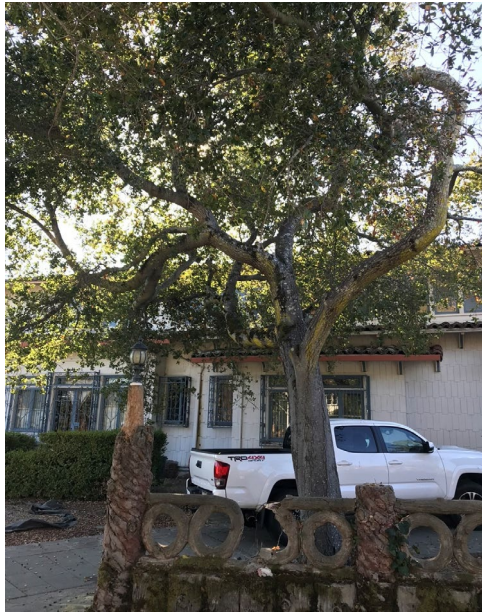
Oak tree #1 is to be retained. The tree is adjacent to an existing driveway. It is recommended to temporarily retain the existing driveway near this tree when underneath the dripline of the tree during the building phase of the project. Temporarily retaining the driveway will act as a tree protection measure and will help to increase staging and access to the site, as removing the driveway at the beginning of the project would make for a larger tree protection zone needed with the fencing being located at the tree's drip line. The existing grade within the tree's dripline is recommended to be retained as is where possible. No grading or excavation is recommended to take place within 10' from this tree (6x diameter) except for the removal of the driveway. At the end of the project, when it is time to demolish the existing driveway near this tree, the Project Arborist is

**Showing portion of driveway recommended to be retained until the landscape phase of the project.**

recommended to be on-site to document and witness the removal of the driveway. A jackhammer is recommended to be used when working within the tree's dripline to break the concrete material into hand manageable-sized pieces. Once broken down the driveway material is recommended to be removed by hand. Exposed roots during the process are recommended to be wrapped in layers of wetted-down burlap to avoid root desiccation. The existing driveway area is recommended to be filled back in once the driveway has been removed so that no roots are exposed to the elements. When backfilling the soil in this area, the area is also to be irrigated. The proposed driveway is further from the tree than the existing driveway and outside of the 10' range and is not expected to have impacts on the tree. The tree is recommended to be deep water fertilized with Nutriroot once the work near the tree has taken place as a mitigation measure for any minor impacts that may take place.
