# 121 Pepper Avenue Burlingame, CA Arborist Report 2024

January 9th, 2025. **Revised April 7, 2025**

Subject: Tree protection plan for 121 Pepper Ave, Burlingame, CA 94010

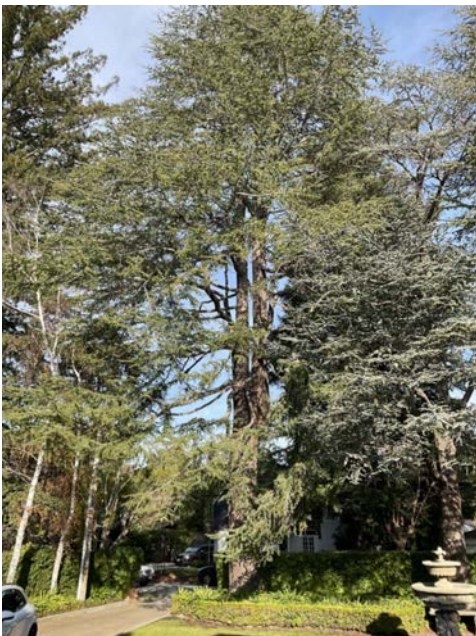
Tree tag #3 - deodar cedar was assigned a poor condition rating. The tree exhibits codominance of the main stem 30 feet above grade and previous limb loss. A cavity, debris, and included bark are visible at the codominant union. The cavity at the codominant union with included bark makes the tree a hazard to property residents, pedestrians, and construction personnel, as the tree is at risk of a significant leader failure. A Level II Tree Risk Assessment was performed on the tree and documentation will be included in this report outlining the findings.

A new, repositioned driveway is proposed for the area in between trees #2 and #3. The client proposed the removal of tree #2 in order to accommodate the new driveway, however we suggested that tree #2 is not a good candidate for removal. We discussed tree removal and design feasibility in length and concluded that best alternative for all stakeholders involves the removal of cedar #3, based on its poor condition rating and the condition issues that the tree displays.
