**Kielty Arborist Services LLC**  
Certified Arborist WE#10724A TRAQ Qualified  
P.O. Box 6187  
San Mateo, CA 94403  
650-532-4418

February 16<sup>th</sup>, 2024

Site: 1385 Hillside Circle, Burlingame, CA

As requested on December 4<sup>th</sup>, 2023, Kielty Arborist Services visited the above site to provide a Tree Inventory Report/Tree Protection Plan for the proposed construction. 3 new homes are proposed for this site, and your concern as to the future health and safety of the tree has prompted this visit. Preliminary landscape plans L1 through L7 dated January 2024, lot 1 site plans A.1 through A.6 dated 10/26/22, lot 2 site plans A.1 through A.6 dated 10/26/21, and lot 3 plans A.1 through A.8 dated 10/26/21 were also reviewed for writing this report. This Tree Inventory Report is not a Tree Risk Assessment. As such, no trees were assessed for risk in accordance with industry standards, nor are there any tree risk ratings or risk mitigation recommendations provided within this preservation plan.

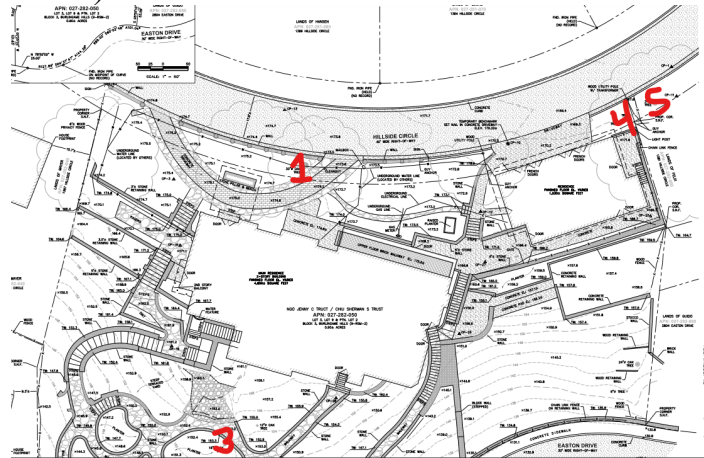
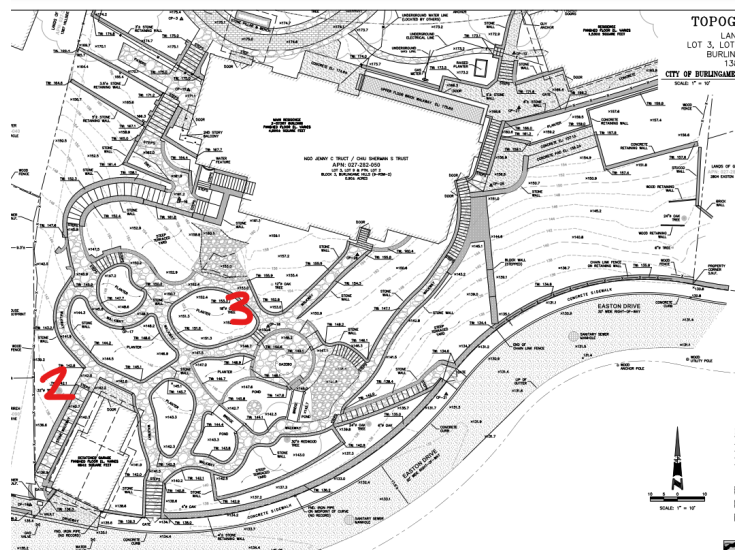
**Tree Location Map**

5 trees were surveyed. 3 native oak trees were observed as well as one invasive acacia tree and a neighboring African fern pine tree. All of the trees except acacia tree #4 are of a protected size in the city of Burlingame. Non-protected Black Acacia tree #4 is proposed for removal due to the tree's location near the proposed driveway/grading.
