**Subject:**       **ARBORIST REPORT**  
Mr. Jeffrey Chan  
1113-1115 Paloma Ave.  
Burlingame, CA. 94010

You own the property at 1113-1115 Paloma Avenue in Burlingame. You plan to develop the site with the demolition of two (2) existing residential units, and the construction of three (3) condominiums.

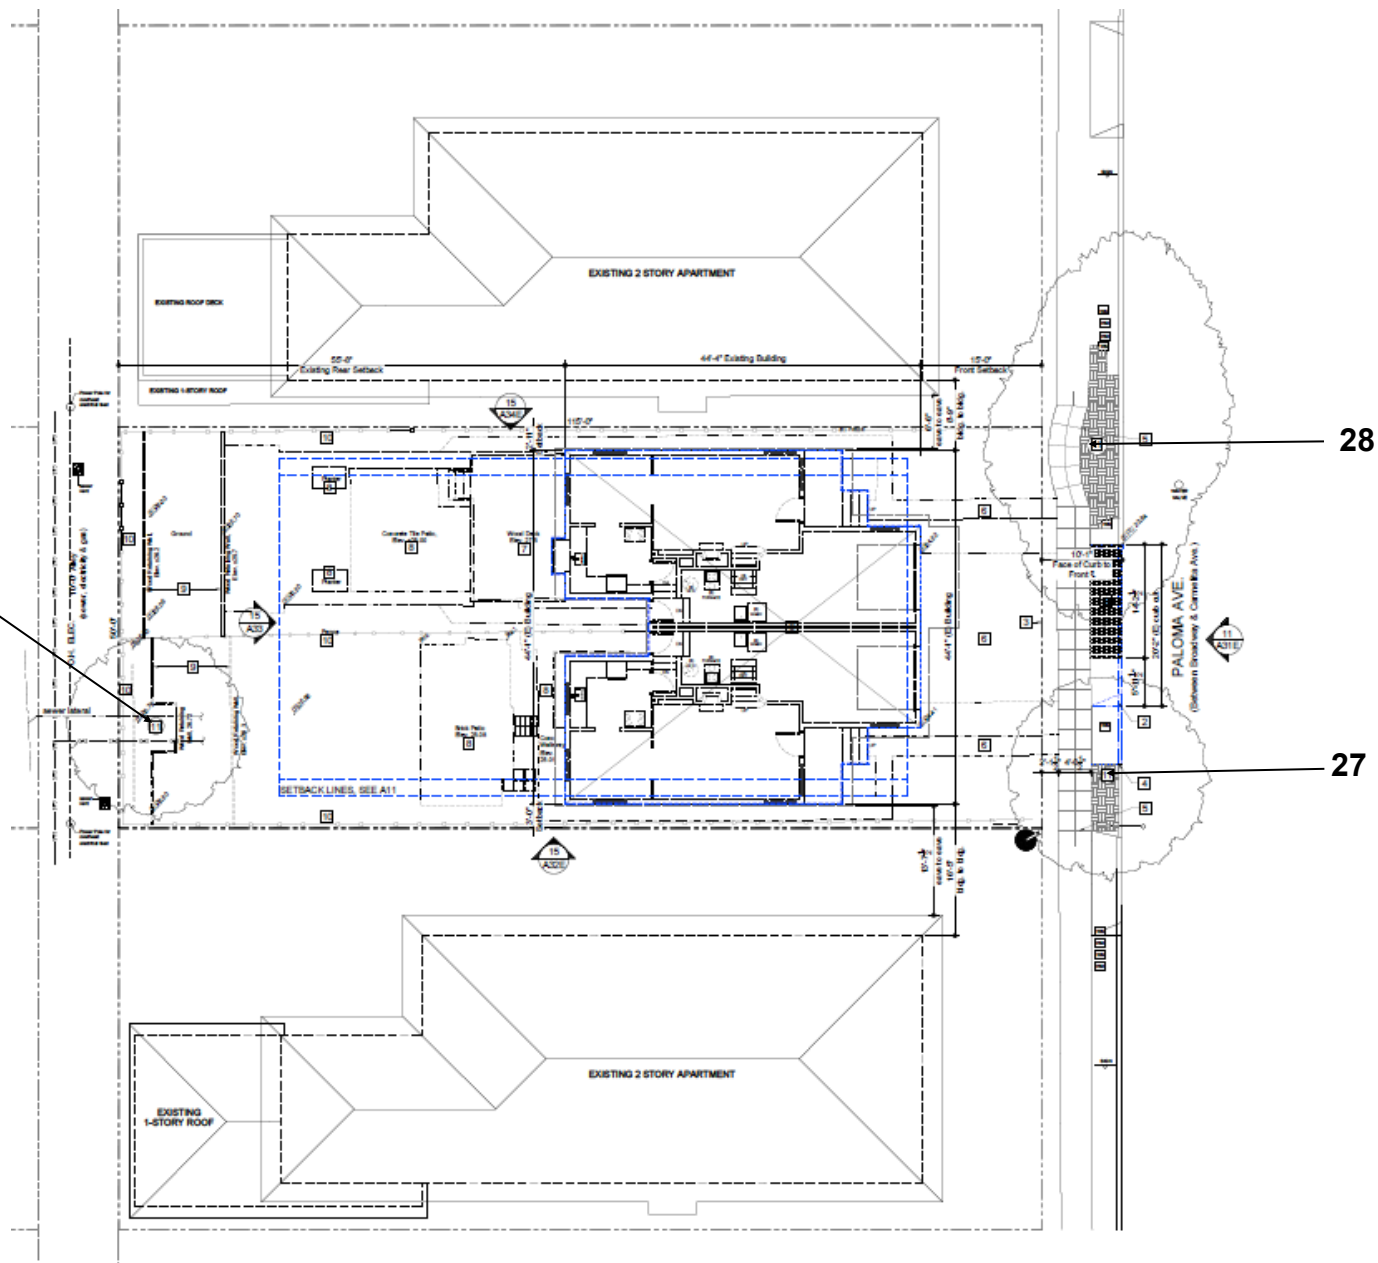
Tree Tag #	Scientific Name	Common Name	Trunk Dia. (in.)	Calculated Circum. (in.)	Condition 1-poor 5-excellent	Protected Tree? Y/N	Driplines (ft.) N S E W	Comments	Recommendations
27	<i>Ginkgo biloba</i>	Maidenhair tree	21	66	2.5	Y	20 18 19 16	Street tree in sidewalk planting strip; poor structure; lowest branch 6' N; codominant branching 10'; upright stems; lower laterals removed; bulge and included bark at codominant attachment; headed to E; epicormics at old wound sites; sidewalk and curb displaced; at street light; moderate vigor.	Preserve.
28	<i>Magnolia grandiflora</i>	Southern magnolia	29	91	2.5	Y	28 28 24 27	Street tree in sidewalk planting strip; poor structure; clockwise trunk torsion; lowest branch 8' N; decay at branch wounds and along lateral stem to N; epicormic shoots along laterals; surface roots, skinned roots, and roots pruned for sidewalk repair; fair-moderate vigor.	Preserve.

29	<i>Fagus sylvatica</i>	European beech	13,8,7	53	1.0	Y	11 12 18 12	Backyard at SW perimeter fence; poor structure; hollow buttress roots to NW; trunk lean to SE; lowest branch 1' to S; dead stems to W and N;; mycellial fans of armillaria root rot on trunk; headed; soggy soil within dripine; epicormic shoots; low vigor and almost dead.	Remove; development impacts outside tree tolerance.
